POOLC PLATFORM HOGAN SUBMARINE CABLE REPAIR PROJECT

MARCH & APRIL 2008

SANTA BARBARA CHANNEL

LONGITUDE 123, INC.

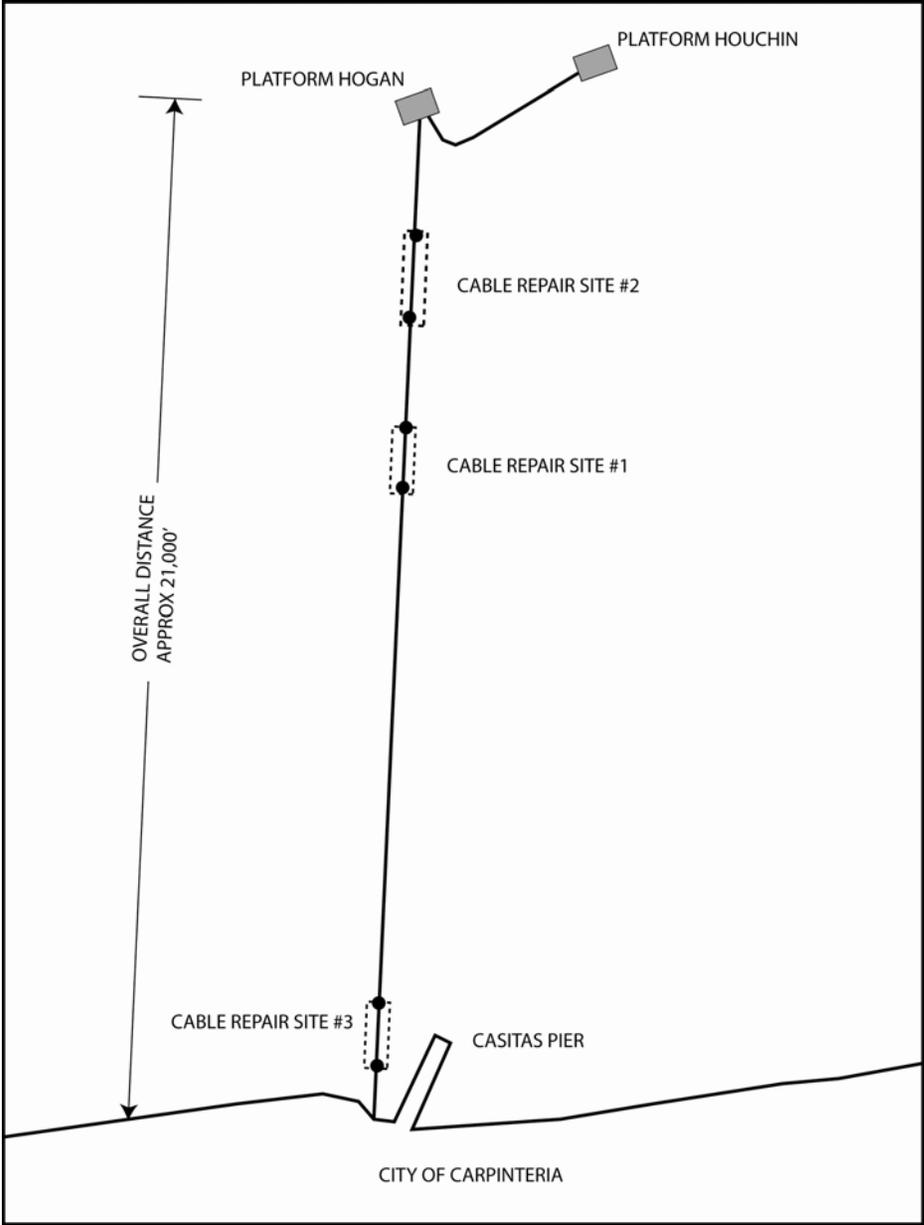
FINAL PROJECT SITE MAP:

- The cable is cut and recovered through trawl-mark Location “B” (Cable Repair Site #1), a distance of approx 307 feet. The cable is found located east of the trawl marks, no fault is found. A “Dutchman” repair cable segment of approx 600 feet is installed (including vertical legs). This repair site is located between 11,948’ and 12,255’ offshore.

- The cable is cut and recovered through trawl-mark Location “A” (Cable Repair Site #2), a distance of approximately 700 feet. A fault is found in the cable. A “Dutchman” repair cable segment of approx 1,000 feet is installed (including vertical legs). This repair site is located between 13,776’ and 14,474’ offshore.

- The cable is cut and recovered at Cable Repair Site #3, a distance of approximately 400 feet. This is the location of three repair splices performed in 1980. One of the existing repair boxes is removed with this segment. A fault is found in the cable. A “Dutchman” repair cable segment of approx 700 feet is installed (including vertical legs).

- All repair segments are buried a minimum of 1 meter below the seafloor using hand-jetting techniques.
- The work was completed in 26 days working 7-day weeks. There were no accidents, injuries or incidents of any kind.

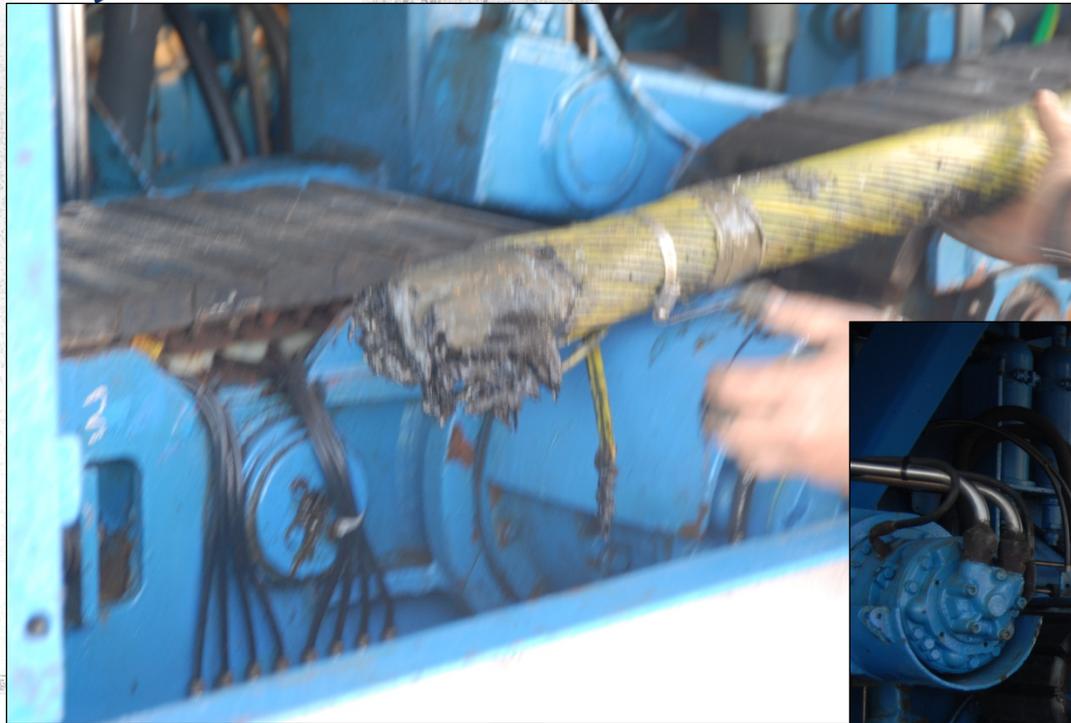
First cable cut in the LCE.

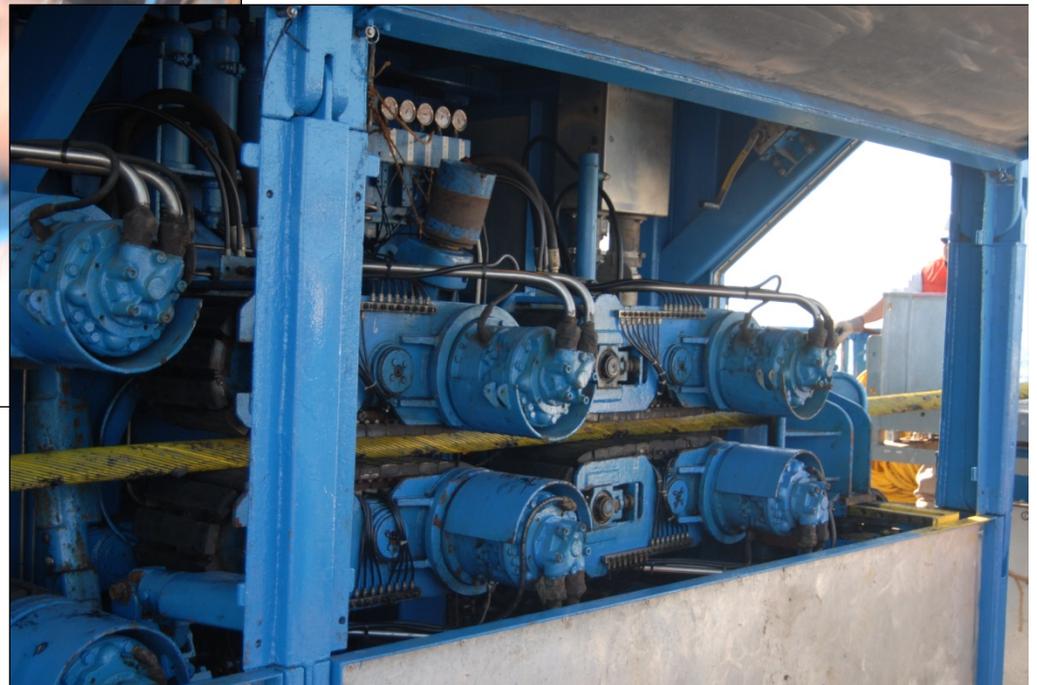
LCE hauling existing cable aboard.

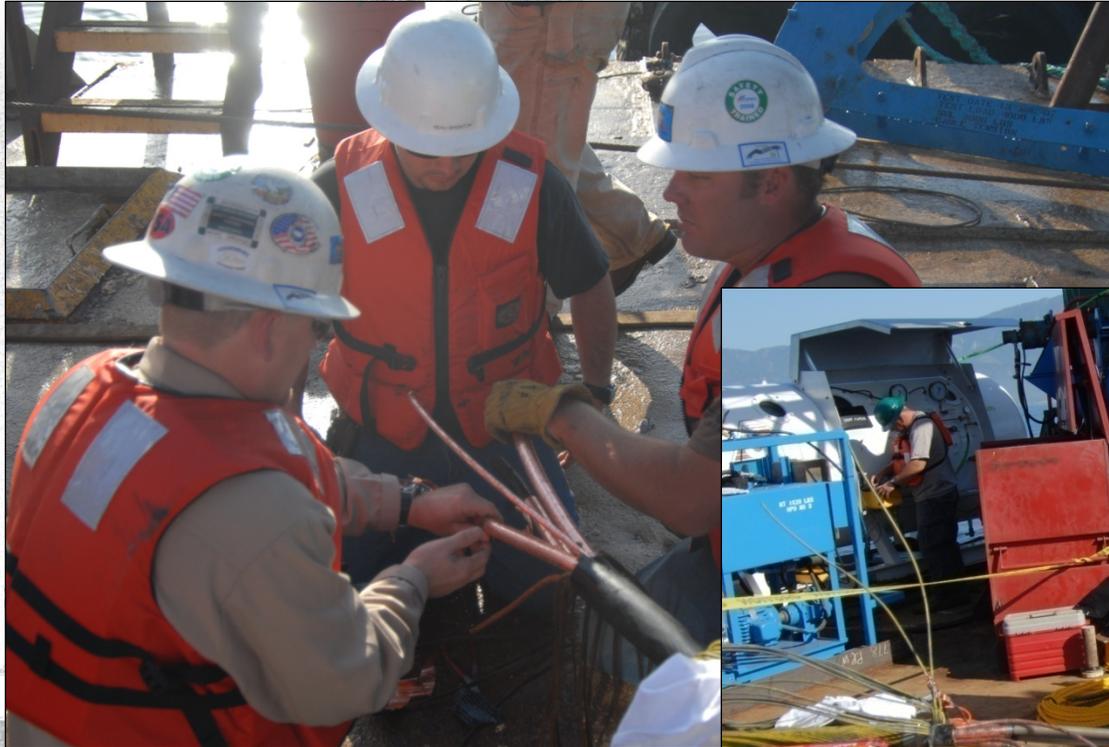
Hampton Tedder crews preparing cable end for testing.

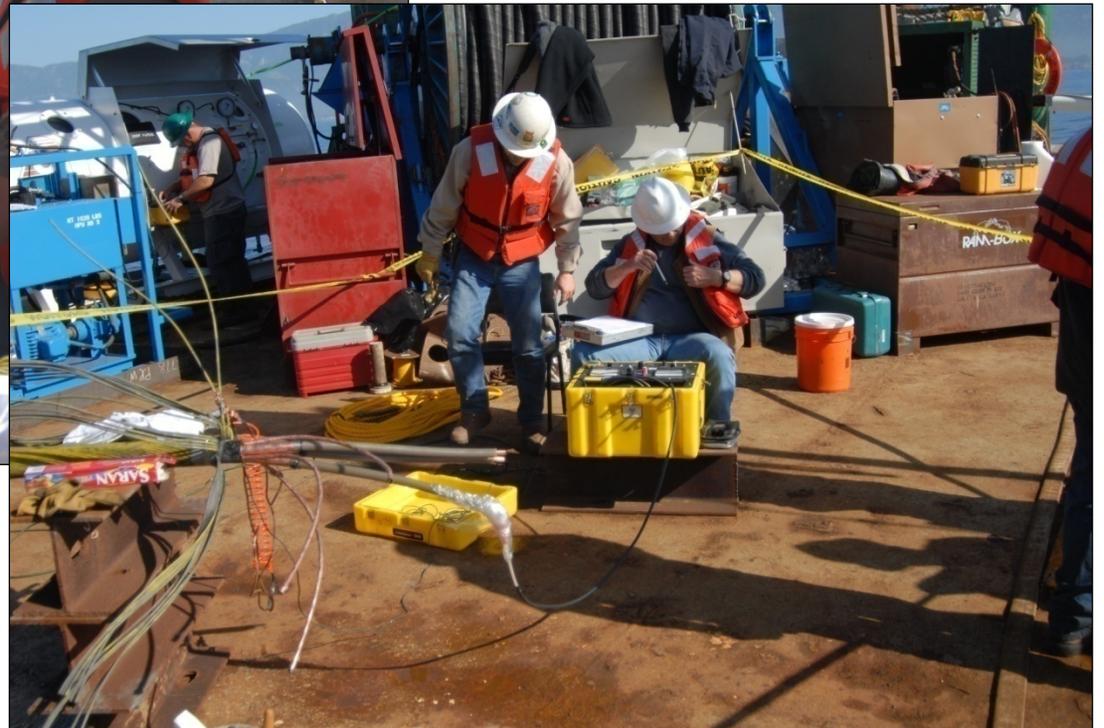
Hi-Pot testing cable segment.

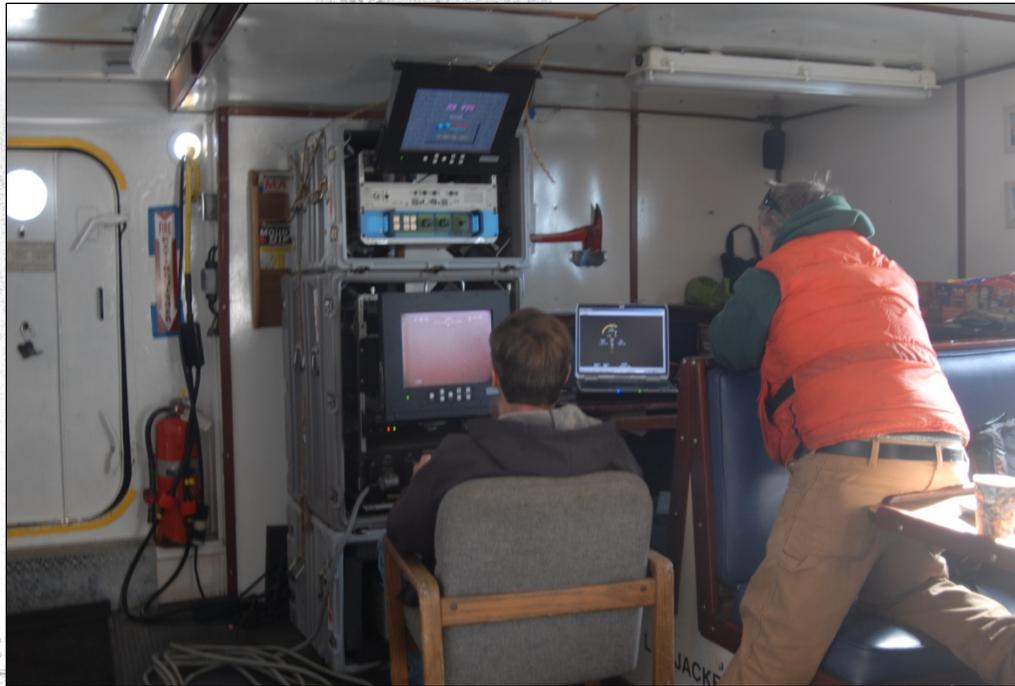
L3-Maripro ROV operator locating cable with cable tracker.

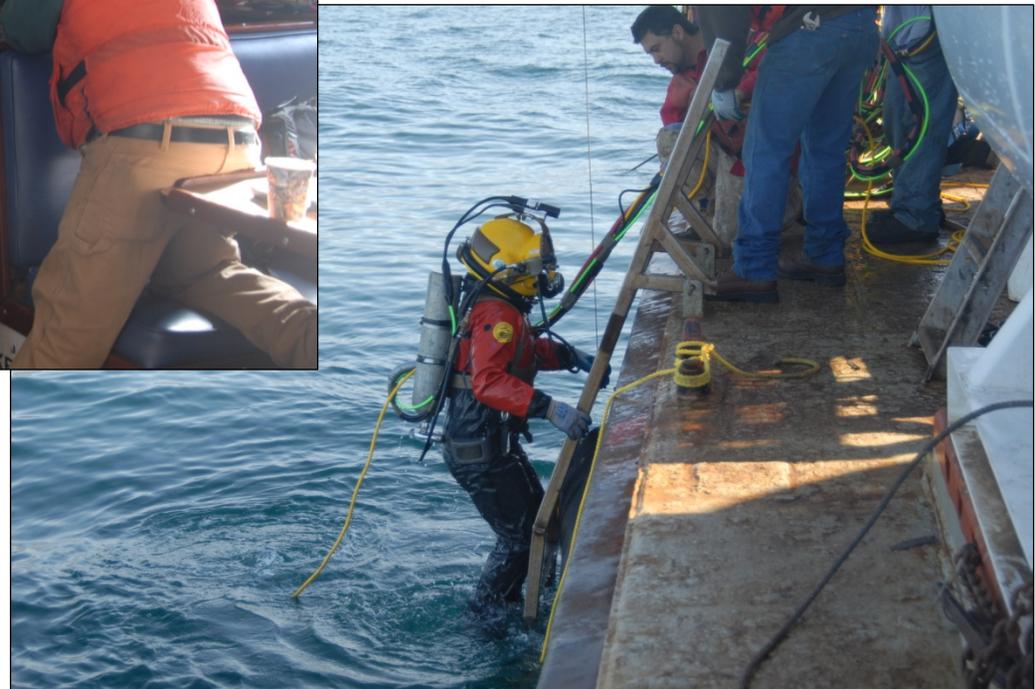
APC diver exiting water after cable location and recovery.

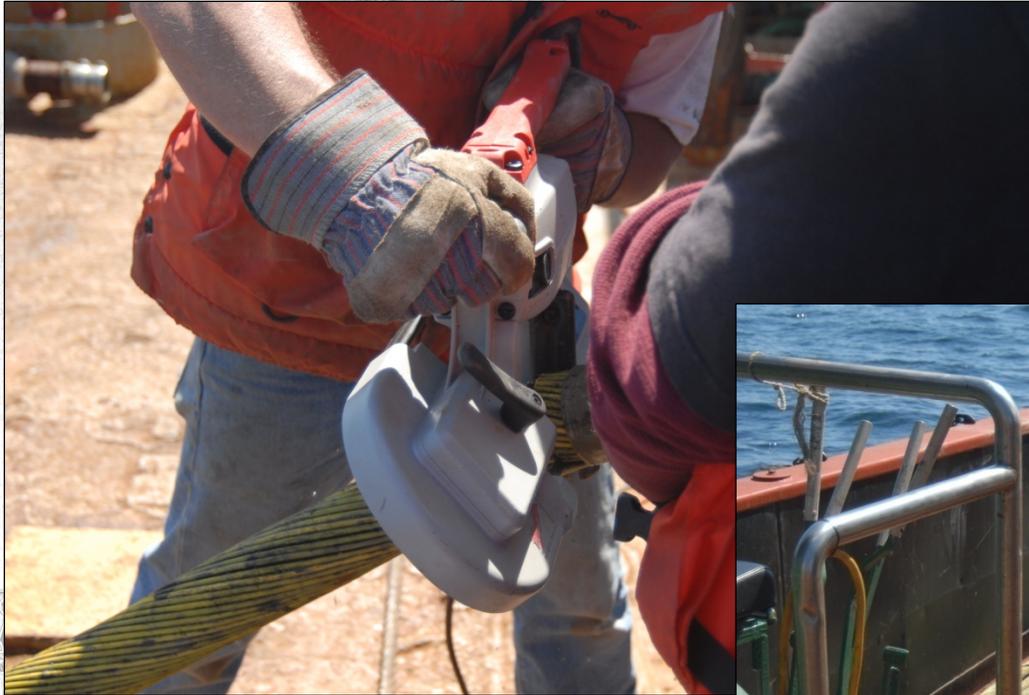
APC crews cut old cable into 25' pcs w/ handheld electric bandsaw.

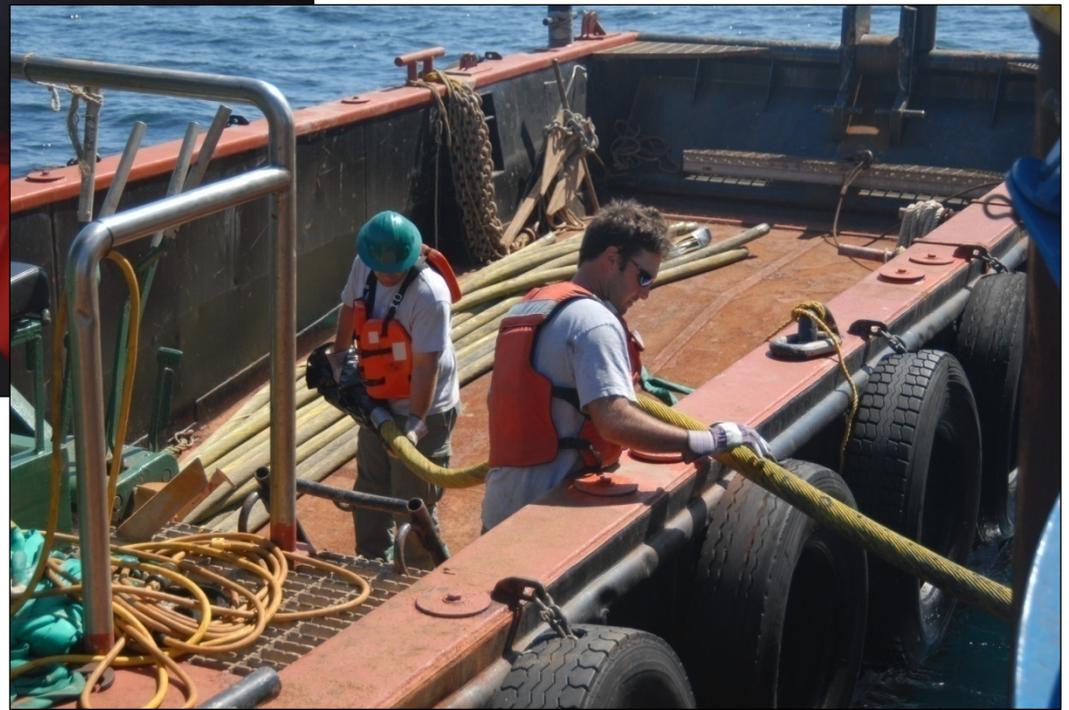
Cut pcs of old cable were stored on T/B Moe.

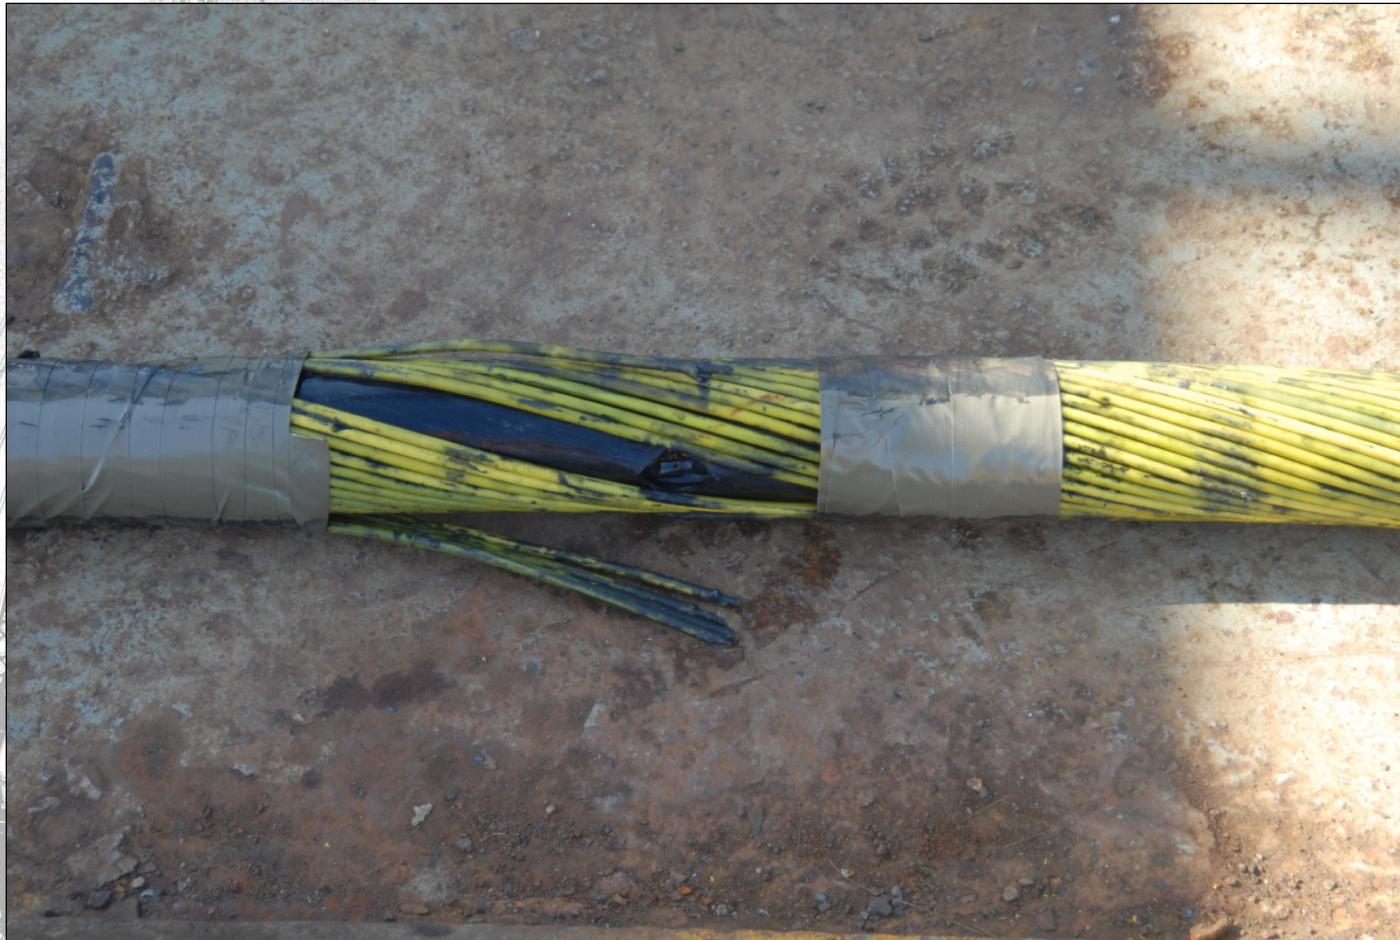
Hole in side of cable at cable fault created when cable was “thumped”.

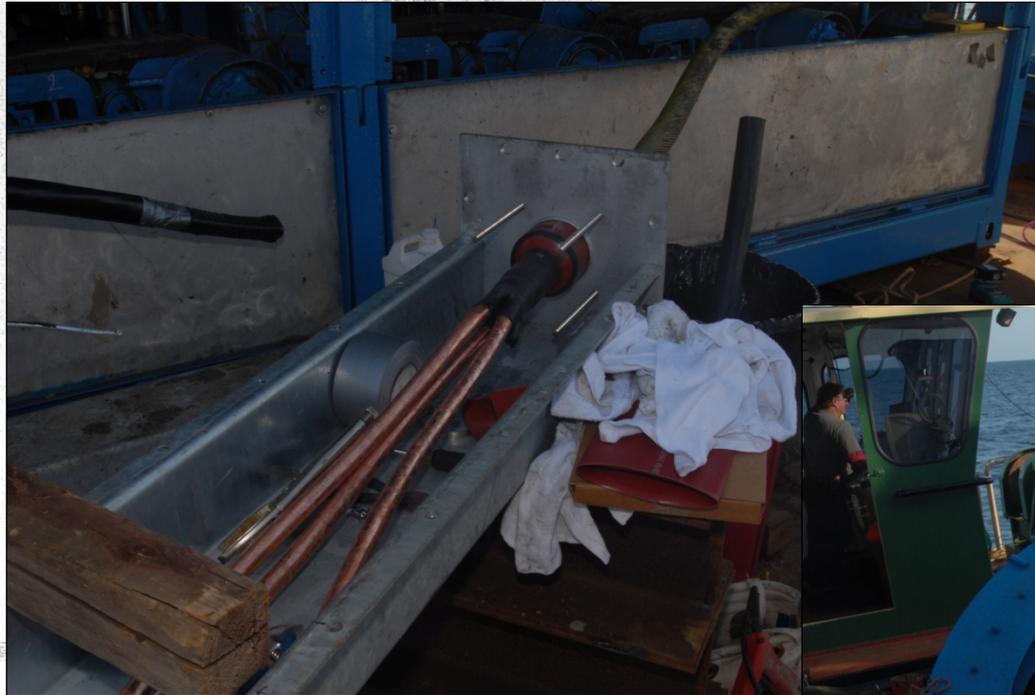
Cable splice under construction.

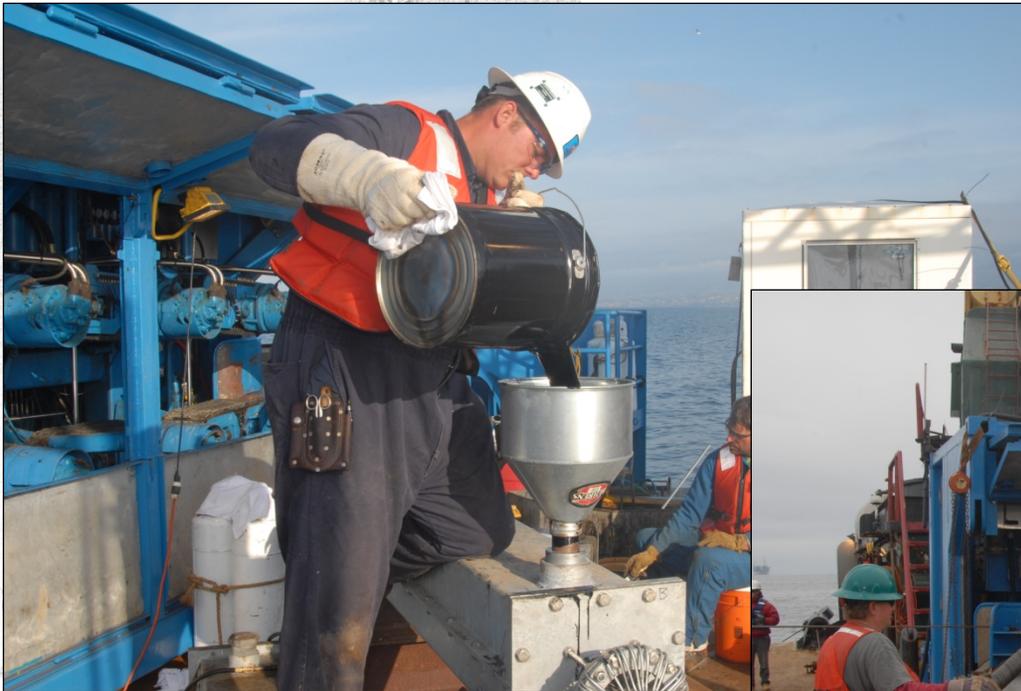
Splice box being filled with No-Void.

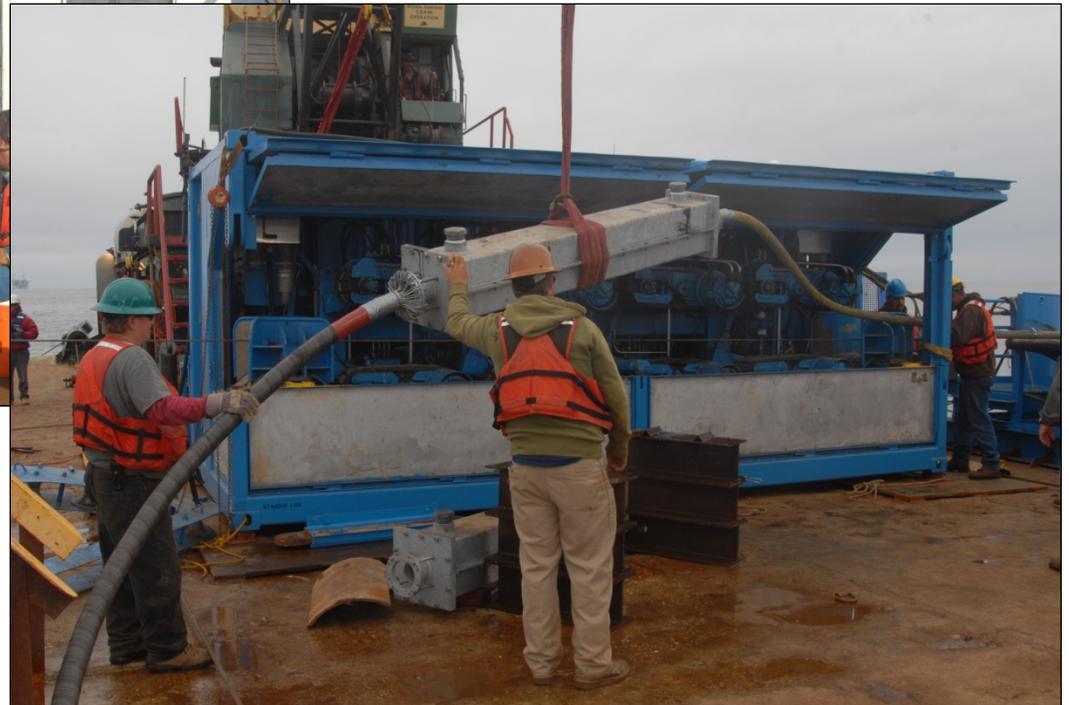
Splice box rigged and ready to overboard.
