Update of Pacific OCS Region Pipelines

Theresa Bell, Petroleum Engineer
Prevention First
Long Beach, Calif., October 2014

Bureau of Safety and Environmental Enforcement (BSEE)

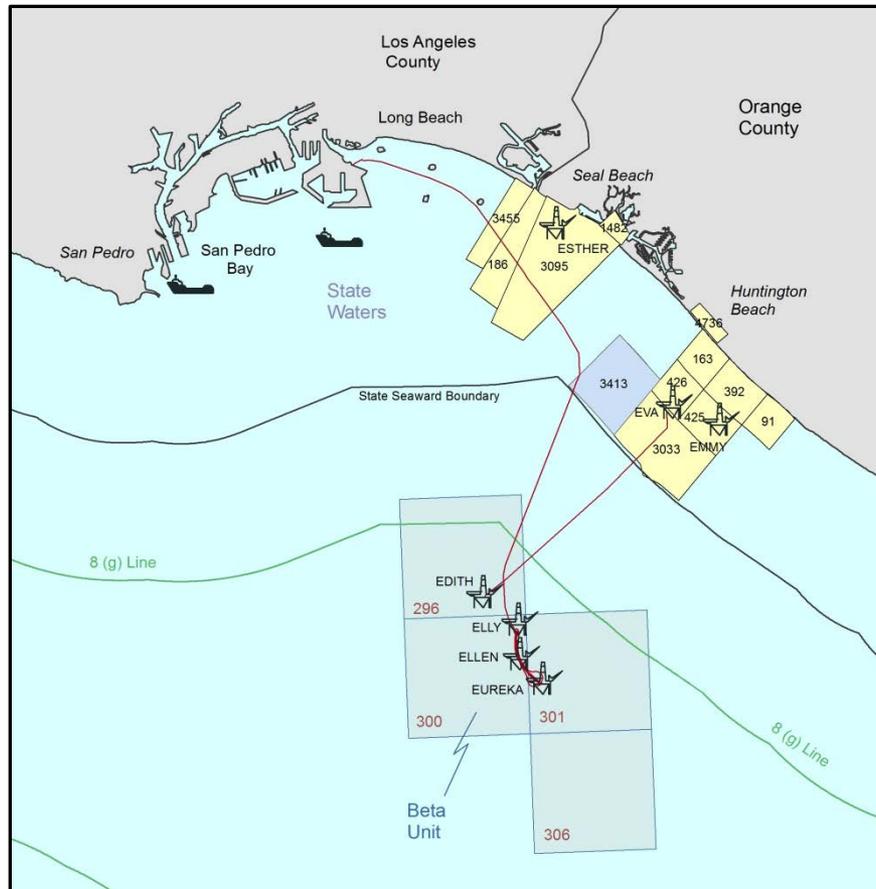
Beta – Cathodic Protection

- Inspection type: ROV and cathodic protection survey
- Problem identified: Platform Elly to shore oil pipeline historically has low cathodic protection readings; less negative than required

- Install 5 test points for future readings,
2 anode sleds, and 4 articulated mats

- All installed except for the 5th test point (in
Long Beach Harbor), due to depth of cover

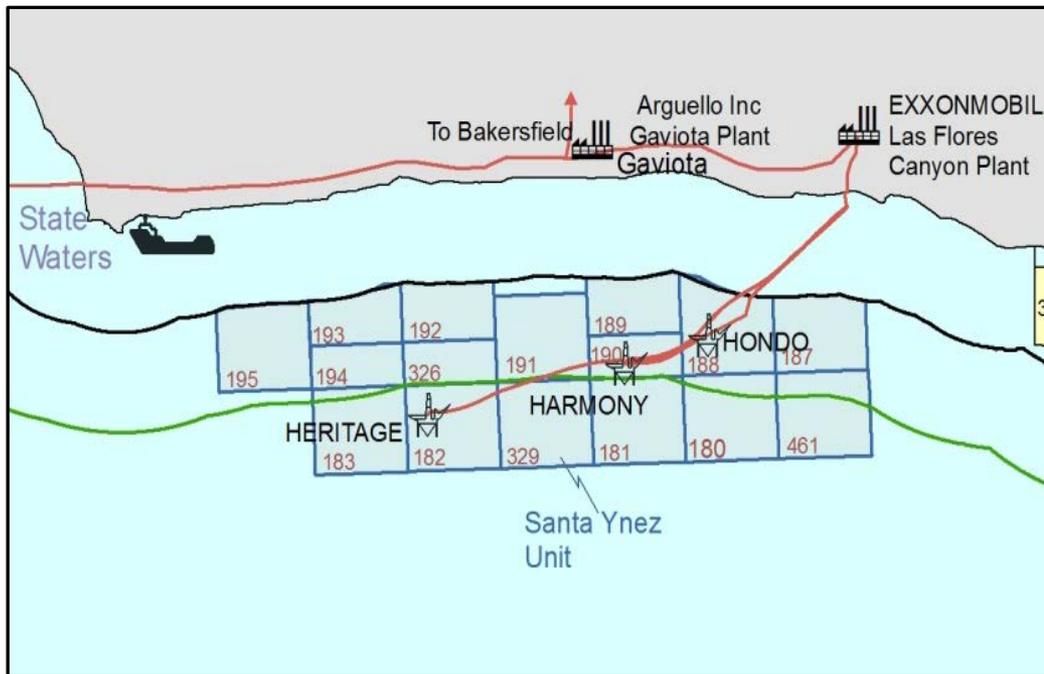
Santa Ynez Unit – Span Remediation

- Inspection type: ROV survey
- Problem identified: Multiple pipelines with excessive span lengths

- Solution:
Setting concrete in burlap bags at predetermined locations under and along the pipelines

Site ID	Pipeline	Remediation
M-1	20" Oil	3 span supports (up to 10" of water under pipeline)
M-2	12" Water	3 span supports (up to 8" of water under pipeline)
M-3	12" Water	4 span supports (up to 12" of water under pipeline)
M-4	20" Oil	3 span supports (up to 10" of water under pipeline)
M-5	12" Gas	4 span supports (up to 18" of water under pipeline)
M-6	12" Gas	3 span supports (up to 12" of water under pipeline)

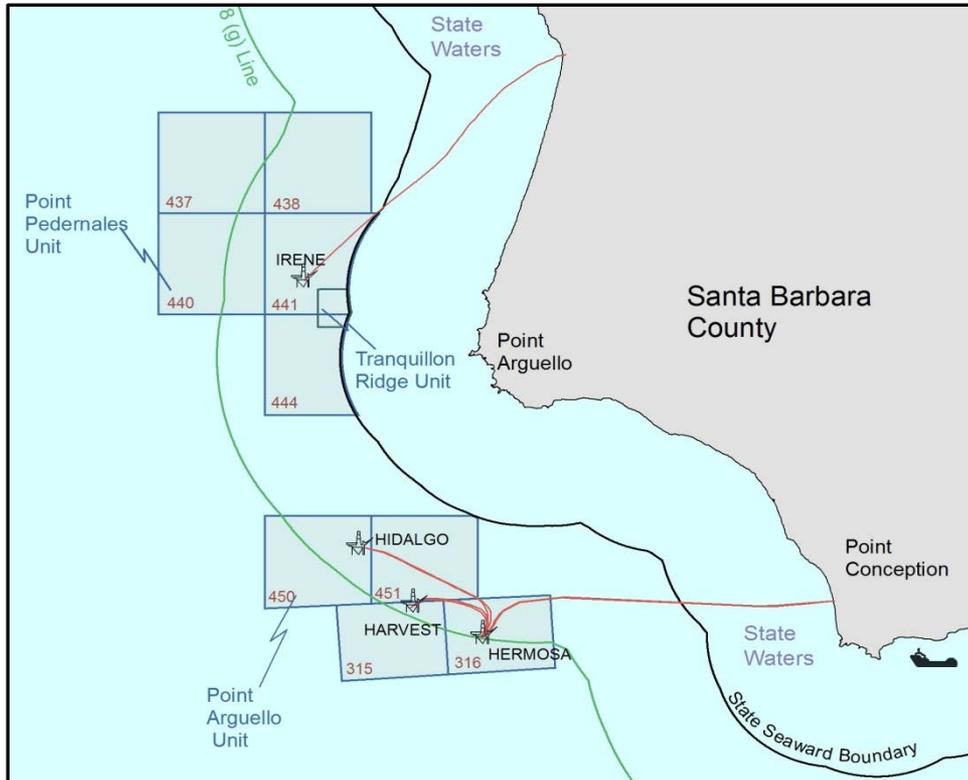
Irene – Pipeline Repair

- Inspection type: Internal inspection (smart pig)
- Problem identified: Wall loss on Irene oil pipeline riser at -35 feet

Results of Irene Riser Oil Emulsion Pipeline Inspections		
Year	Type of Inspection	Wall Loss
2004	Smart Pig	45%
2004	UT/ Pit Gauge	40%
2005	Smart Pig	40%
2006	Smart Pig	40%
2007	Smart Pig	32%
2008	Smart Pig	41%
2009	Smart Pig	49%
2010	UT/ Pit Gauge	41%
2010	Smart Pig	47%
2011	Smart Pig	36%
2012	Smart Pig	54%

- Solution:
Relocate riser support clamp and install full encirclement clamp over wall loss
