## Appendix C: DPR Site Records

\*Resource Name or #: Y-3

**P1. Other Identifier:** Goodnow Slough

2007 Archaeological Survey Report for the PG&E Line 406 Pipeline Project, Yolo County, California. Prepared for CH2M HILL. 155 Grand Avenue, Suite 100, Oakland, CA 94612. Prepared by Garcia and Associates, 1512 Franklin Street, Suite 100, Oakland, CA 94612.

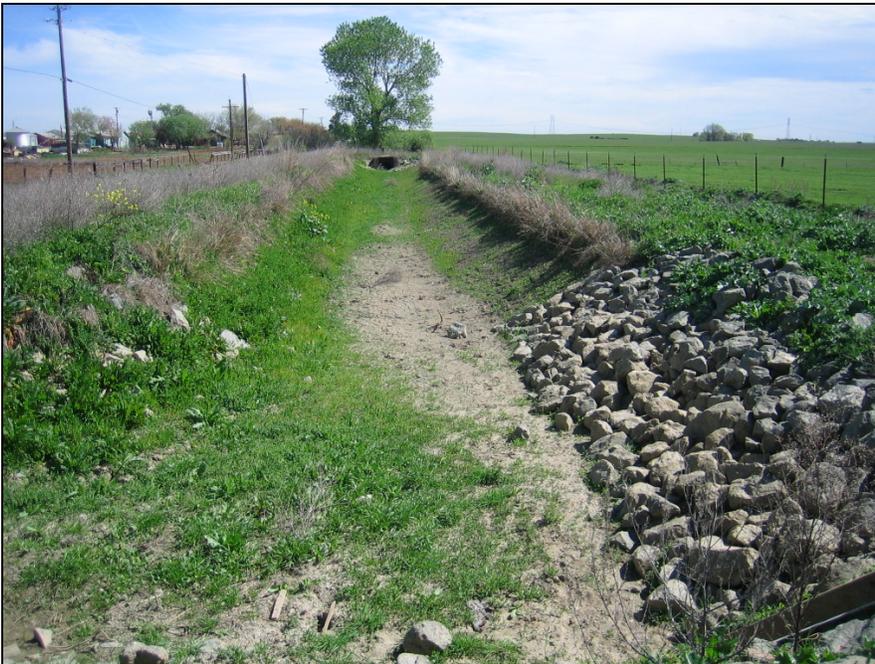
Eastern overview of Goodnow Slough; ditch is on the south side of County Road 17 and at this point parallel to CR 17; 03/19/2007; IMG\_1368.

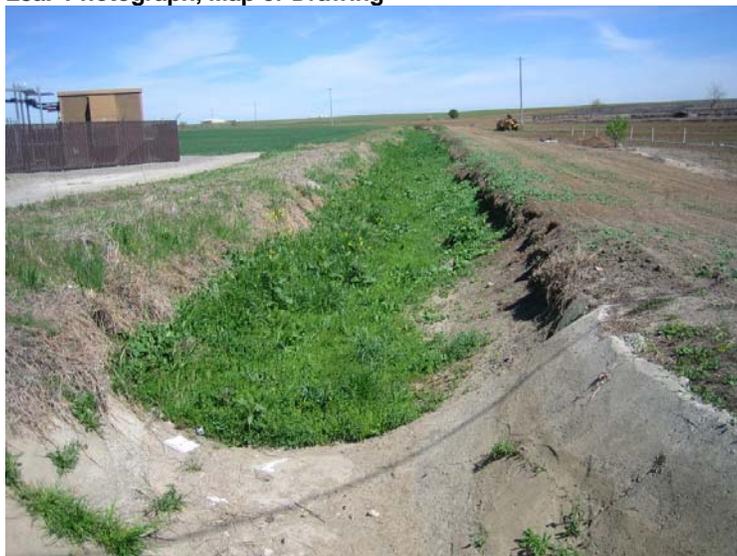
The canal is in excellent condition and is presently in use and actively maintained.

Overview of the Goodnow Slough north of County Road 17, facing north; 03/19/2007; IMG\_1367.

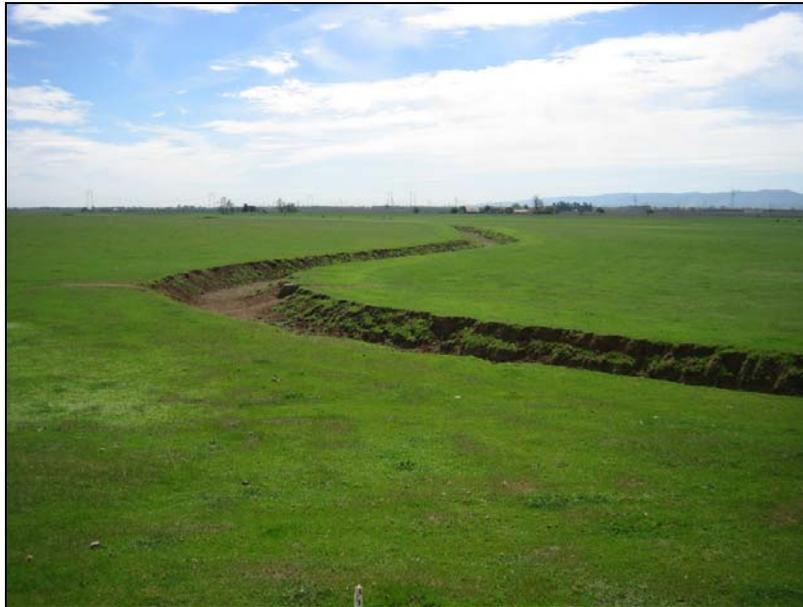
Southerly overview of Goodnow Slough situated in grazing lands south of County Road 17; 03/19/2007; IMG\_1369.

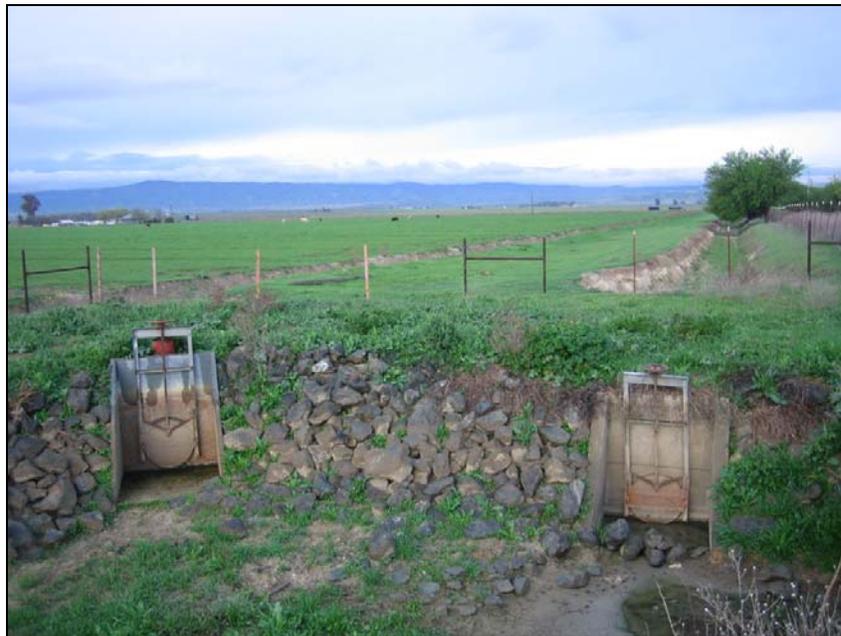
Southwestern overview of two ditch gates opening into two parallel spurs off the Goodnow Slough; 03/20/2007; IMG\_1389.

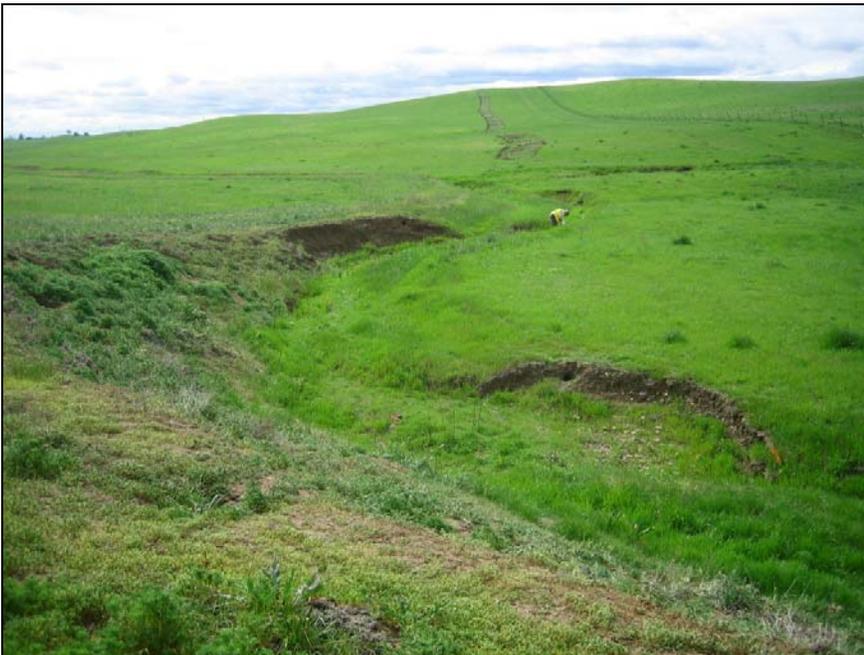
Southern overview of gulch with historic trash; 03/20/2007; IMG\_1397

\*A7. **Site Condition:**  Good  Fair  Poor (Describe disturbances.): The artifacts are eroding out of the side walls of the gulch and downstream.

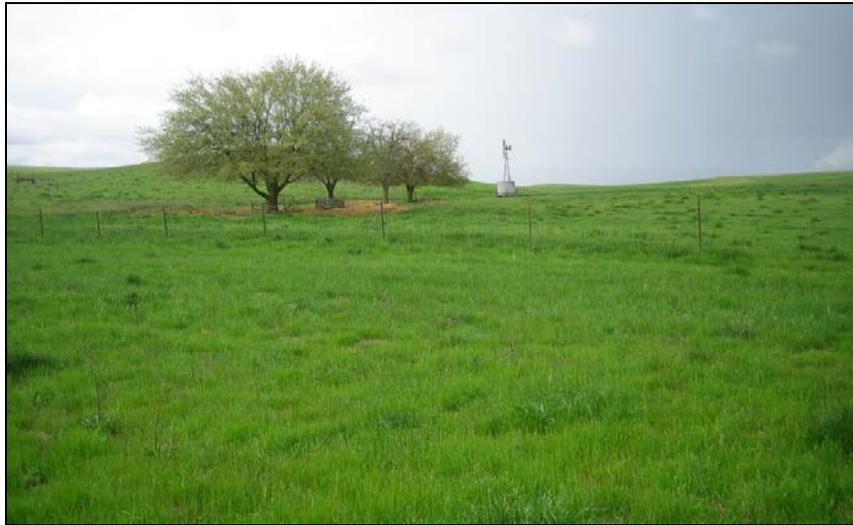
Southwesterly overview of water well with windmill, row of four trees, trough, and water tank, located 160 feet west of the Y-6 historic trash dump; 03/20/2007; IMG\_1393.

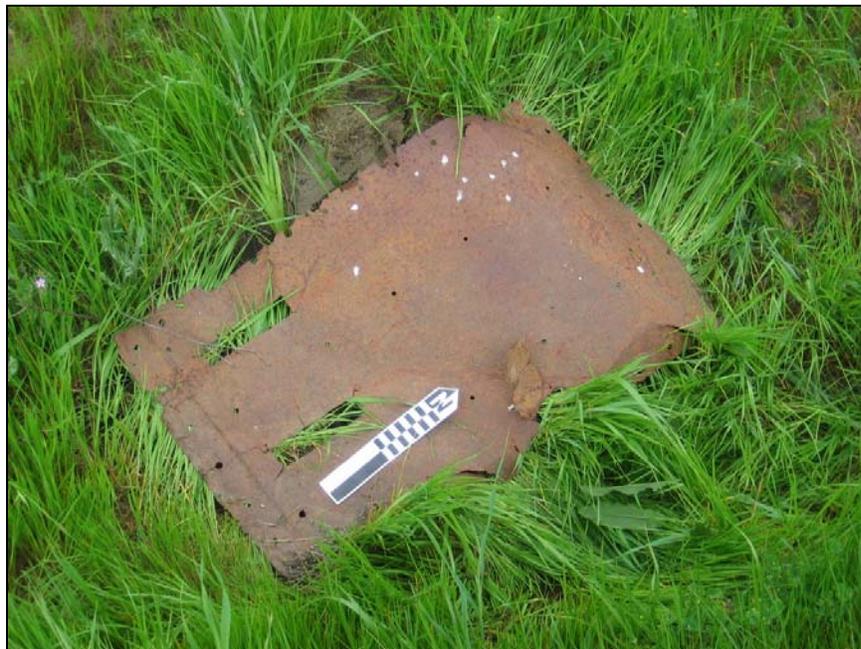
Artifact 14: Thin ferrous sheet metal plate with regularly spaced perforations for fastening; 03/20/2007; IMG\_1405.

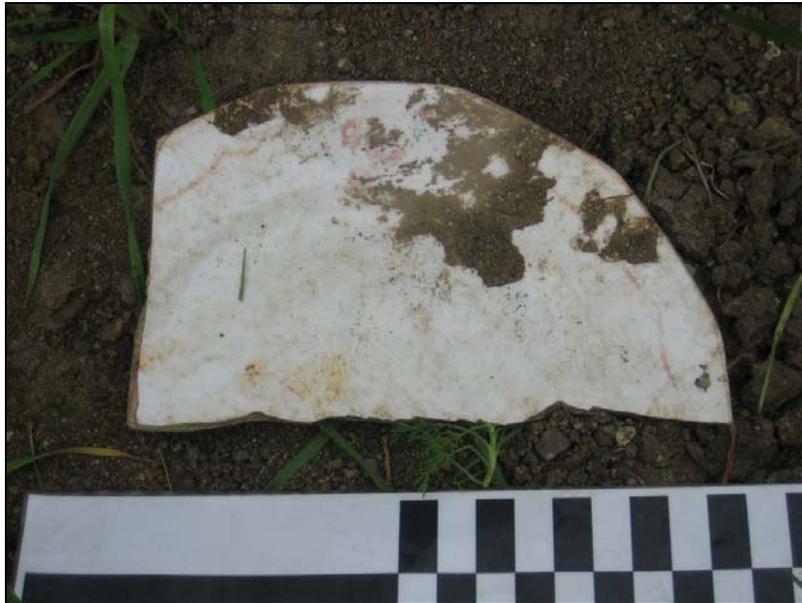
Artifact 4: Whiteware fragment with floral transfer polychrome and gilding from a serving dish, on gulch floor at Site Y-6; 03/20/2007; IMG\_1402.

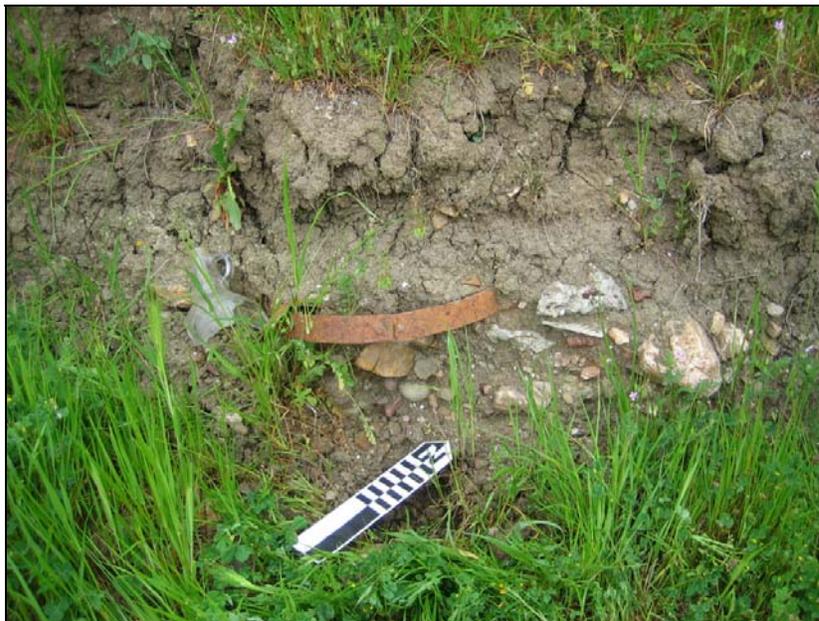
Artifact 17 and 4: Ferrous barrel hoop, glass jug fragments and concrete, exposed in cut bank at Site Y-6; 03/20/2007; IMG\_1404.

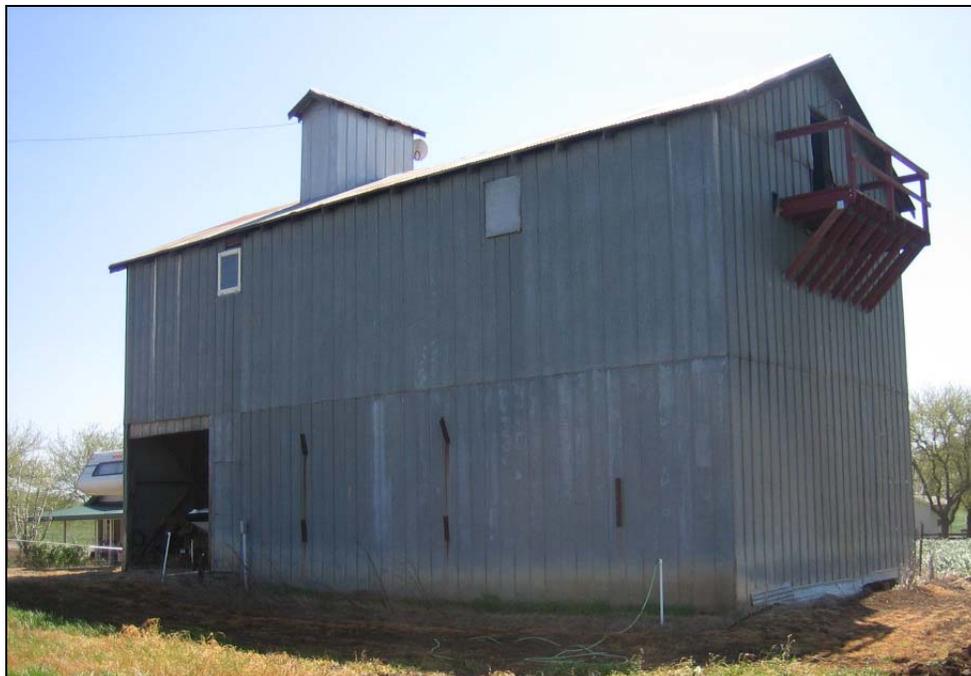
Granaries were commonly constructed with an upper grain storeroom and storage space below. The building was constructed with few windows to minimize invasions from rodents and other pests. However, the cupola was probably once vented using louvers to prevent spontaneous combustion, although it is also possible that there had been a door in the cupola to allow grain to be delivered into the building by an elevated conveyor. It is likely that the two pipes extending down on the east elevation were used for easy access to the grain for feeding livestock. Structurally, the former granary is in good condition; however, there have been modifications made to some of the windows, the cupola has been modified, and the balcony is a recent addition.

Southeastern overview of northern façade and western elevation of Building No.1, the granary at Y-7; 03/21/2007; IMG\_1467.

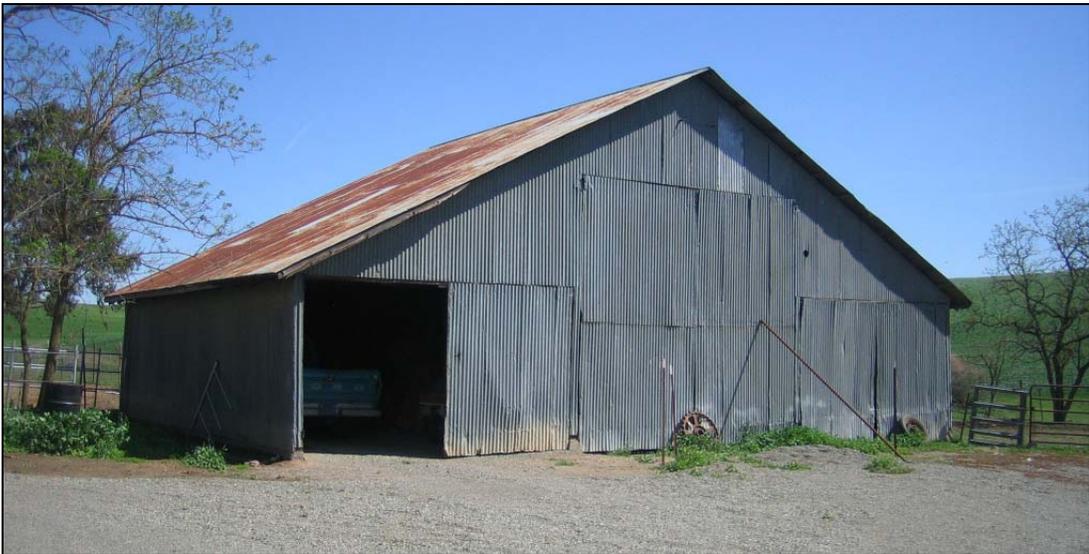
Farm Building No. 3 is east of Farm Building No. 2 and measures approximately 50 feet long x 32 feet wide. According to the owner, the barn was constructed in the 1940s. The barn is two-stories with a wide expanse roofline and moderate pitched front-gabled roof. It has timber-framing and the roof and exterior walls are clad with corrugated metal panels. The barn has a concrete foundation with a dirt floor. The west façade of the building features a swinging corrugated panel door on the north end, although fenestration is absent. The barn presently houses horses and/or other livestock. A fence abutting the building is used as a horse pen.

Overview of west façade and north elevation of the horse barn (Farm Building No. 3) at Y-7, facing southeast, 03/21/2007.

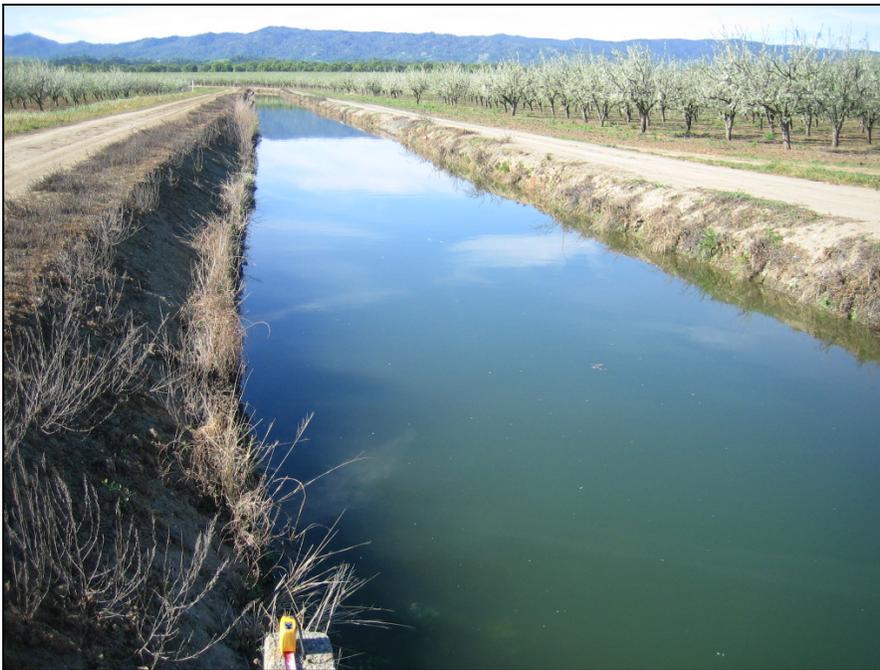
Southwestern overview of Hungry Hollow Canal from bridge abutment; 03/21/2007; IMG\_1364
