## **Appendix B**

### **Underwater Inspection Report**

**Port Costa Underwater Inspection**

**March 19-21, 2013**

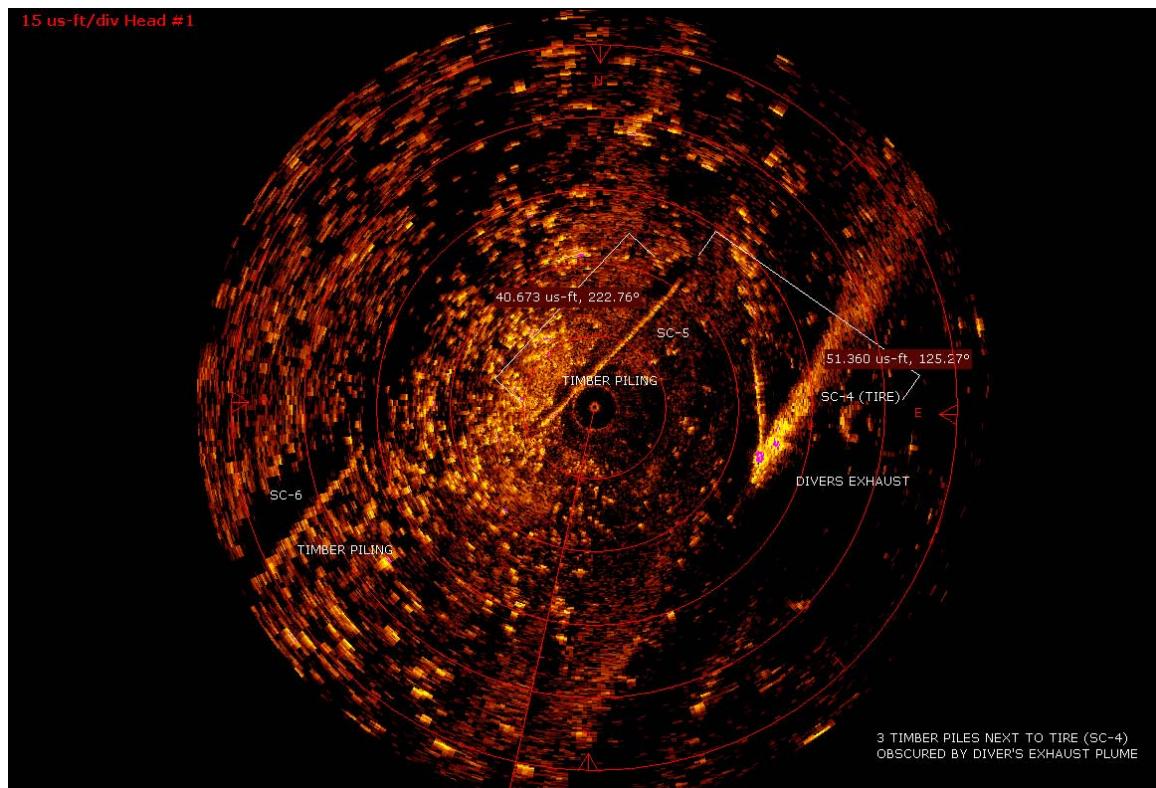
The sonar displayed a very good image of what turned out to be a large truck tire, 7 feet in diameter. About 10 feet inshore of the tire, the diver reported two timber pilings lying next to each other. A short, 10 foot section of pile is laying at a perpendicular angle to the tire and two adjacent pilings. The piling diameters are about 13 inches, which matches the wharf timber support pilings. The two longer pilings are about 40-45 feet in length,

**Figure 1:** Sonar scan showing diver inspection 3 pilings adjacent to truck tire. Divers exhaust plume temporarily obscures pilings at SC-4.

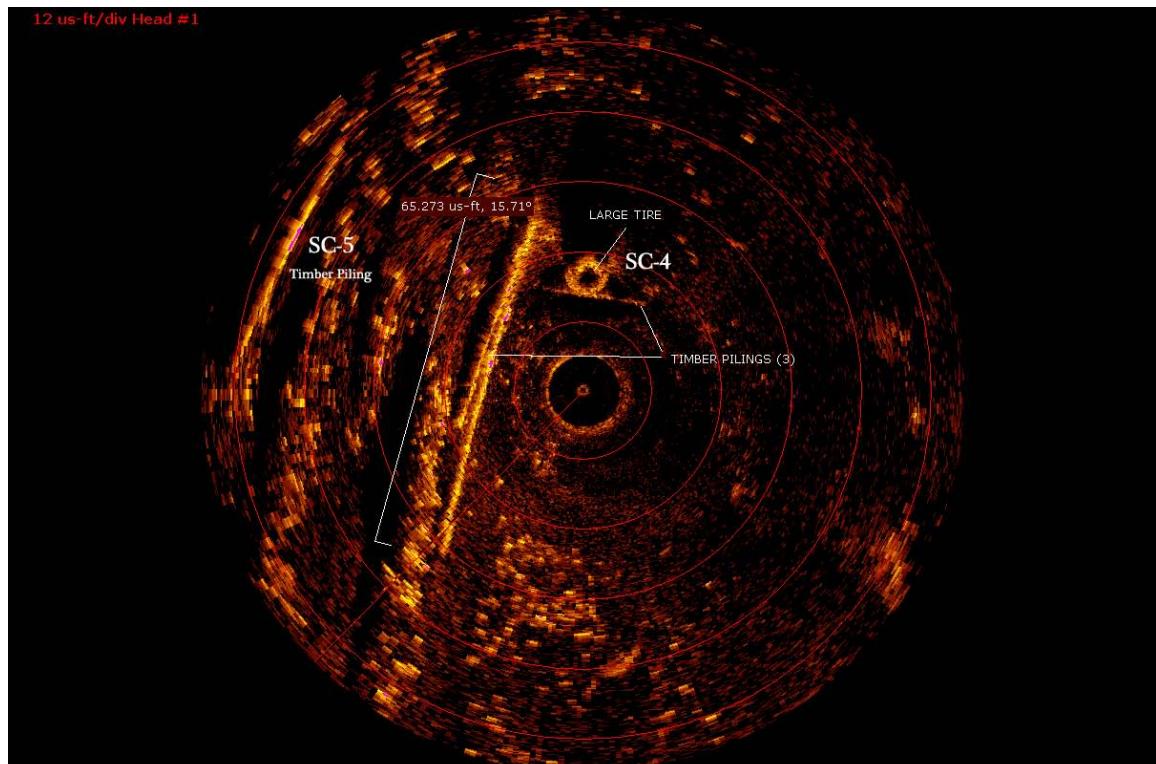
but due to their staggered position the overall object length is about 65 feet. The pilings appear to be in generally good condition, based on the diver's touch. The bottom consists of a soft layer of mud or silt over a firmer substrate. There would be no difficulty attaching slings or other rigging to recover the pilings or tire.

**Figure 2:** This scan clearly shows the three timber pilings adjacent to the tire. The two long pilings are about 40 feet long, but in a staggered position, increasing overall object length to about 65 feet.

It is assumed a derrick barge, and perhaps a materials barge or two, would be utilized during demolition and site cleanup. The timber pilings and truck tire can be easily rigged and recovered to the surface in single crane picks. The long pipe section recovery will likely require lifting one end up to the barge deck, and cutting the piping into lengths required for handling, transport.

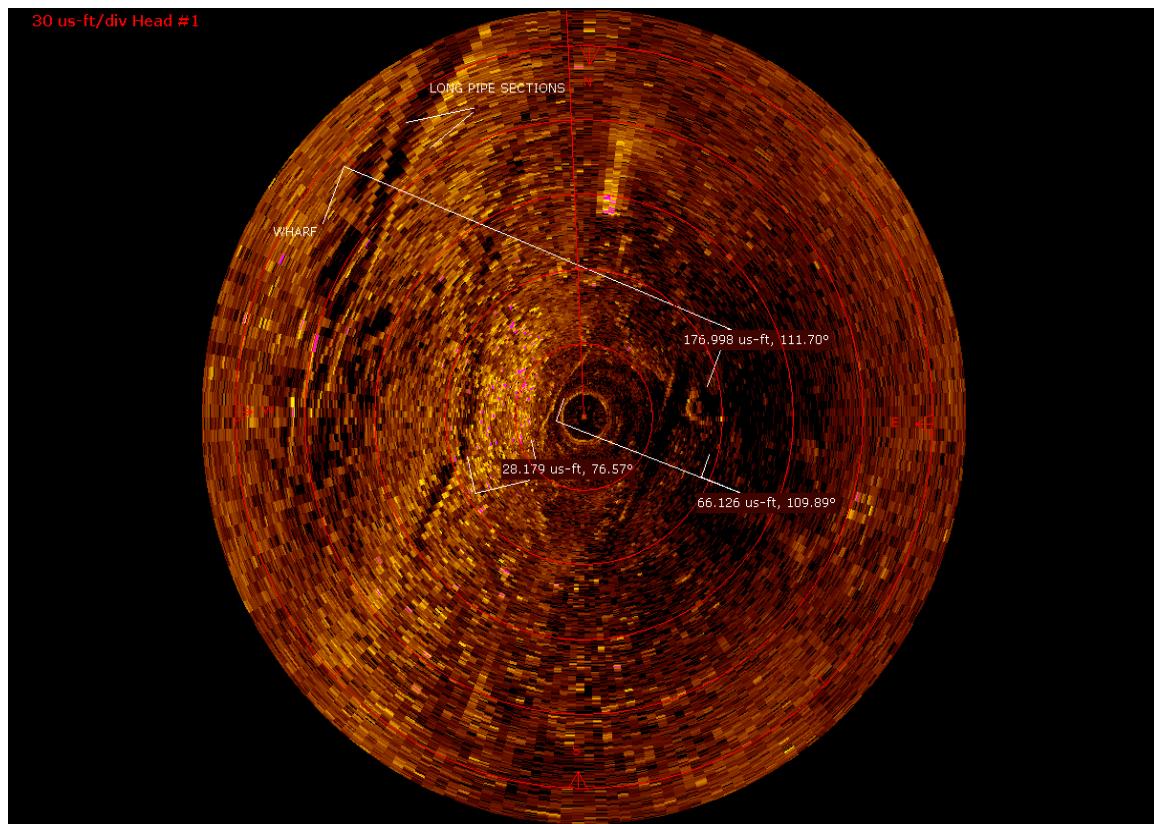
**Figure 3:** The scan above shows all the submerged objects in the survey area, and confirm the 175 distance from the wharf to the SC-4 targets.
