Appendix D Royal Environmental Services, Inc. Letter Report
Regarding Pre-Demolition Asbestos and Lead
Paint Survey Encina Power Station Marine
Terminal, Carlsbad, California

February 12, 2013

**RE: Pre-demolition Asbestos and Lead Paint Survey
Encina Power Station Marine Terminal
Carlsbad, California**

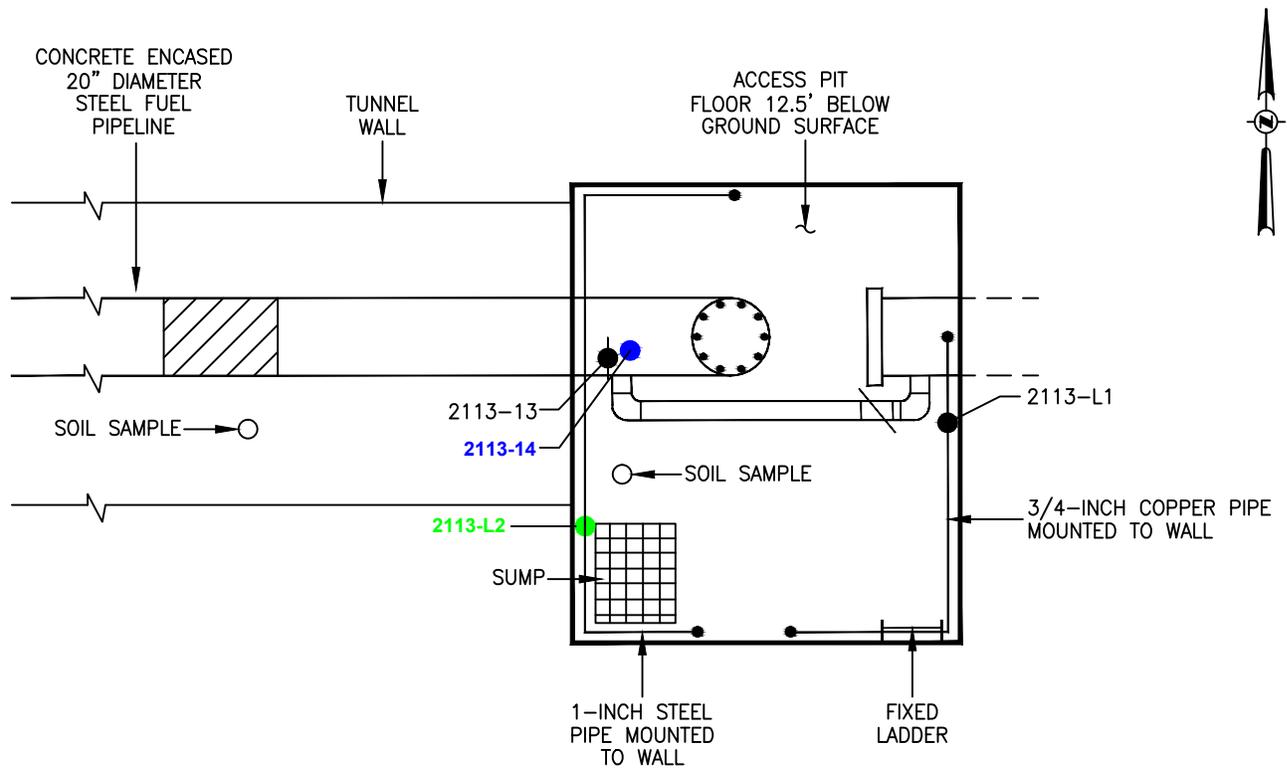
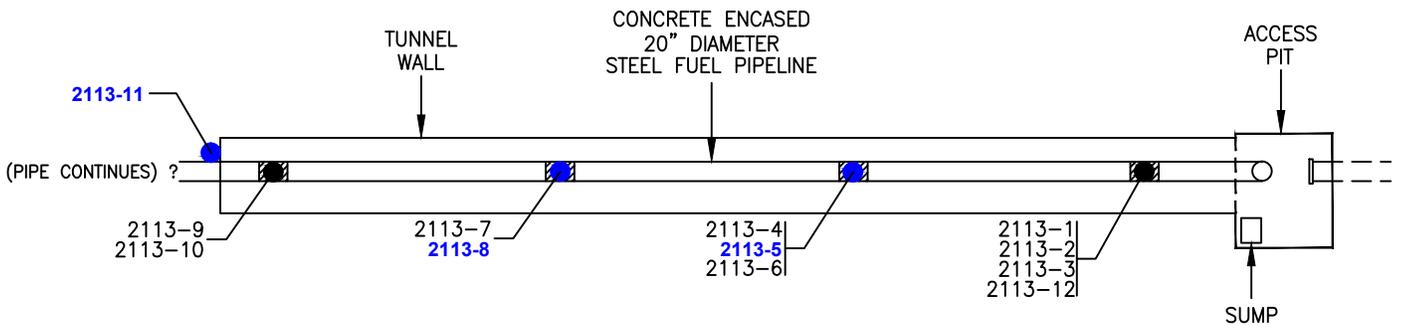
SAMPLE LOCATION MAP FOR ASBESTOS AND PAINT SAMPLES

The descriptions and locations of the materials identified as SACM and listed in Table 1, those materials found to contain asbestos are summarized in Table 2. The sampling locations for those materials found to contain asbestos are

depicted on Figure 2 and photographs of asbestos containing material are presented in Appendix A. The following materials were found to contain asbestos and are now considered ACM:

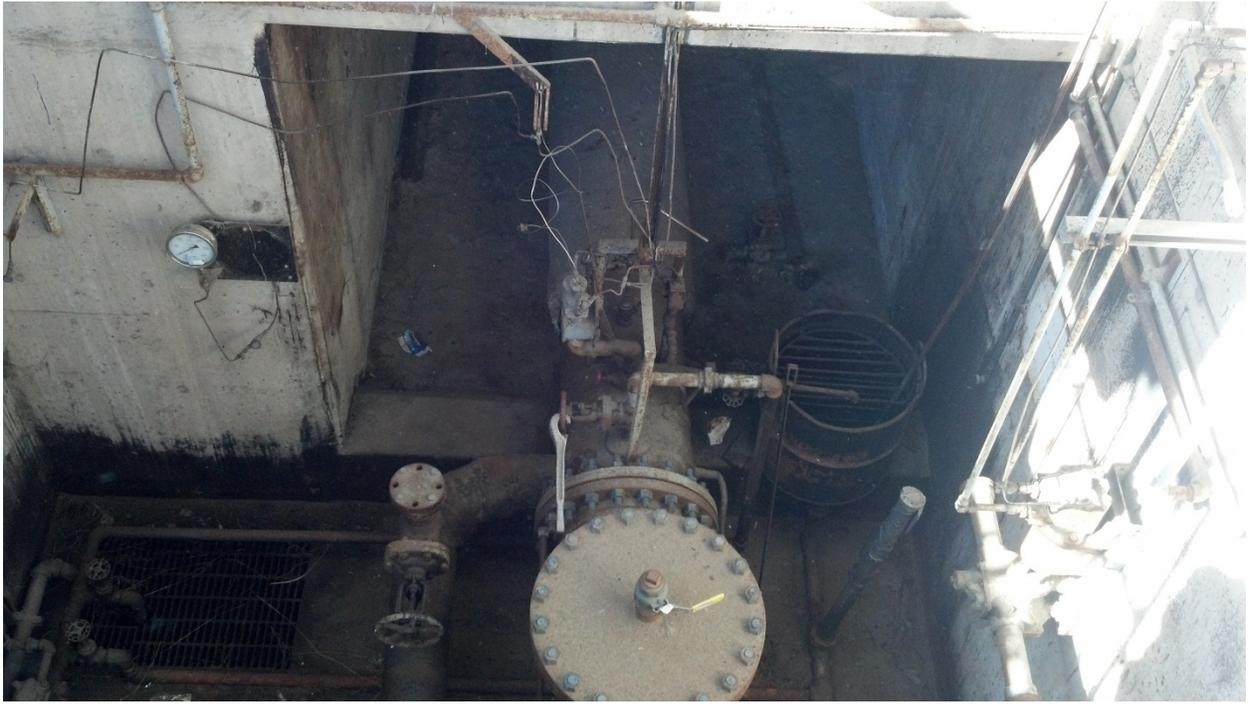
The gray paint is in poor condition and any loose, flaking, or otherwise damaged paint present must be removed prior to demolition and handled and disposed of as hazardous material. Once the paint is removed following lead-safe work practices, the pipe and support structures can be disposed of as construction debris during demolition activities.

Photograph 1: View of Access pit looking west, 20-inch fuel oil pipe in tunnel, control piping and valves. 1-inch steel pipe with gray lead based paint represented by sample 2113 L-2 on wall in upper left and across top of view.

The gray paint found on the steel pipe was found to exhibit loose, flaky, and/or otherwise damaged lead based paint and requires abatement prior to demolition or handling for metal recycling. Where other metal structures in the access pit have gray paint it is likely LBP and should abated as well prior to demolition. RES recommends that a California licensed contractor certified by the CDPH as a lead abatement company be retained to accomplish this abatement work.

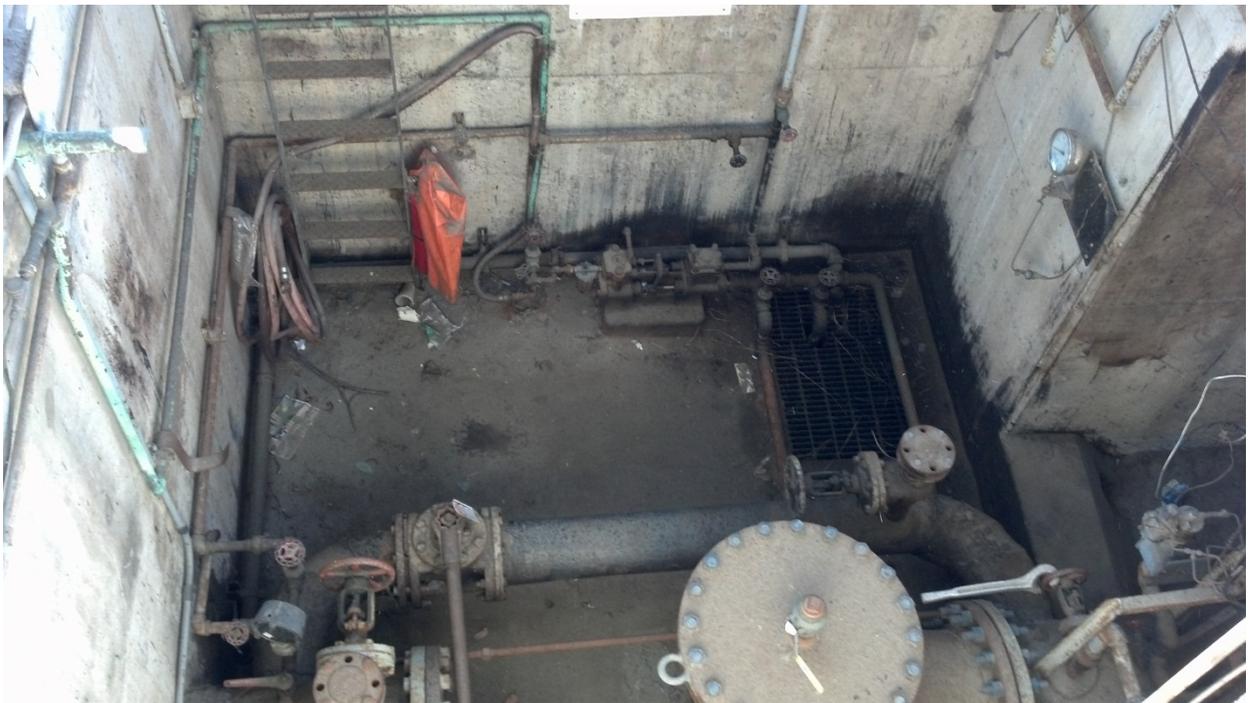
Photograph 2: View of Access pit looking south, fuel oil pipe, control piping, valves, and sump.

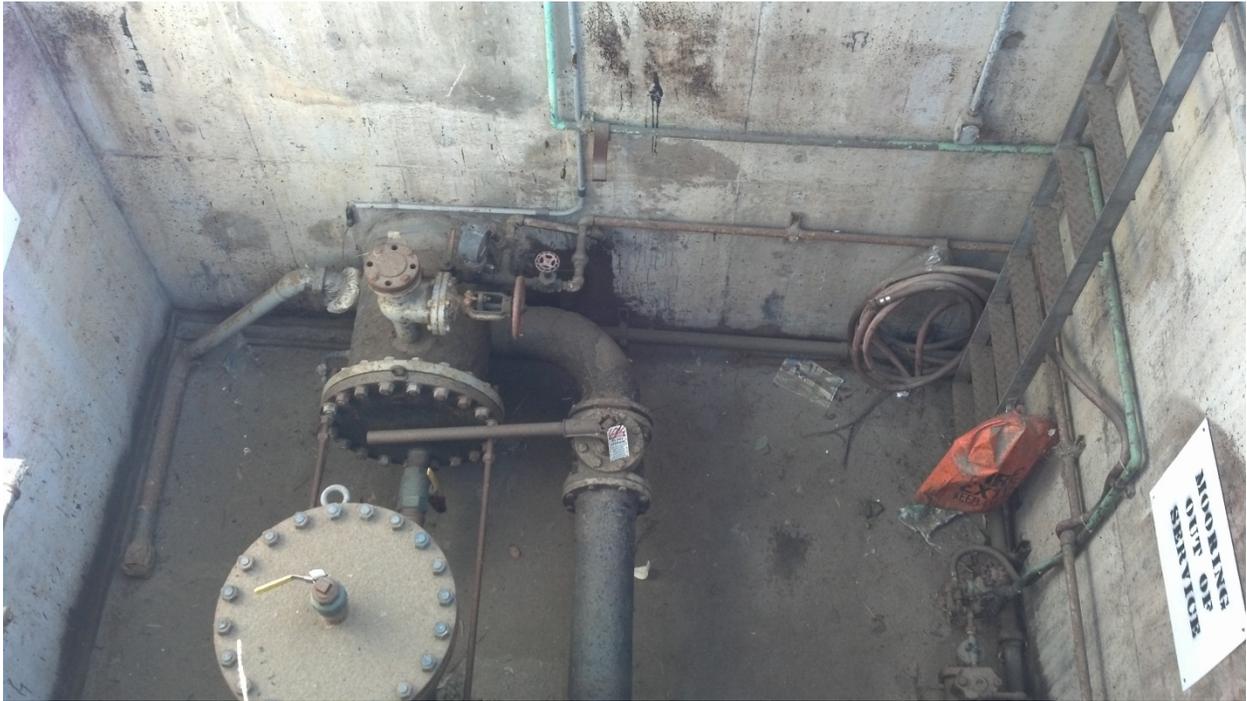
Photograph 3: View of Access pit looking east, fuel oil pipe, control piping and valves. Access ladder on upper right of photograph.

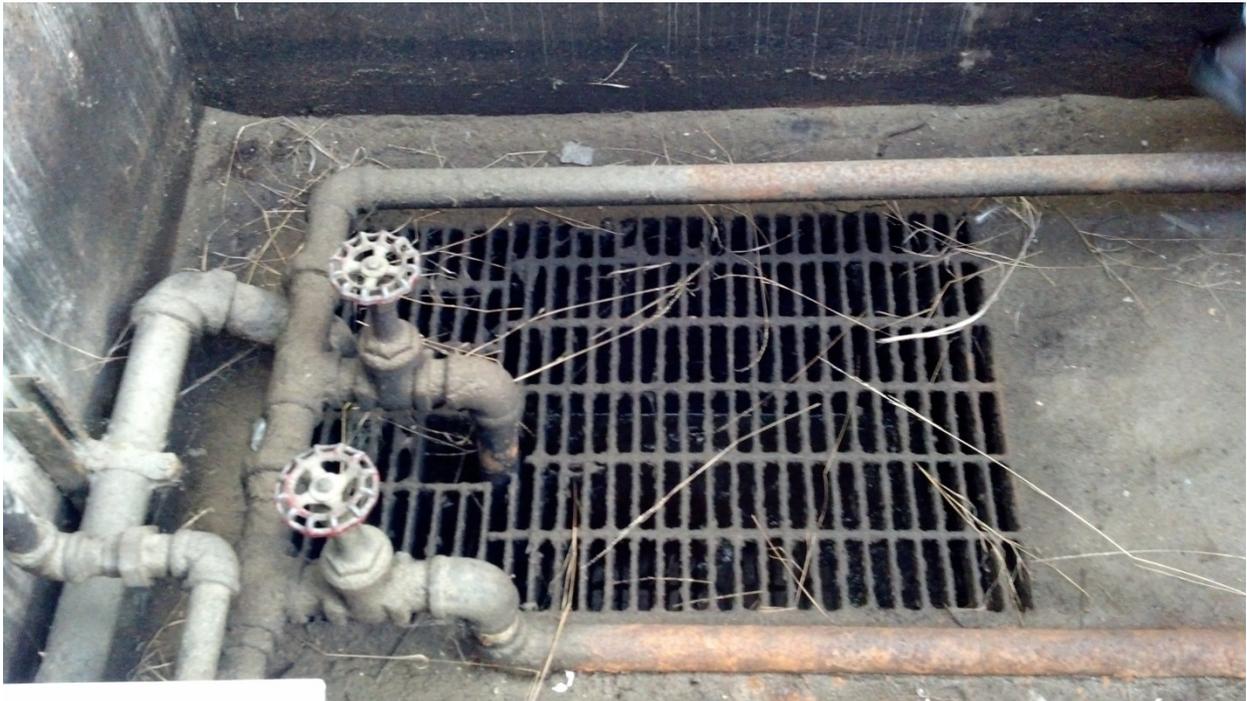
The sampling performed indicates the sand in the bottom of the access pit and tunnel are impacted with TPH. Sand farther from the access pit may not be impacted with TPH and can be left in place.

Photograph 4: View of sump and accumulated sand on bottom of access pit with petroleum hydrocarbon content.

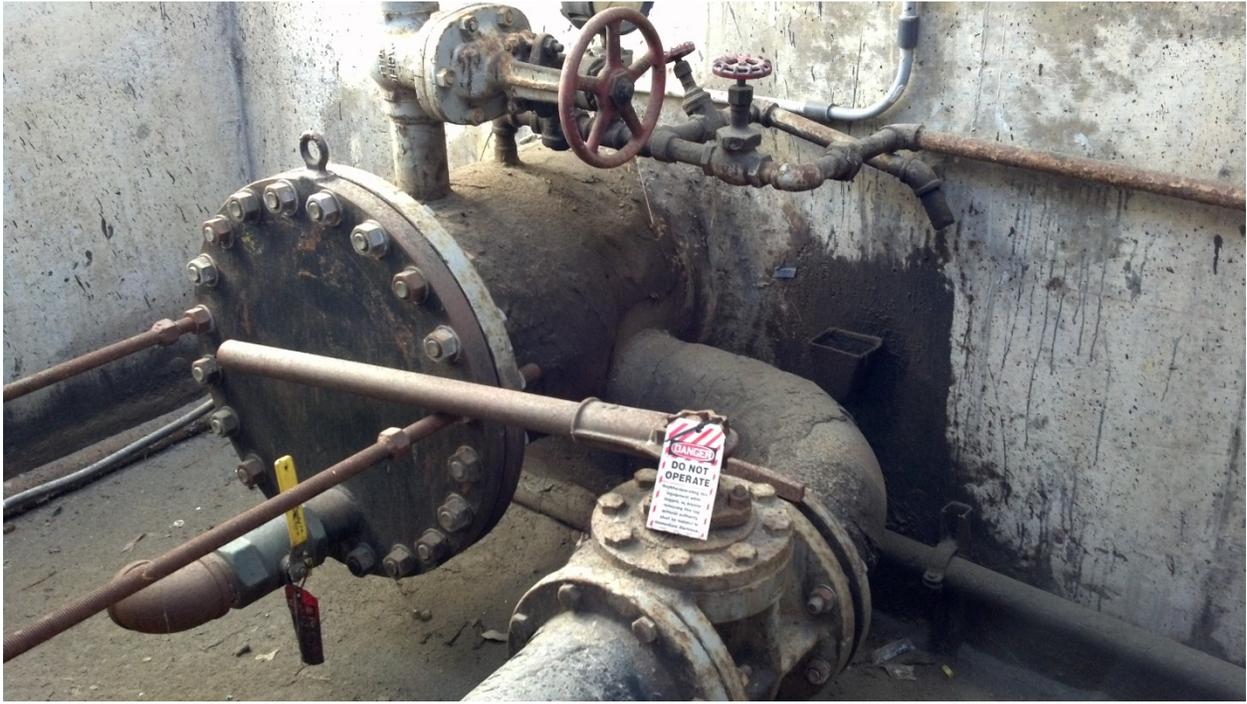
Photograph 5: View of fuel oil pipe transition through east wall of access pit, control piping and valves. Asbestos containing pipe wrap represented by sample 2113-14

Asbestos containing materials should be removed by qualified personnel prior to demolition of the fuel pipeline. Any certified asbestos abatement contractors invited to submit bids for removal of the ACM from this site should personally verify quantities, condition, and locations of any and all ACM that may be in these structures, prior to bidding, at a pre-bid 'job walk', which should be conducted when the site is completely accessible.

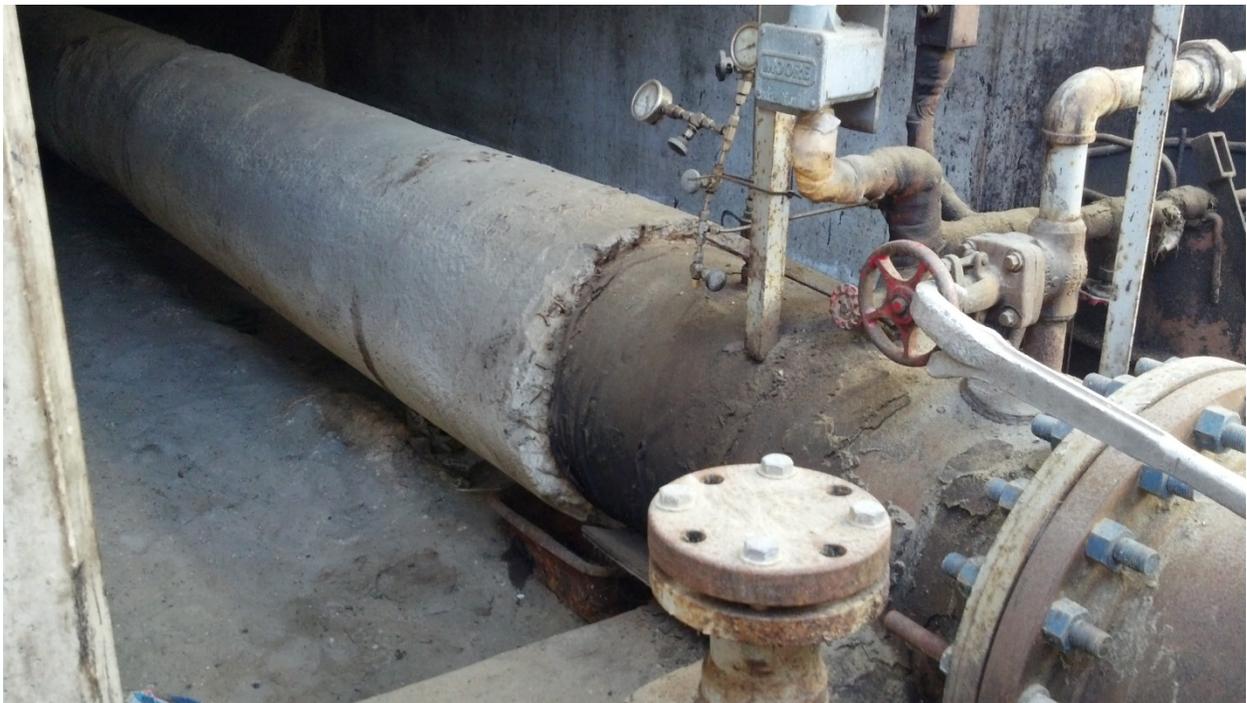
Photograph 6: View of fuel oil pipe in tunnel on west side of access pit, control piping and valves. Black asbestos containing pipe wrap represented by sample 2113-14. Soil sample "tunnel floor" collected below pipe patch in upper left of view.

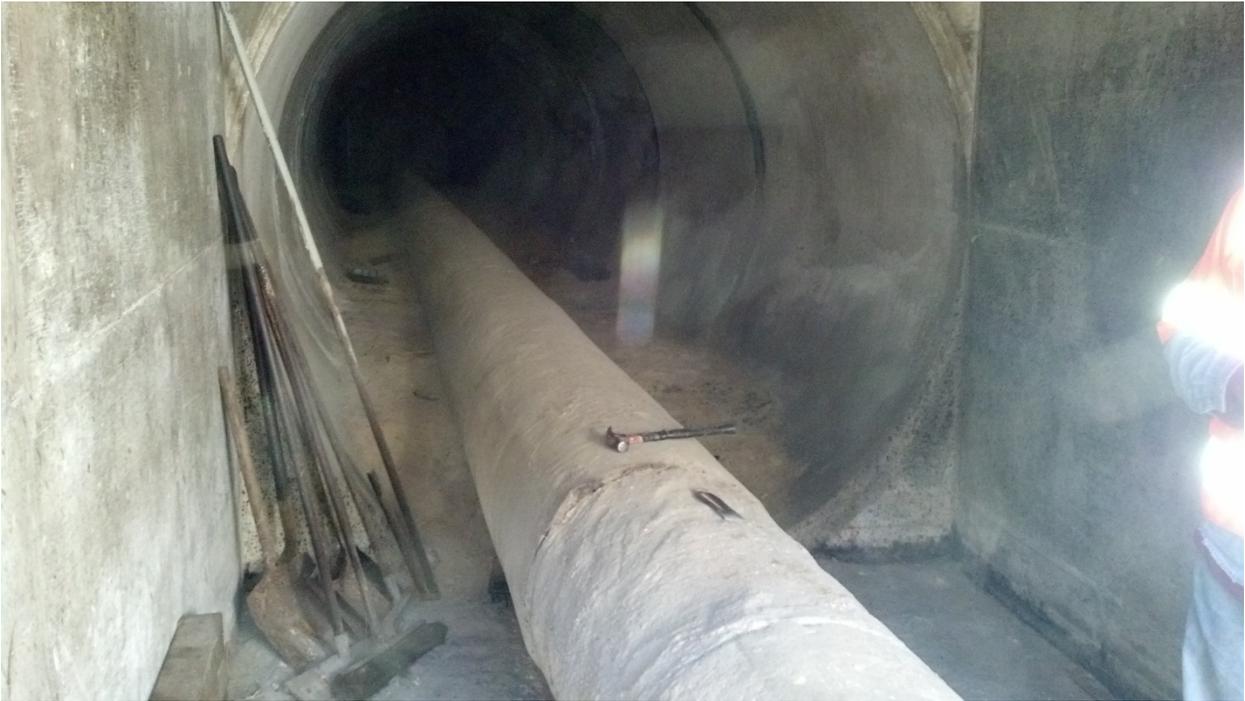
- Gray/black pipe mastic (2113-5 and 2113-8) on the 20-inch fuel pipeline. This material likely underlies the concrete covering and patches along the entire 104 foot length (545 square feet).
- Gray pipe wrap (2113-11) on the 20-inch fuel pipeline at the joint with the concrete wall at west end of tunnel (3 square feet).
- Black large pipe wrap (2113-14) on the 20-inch fuel pipeline and attached 6-inch pipeline (40 square feet).

The Gray/black pipe mastic and gray pipe wrap are in good condition and have a low potential for future damage unless unqualified, non-certified asbestos abatement personnel attempt repairs or removal or disturbance such as would occur during building demolition or modifications. The Black large pipe wrap is in poor condition and has a low to moderate potential for future damage due to its exposed position in the access pit.

Photograph 7: View of fuel oil pipe in tunnel west of access pit. Uniform concrete coating and representative concrete joint patch in foreground. Asbestos containing pipe wrap in joint of patch represented by sample 2113-5 and 2113-8.

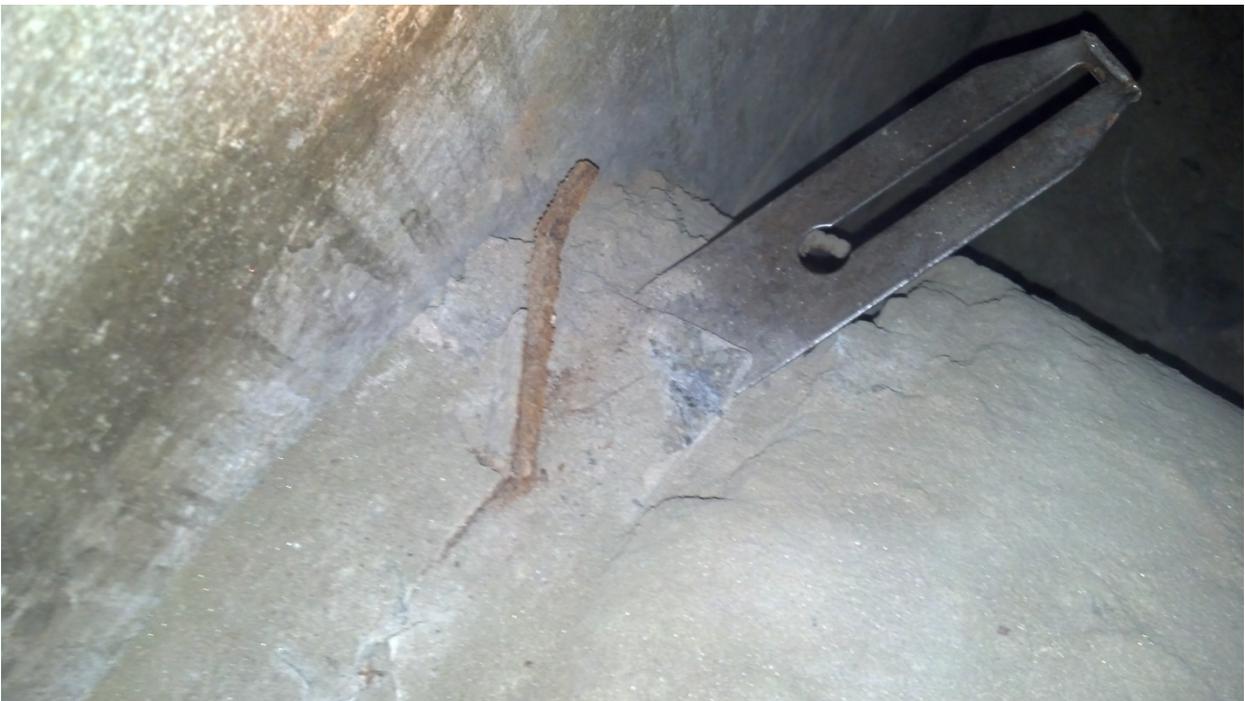
Photograph 8: View of Fibrous mineral pipe wrap at penetration of fuel oil pipe and concrete wall at western end of tunnel in center of view. Asbestos containing pipe wrap represented by sample 2113-11.
