ANALYSIS OF THE P-36 ACCIDENT IN CAMPOS BASIN, BRAZIL

Oswaldo A. Pedrosa Jr.

ANP Development and Production Manager

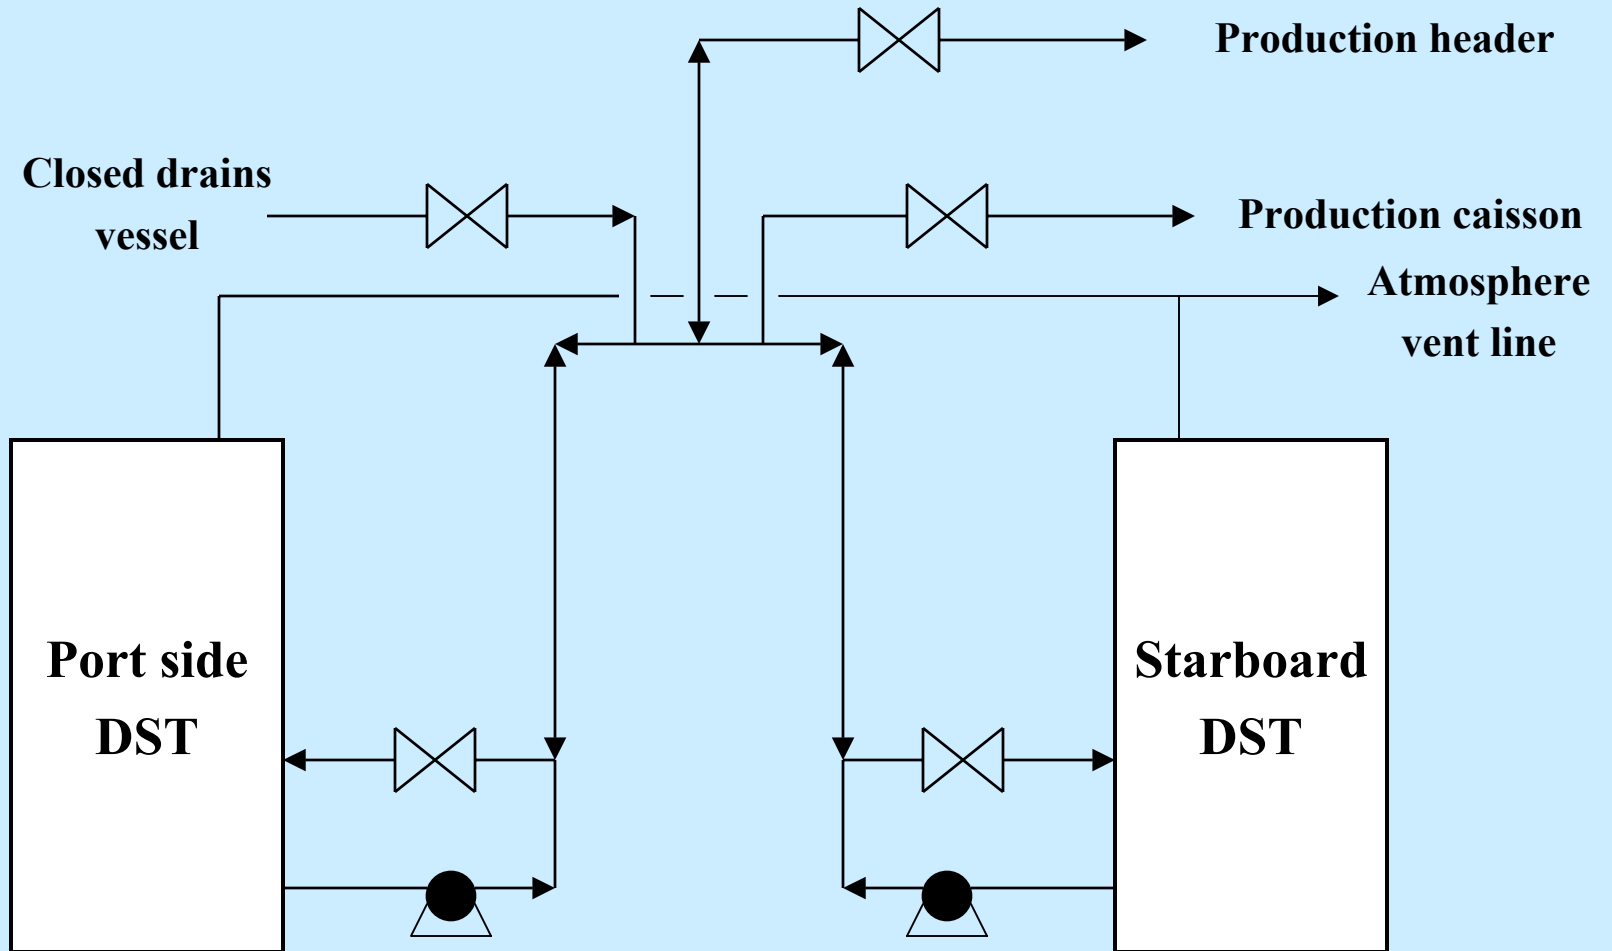
Process Flow Diagram of the Drains Storage Tanks

- ↖ Drainage operation of the **Drains Storage Tank** in the aft port side column

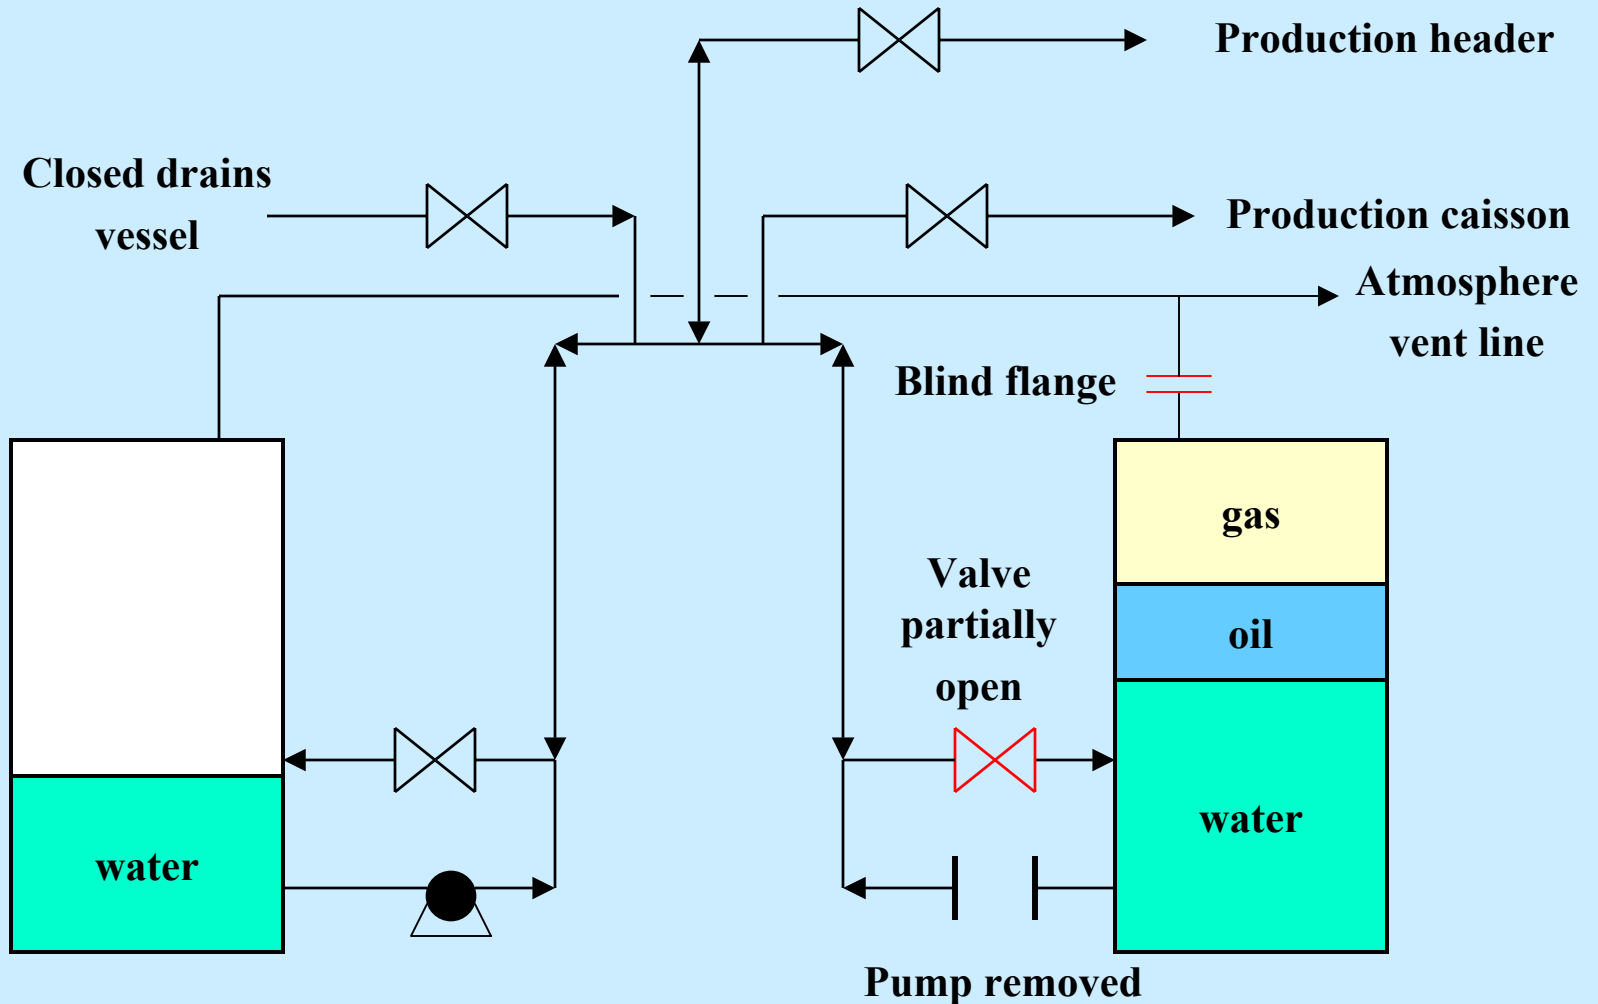
Process Flow Diagram (time of 1st explosion)

- **First explosion** - mechanical explosion caused by the rupture of the tank (12:22 a.m. on March 15, 2001)
- **Second explosion** – very large chemical explosion killing eleven members of the fire brigade (12:39 a.m. on March 15, 2001)

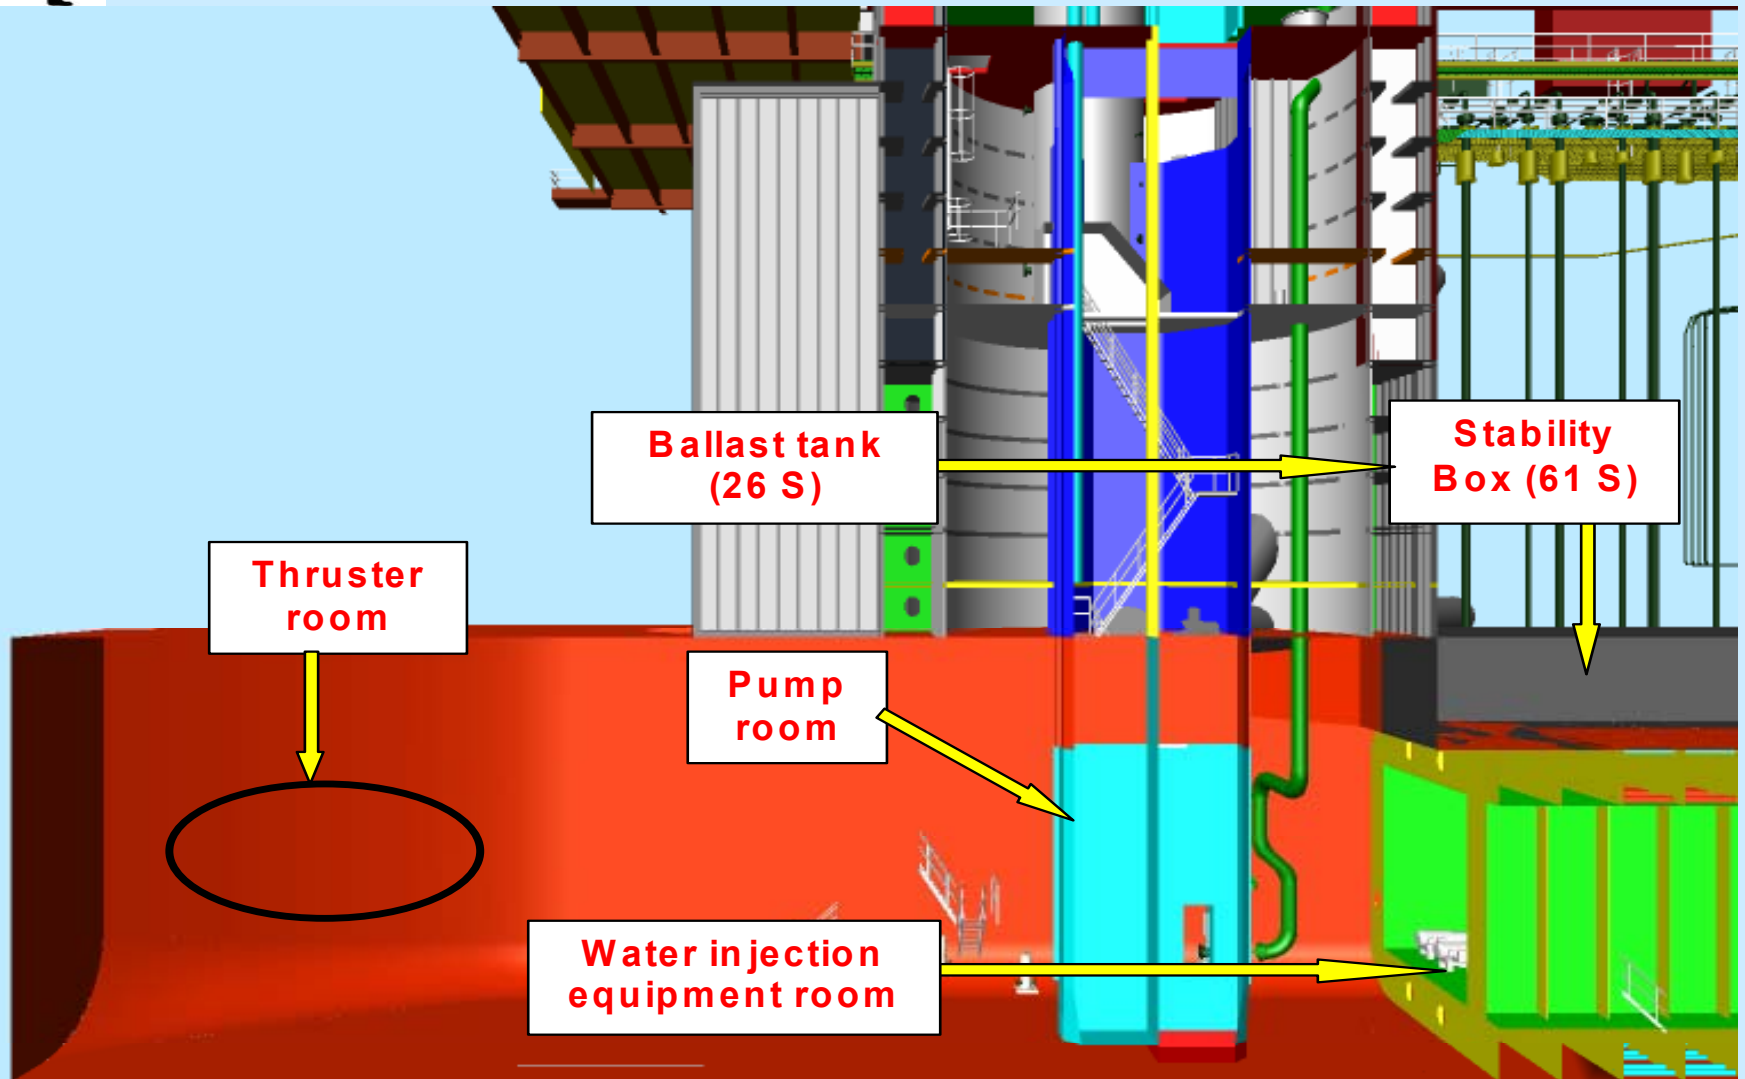
Column and Part of Aft Starboard Pontoon

**Flooding of the column
and pontoon**

**Failure of the dampers of the column
ventilation system**
(maintenance procedures malfunction)

**Man holes to aft starboard ballast tank
and adjacent stability box left open**
(operating procedures malfunction)
