Chevron Richmond Long Wharf - A MOTEMS Journey

October 2014

Karen Boven, P.G.
Chevron Project Manager

Richmond Long Wharf – MOTEMS Compliance Journey

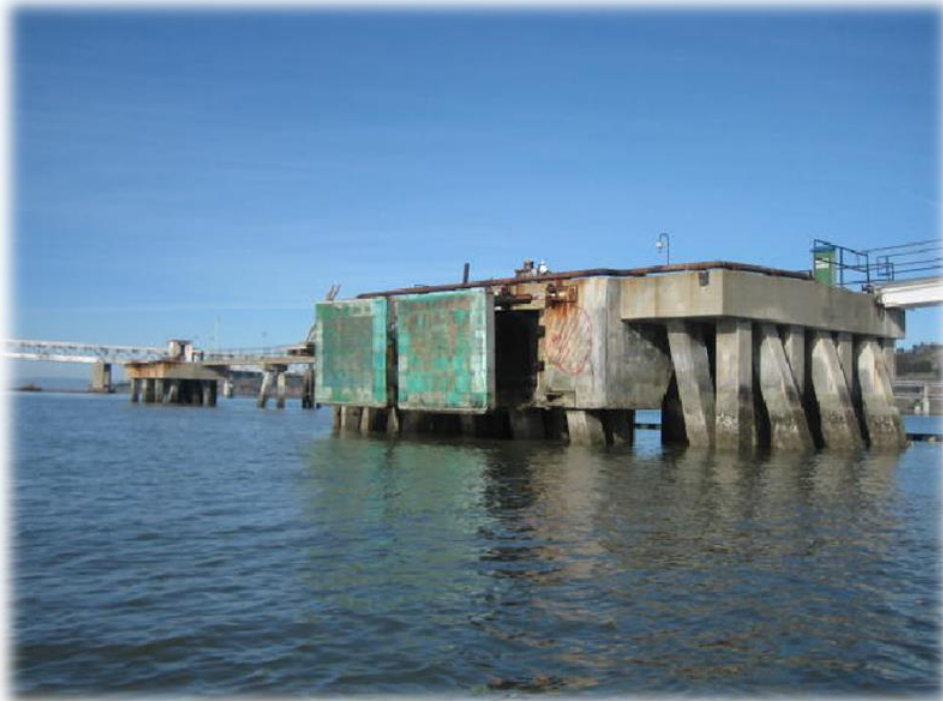
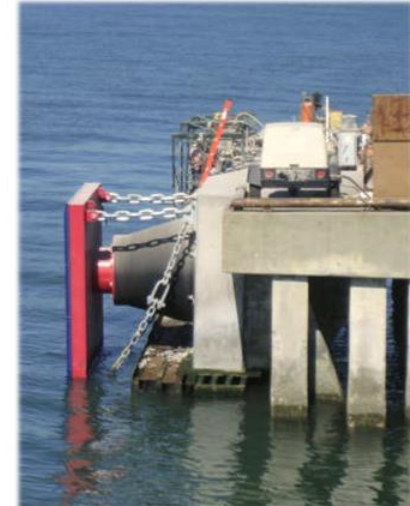
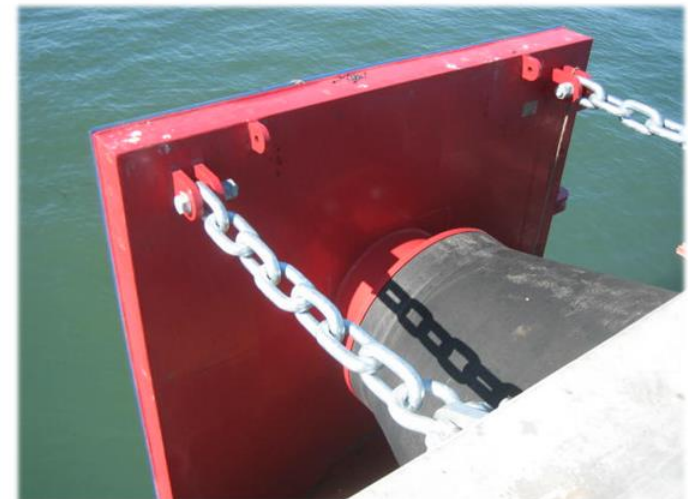
Berth 4 Breasting Dolphin Fender Replacement (Oct 2011) – P3 Deficiency

Drivers for replacement:

1. Seibu parts difficult to obtain.
2. Standardize fenders, larger panels.
3. Better performance with cone panels.

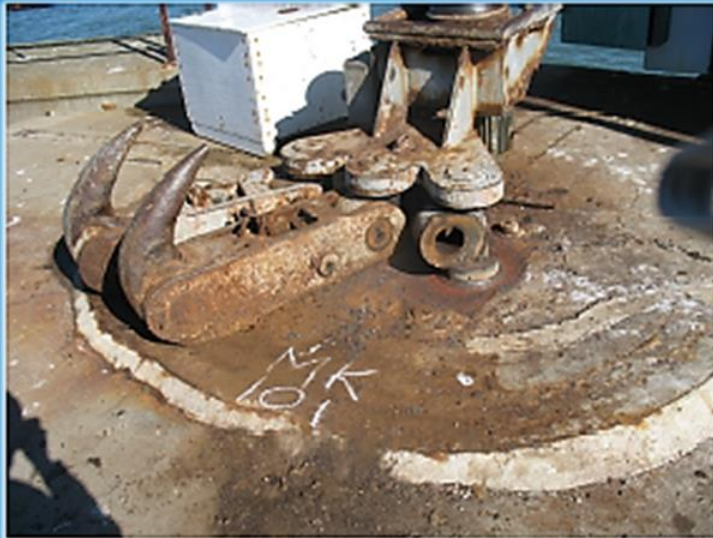
Photograph 49: MK101, Berth 1 Main Wharf

Berth 1 South Mooring Dolphin Mooring Hook Replacement (2013) – P3/P4 Deficiencies

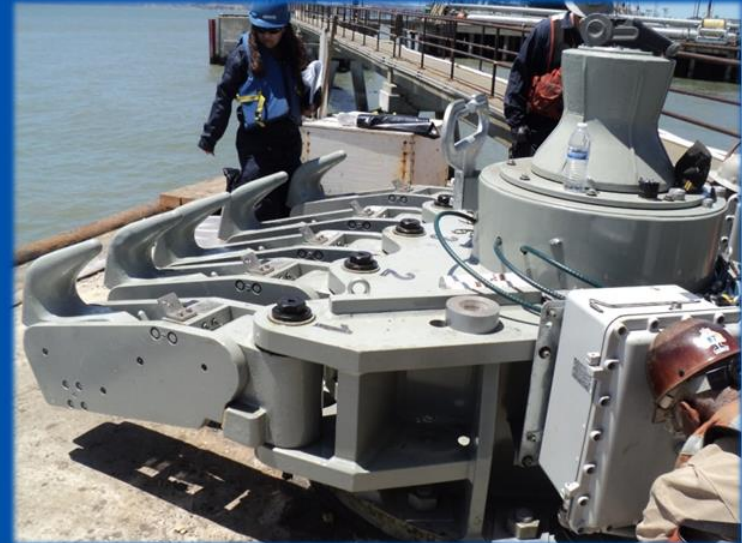
After Replacement (2013)

30-year CSLC lease renewal
required tension monitoring at
Berth 1 so Chevron installed a
quintuple hook.

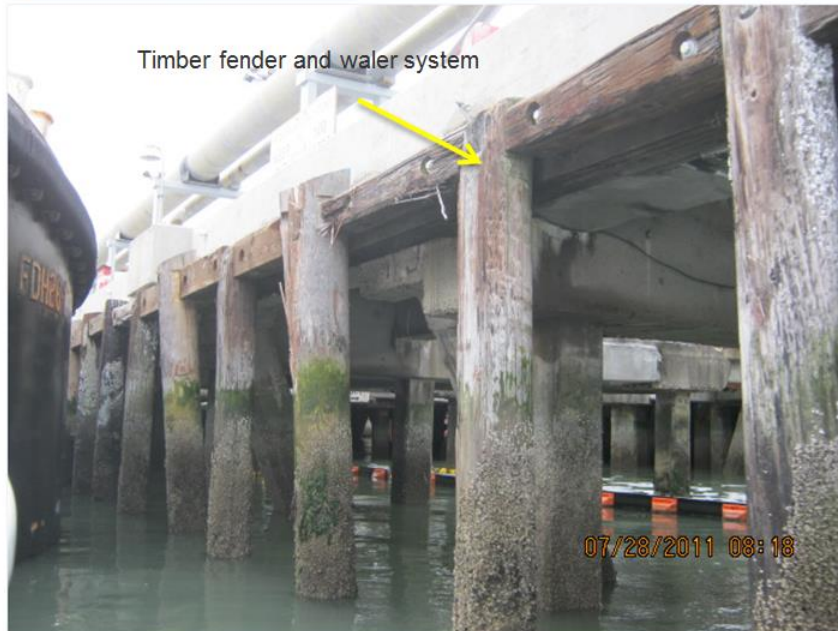
Main Wharf, Berth 9 (before)
Approach velocity limitations, requiring AAS
velocity monitoring.

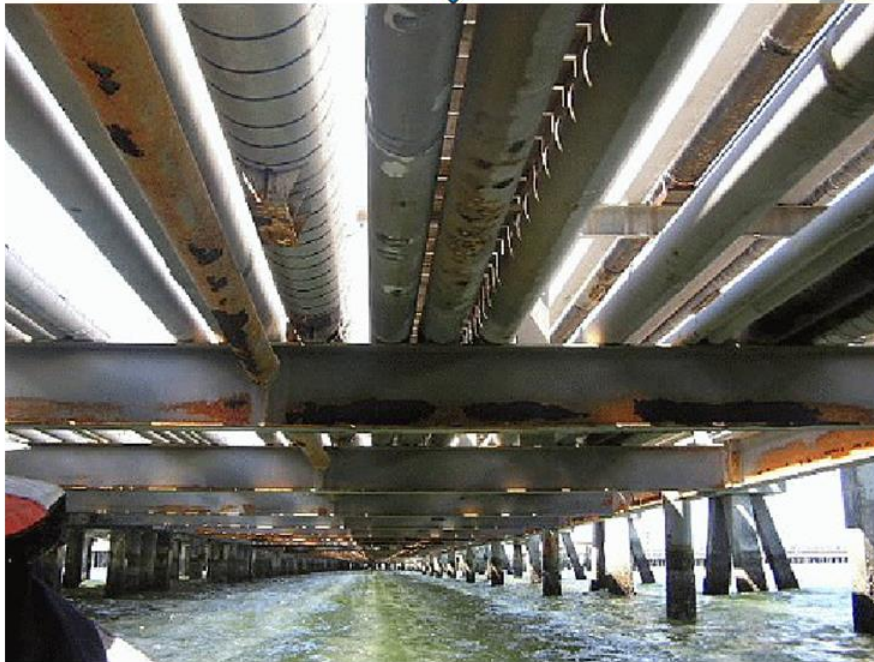
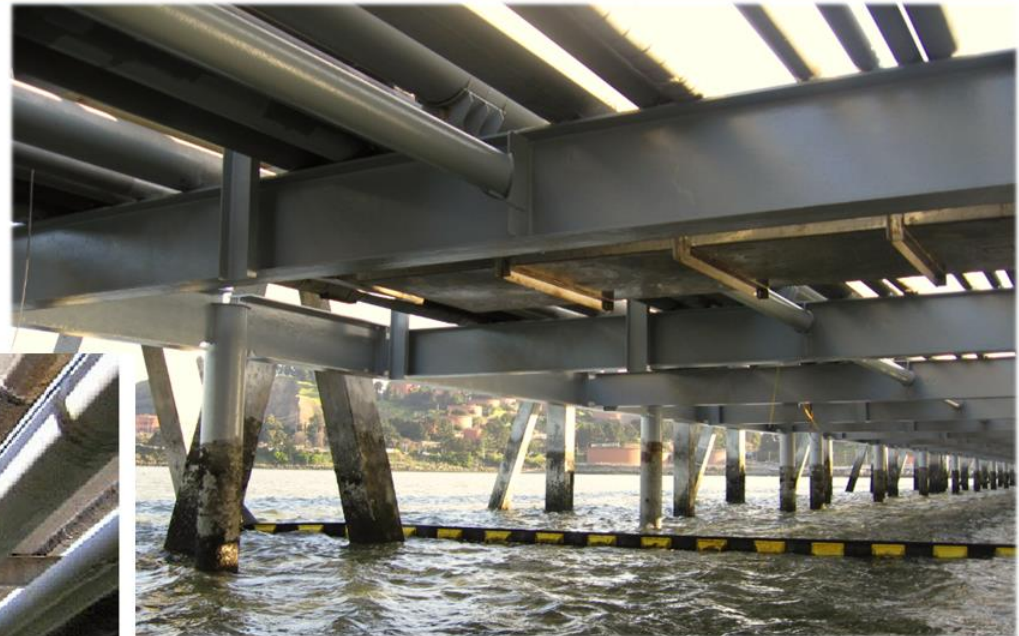
Photograph 2: Pipeway Trestle W-section Girders with Pipe Bracing

Coating system nearing end of life resulting in surficial corrosion.
