VENOCO, INC.

Platform Holly Sub Sea **Power Cable Replacement** October 8, 2014

Platform Holly Sub Sea Power Cable Replacement

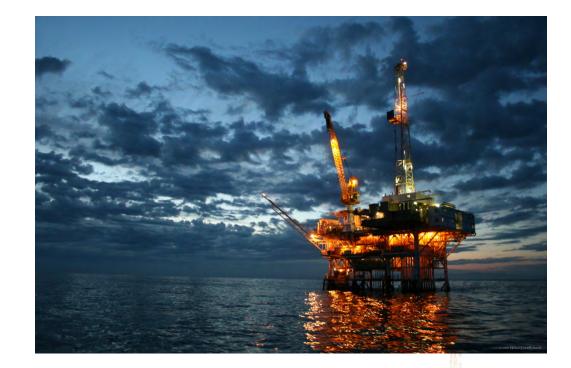
- Installed in 1966 as part of original Platform
- Power Cable de-rated over years
- At times Cable has limited production
- Bundled communication cables had already failed
- Cable pre-dated modern design and codes
- Cable and Power Supply Reliability in question

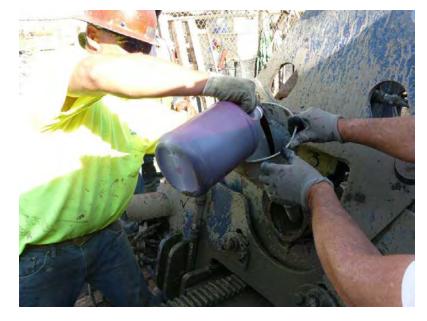
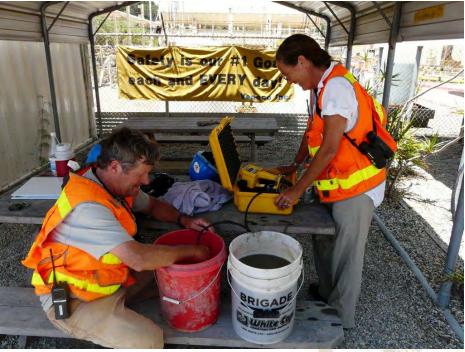
Platform Holly Cable Replacement Rhodamine Dye Requirement

- Inadvertent Surface Release of Drilling Mud
 - Material detected in water, no dye detected
- New Plan
 - Drill and Ream the last 300' with Water Only (No Drilling Mud)

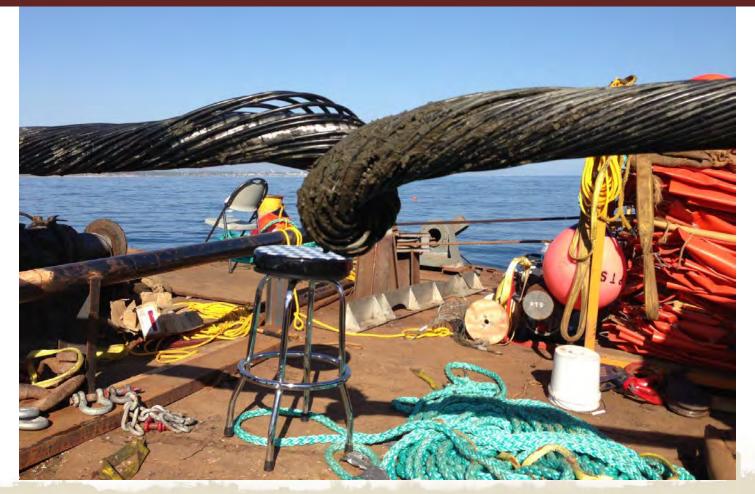
It Gets Worse - Twisted
