Appendix J

**ENVIRONMENTAL RELEASES DURING LINE 96
CONSTRUCTION**

Table 1 Spills and Environmental Releases during Line 96 Construction

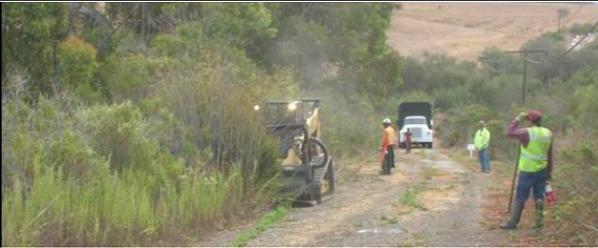
Date	Location	Size/ Material	Description from Daily Monitoring Report	Photo Documentation of Incident Setting from Monitoring Report
Oct 4, 2011	Dos Pueblos Horizontal Directional Drill site	<1 pint, hydraulic fluid	A small volume of hydraulic fluid (<1 pint) spilled from a piece of rental equipment at the Dos Pueblos HDD site. The incident was immediately brought to the attention of the EQAP Environmental Monitor. Affected soil was shoveled into a labeled container for appropriate handling and disposal.

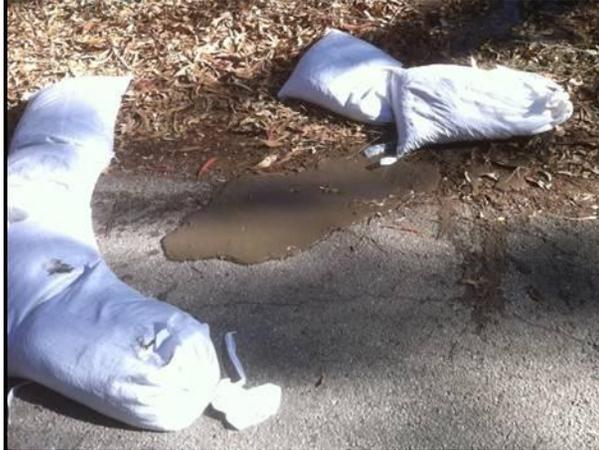
Date	Location	Size/ Material	Description from Daily Monitoring Report	Photo Documentation of Incident Setting from Monitoring Report
Oct 11, 2011	Road shoulder, east side of Dos Pueblos Canyon	2 X 10 gallons, drilling fluids	<p>There were two small (approx. 10 gallons each) releases of drilling fluids ("frac-outs") on the east side of Dos Pueblos Canyon. Both events occurred along the road shoulder of the Dos Pueblos Canyon highway off-ramp, within 150 feet of the exit pit and well away from Dos Pueblos Creek. Both releases were quickly detected, contained, and cleaned up.... No evidence of drilling fluids was observed within the creek. (Note: location was over 100 yards from the creek)</p>

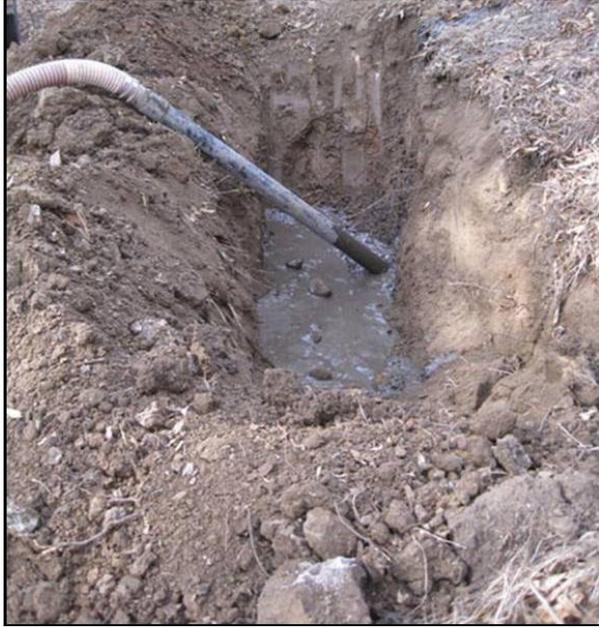
Oct 14, 2011	Road shoulder, east side of Dos Pueblos Canyon and Storm drain outlet	(2 events) Unknown amount, drilling fluids	<p>At approximately 2:45 PM, drilling fluids began surfacing on the road shoulder.... A pit was excavated at this location and mud was recovered with a vacuum truck as it filled the excavation.</p> <p>At approximately 6:00 PM, monitors observed drilling fluids at a storm drain outlet down-gradient from the exit pit. The contractor had proactively installed a temporary barrier here prior to initiating the pilot bore and this was effective in containing the drilling fluids. A storm drain inlet, also equipped with temporary containment barrier, is located a few feet down-gradient from this outlet. This second drain discharges directly into Dos Pueblos Creek, approximately 150 feet to the west.</p> <p>Reaming was immediately stopped when the fluids were detected in the storm drain....It was decided that operations would be suspended at</p>

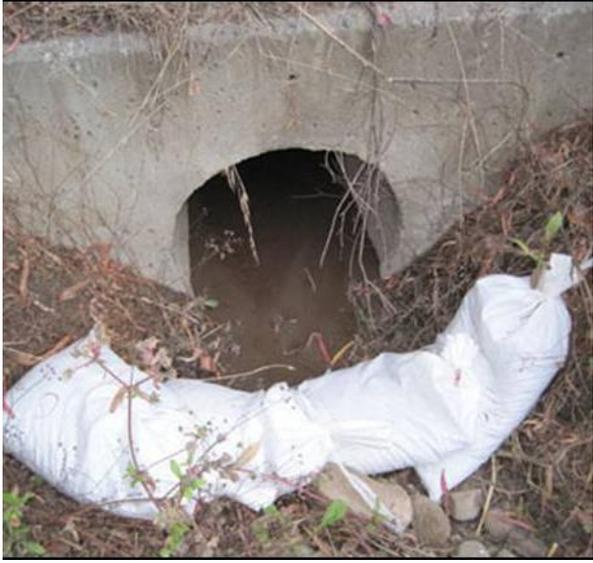
Date	Location	Size/ Material	Description from Daily Monitoring Report	Photo Documentation of Incident Setting from Monitoring Report
			<p>that point, in view of the uncontrolled fluid release and difficulties imposed by darkness. Operations were suspended at 7:00 PM and the site was secured (clean-up, plating or otherwise covering open excavations)....Monitors were stationed at the creek throughout the reaming process and no evidence of drilling fluids within the riparian zone was observed.</p>

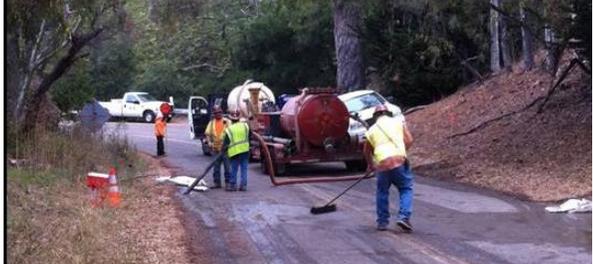
Oct 15, 2011	"point of previous release" from October 14, 2011	Unknown, drilling fluids	<p>Drill mud surfaced at the point of previous releases and was effectively contained and cleaned up. There was no evidence of drilling fluids entering the storm drain system.</p>

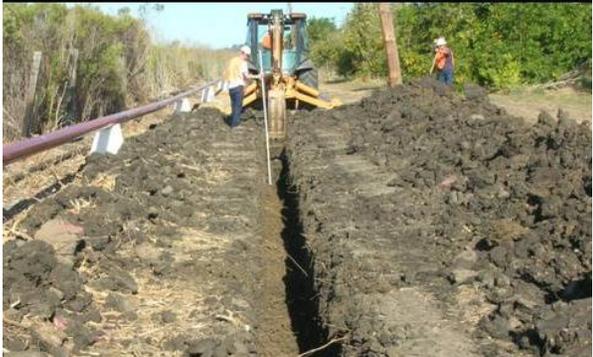
Date	Location	Size/ Material	Description from Daily Monitoring Report	Photo Documentation of Incident Setting from Monitoring Report
Oct 17, 2011	West of Dos Pueblos Canyon	< 0.5 cup, hydraulic fluid	A very small leak of hydraulic fluid (<1/2 cup) occurred shortly after trenching began. The leak was immediately contained. The Site Safety Officer documented the incident with a CARE Form and supervised cleanup.

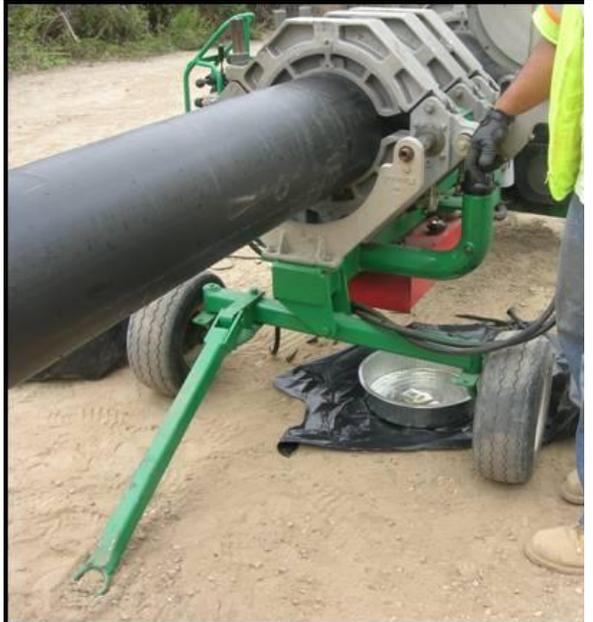
Oct 24, 2011	Ellwood Offshore Facility	4-6 ounces, hydraulic fluid	A small leak of hydraulic fluid (4-6 ounces) occurred beneath the clamp used to secure the casing as it was fitted. The leak was detected almost immediately. Containment and cleanup were efficient and effective.

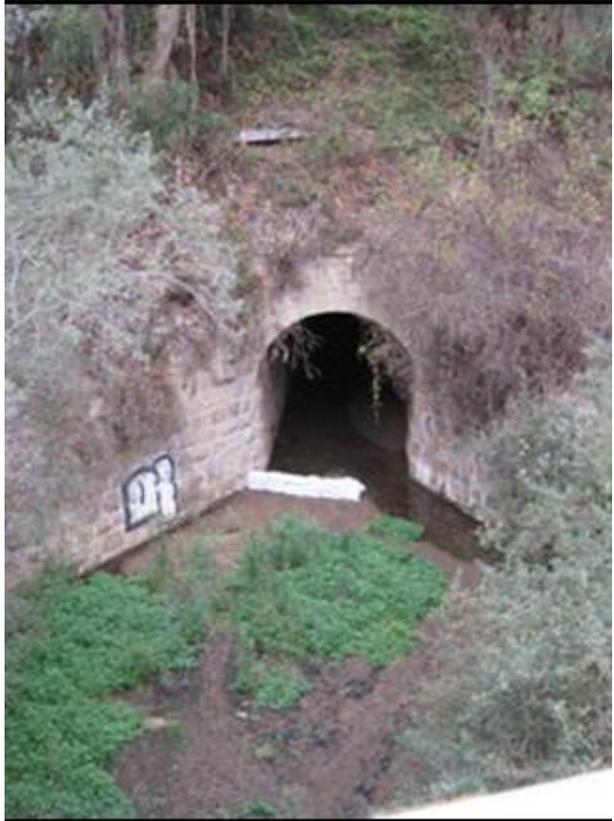
Date	Location	Size/ Material	Description from Daily Monitoring Report	Photo Documentation of Incident Setting from Monitoring Report
Oct 26, 2011	Culvert passing beneath the highway and UP Railroad	Unknown, potentially up to 117 gallons (6-inch diameter hole for 80 feet), drilling fluid	<p>A sudden loss of circulation of drilling fluids was noticed by the operator of the bore machine at about 12:30 PM. The Drilling Foreman directed that the machine be immediately shut off....Upon inspection of the culvert passing beneath the highway and UP Railroad, a slight increase in turbidity of water at the mouth of the culvert was observed. Closer inspection revealed a slow, low-volume release of fine sediments from a crack in the floor of the culvert, approximately 150 feet from its north (upstream) end. Water downstream was also slightly cloudy as noted above. Several small fish, tentatively identified as Tidewater Goby were observed in shallow pools within the culvert, downstream from where the sediments were originating.</p> <p>Upon further examination it was determined with some certainty that the sediments were originating from the bore hole. At this point (approximately 1:00 PM) the volume of affected water was estimated at about one gallon. Initial attempts at containment included a barrier of sand bags to isolate stream flow from the frac-out. A second barrier of sand bags had been proactively installed downstream, at the mouth of the culvert. A monitor was stationed the downstream end of the culvert ensure that no one entered the "wet" portion the channel. This was done to prevent inadvertent injury to gobies as a result of foot traffic associated with frac-out response. Entering from the north end of the culvert posed no such risk – there were no fish</p>

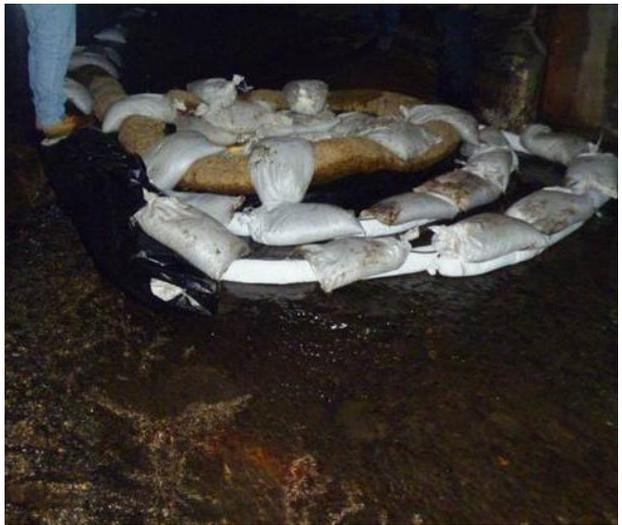
Date	Location	Size/ Material	Description from Daily Monitoring Report	Photo Documentation of Incident Setting from Monitoring Report
			<p>in this portion of the channel.</p> <p>An aquatic biologist holding a Federal Recovery Permit for tidewater goby was called out to make a positive identification and to assess overall health of the fish. She identified the fish as Tidewater Goby. She reported seeing 12-15 fish in the culvert; all of these appeared unaffected by the increase in turbidity.</p> <p>The drilling crew and Environmental Monitors worked throughout the afternoon to improve containment at the point of the frac-out. Stream flow was diverted away from the point where sediment was being released by means of rows of sand bags covered in plastic (the plastic formed a better seal against the concrete floor of the culvert). The frac-out point was then enclosed with a ring of plastic-covered sand bags encircled with a straw wattle and two rows of synthetic boom for filtration. At 6:00 PM it was determined that no further measures could or should be implemented without agency consultation. The crew and monitors left the site at about 6:00 PM.</p> <p>The volume of the drilling mud released cannot be accurately determined. When first noticed, it amounted to a small "trickle" (see estimate of 1 gallon of affected water), but the release was steady for at least 5-6 hours. After 6:00 PM when sediment controls were completed, the mud was effectively contained, but water was still seeping from the crack in the floor of the culvert. When inspected the following morning, water flowing through the containment/filtration</p>

Date	Location	Size/ Material	Description from Daily Monitoring Report	Photo Documentation of Incident Setting from Monitoring Report
			<p>device was clear. The volume of drilling fluids potentially released would have amounted to what was injected into the 6-inch diameter pilot hole for a distance of about 80 feet (distance that the drill bit had been advanced before circulation was lost). Much of the bentonite likely remained in the annulus once down-hole pressure was relieved.</p> <p>It appears that the drill head penetrated an aquifer, or perhaps intercepted base flow beneath the culvert. There is a natural "spring" that issues from a crack in the floor of the culvert from which the drilling mud was released. The groundwater likely mixed with drill mud from the annulus due to pressure and gradient and the water at the surface remained cloudy until that pressure equalized.</p>
