Overcoming the Challenges to Intelligently Pig the Unpiggable – Platform Elly to Shore Oil Pipeline Case Study

Prevention First 2008

Background

- 17.3 mile sub sea pipeline installed in 1980 from Platform Elly to Long Beach Harbor
- 16" OD, 0.5" wt API 5LX 52, 0.844" wt riser, zinc sacrificial anodes
- Product – dry oil separated
 - 15.2 API gravity
 - 1.9% BS&W
 - Paraffins & asphaltenes in 3:1 ratio
- Using only sphere pig to remove H₂O

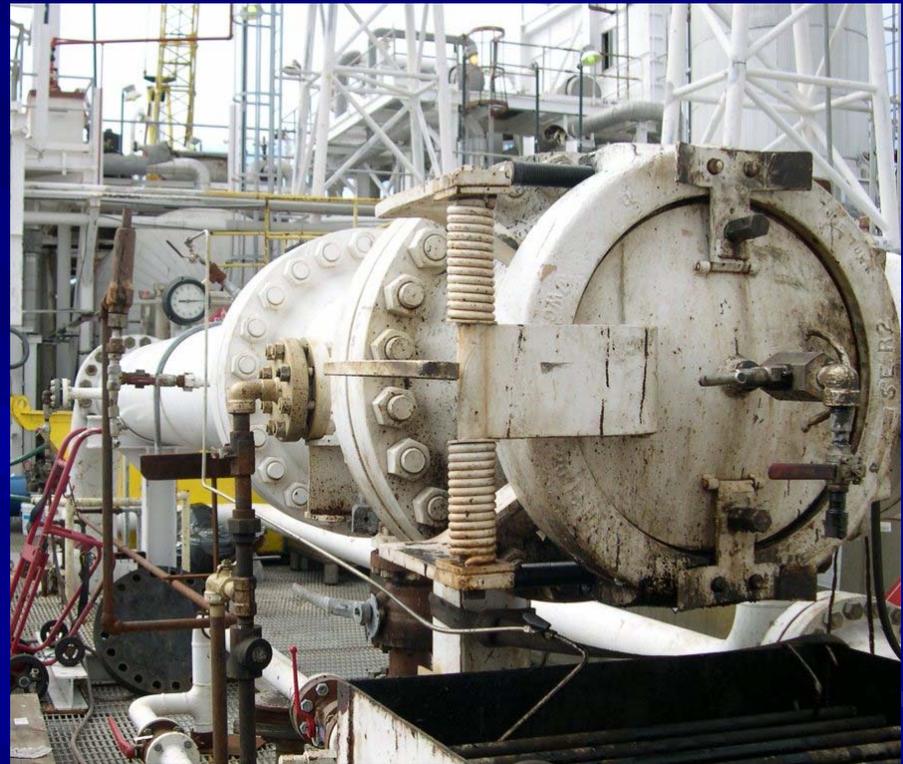
- Beta Station & Elly Modifications
- Pig Detection
- Procedures for Cleaning
- Caliper Pig
- Cleaning Pipeline (Est. 6 months)

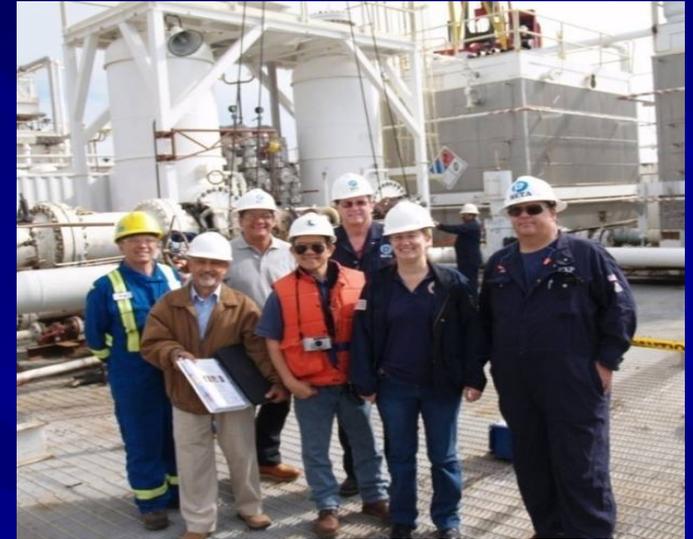
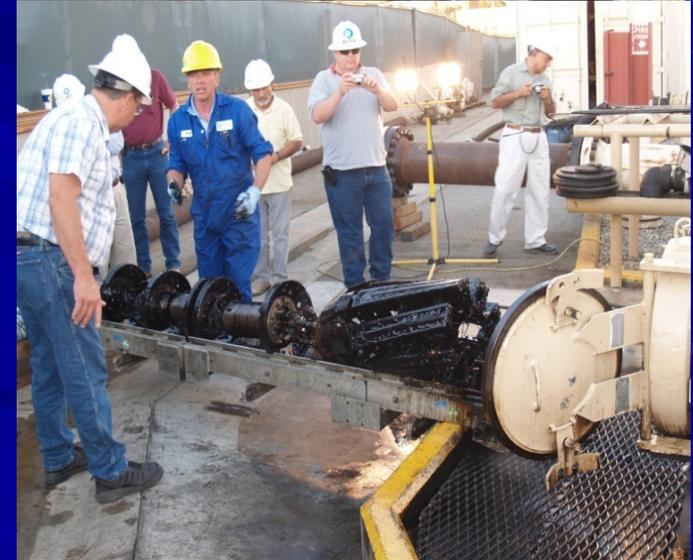
- Moving the UT tool: push with water due to velocity / time constraints
- Getting enough clean water from the source well to Launcher
- Disposing of chemicals and 60,000 bbls of water on shore
- First UT tool run was unsuccessful due to contamination of the sensors

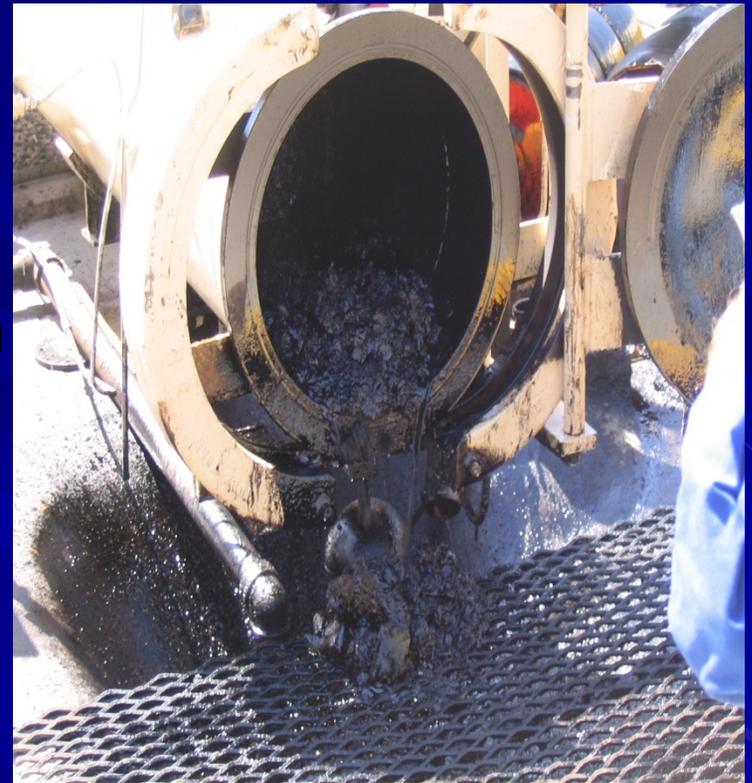
- Accelerated chemical cleaning to remove possible remaining hard wax
- Used more aggressive pigs, with “pills” of solvent followed by even more aggressive discs and brushes.
- 30 ft wax candle “surprise” at Beta Station. Entire prior cleaning program produced nothing like this.

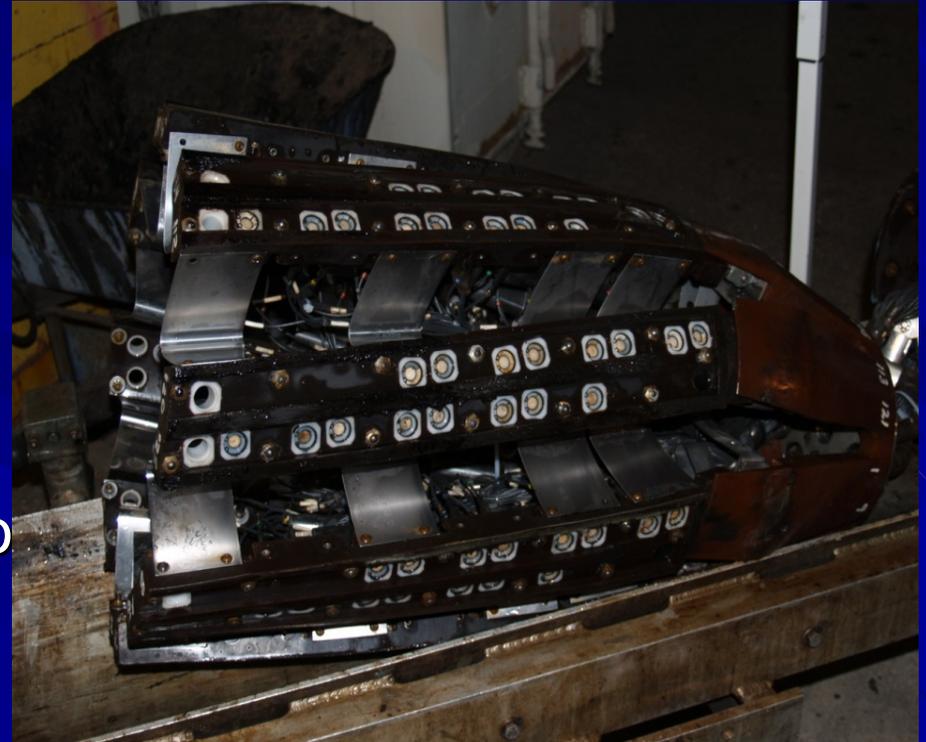
GE PII UT Tool Data

DEPTH BASED HISTOGRAM

Platform Elly to Beta Station
UltraScan WM Run 2AHB
