August 30, 2013  
(20252)

**SUBJECT: POTENTIAL IMPACTS TO TRANCAS LAGOON BY EQUIPMENT CROSSING FOR BROAD BEACH RESTORATION PROJECT**

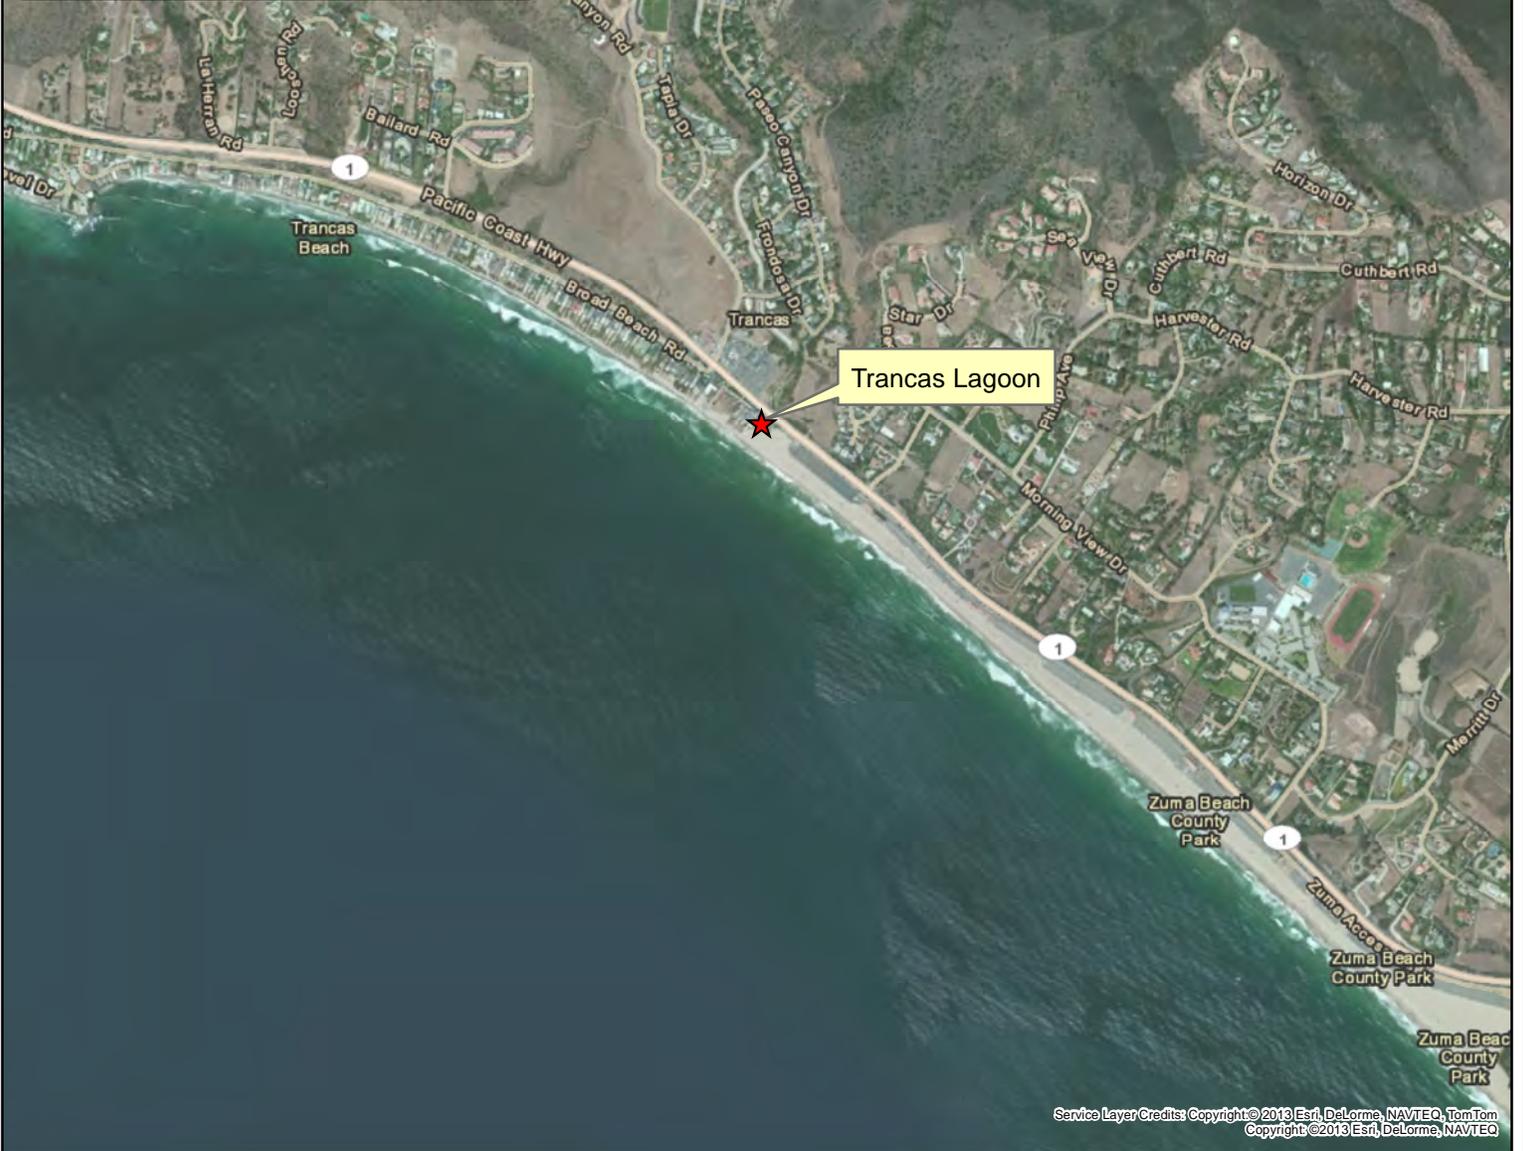
**Figure 2**  
Trancas Lagoon  
Lagoon Perimeter Map

Figure 2 shows the perimeter of Trancas Lagoon mapped on August 14, 2013. The water level in the lagoon was very low probably because it was towards the end of summer in a very dry year. The base aerial photograph taken in summer 2011 shows more water in the lagoon probably because the winter of 2010/2011 was wetter.

Perimeter on August 14, 2013
-

Open Water

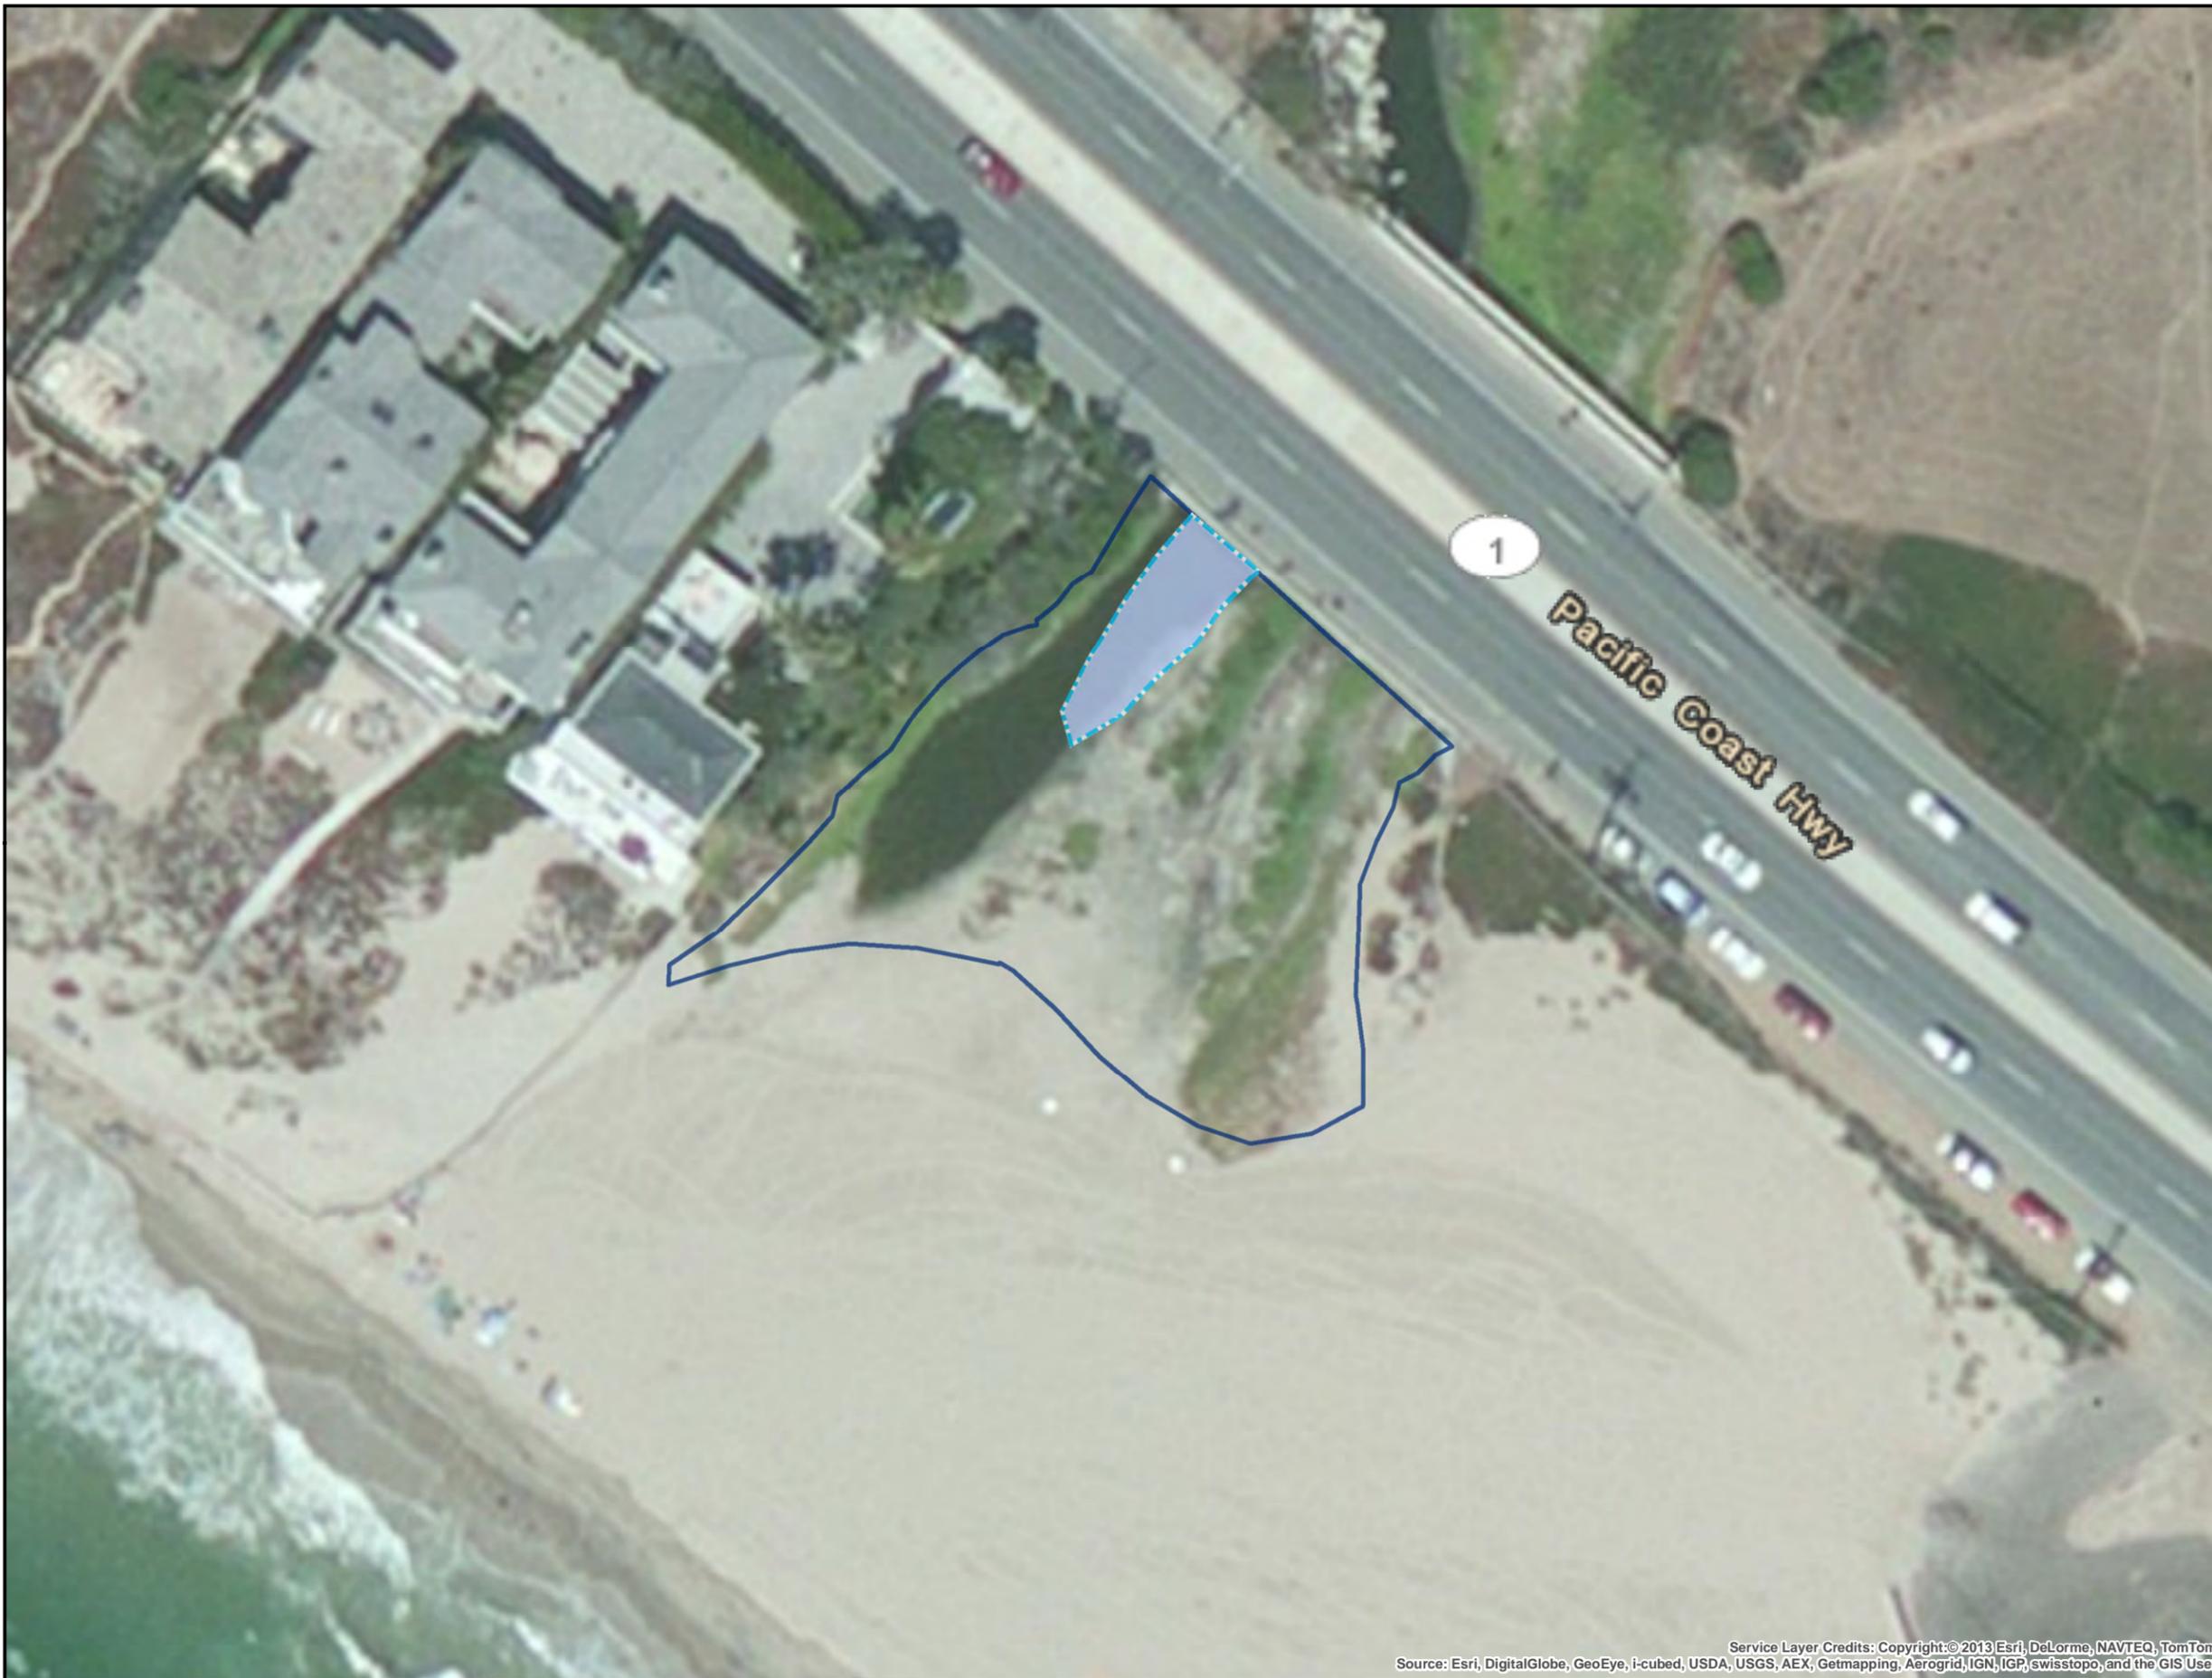
**Figure 3**  
Trancas Lagoon  
Aerial From January 2006

Figures 3, 4, and 5 show the lagoon under typical winter conditions, when the lagoon is breached. Figure 3 is from January 2006, Figure 4 is from January 8, 2008, and Figure 5 is April 26, 2011.
