**SHALLOW OFFSHORE SEISMIC INVESTIGATION
PALOS VERDES, CALIFORNIA**

Field Operations Report

ECO-M Reference No. 14-01
20 January 2014

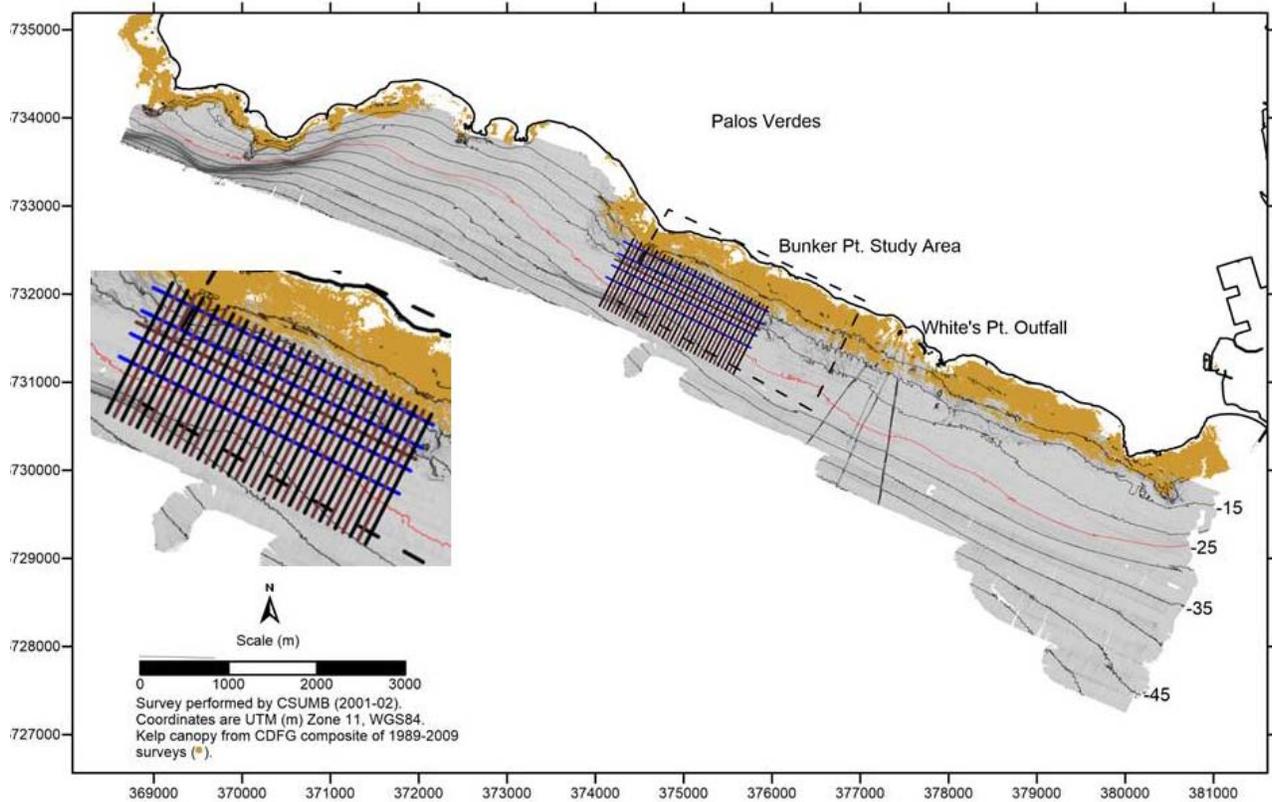
Figure 1-1. Survey area and survey lines for the survey of Palos Verdes performed on 6-7 January 2014. Blue upcoast/downcoast lines are side-scan survey lines. Black inshore/offshore lines are sub-bottom profile and bathymetric lines. Brown inshore/offshore lines are bathymetric lines only.

The surveyed area and survey lines are shown in Figure 1-1. Surveys were performed from the seaward edge of existing kelp beds out to the 30m isobath. The side-scan survey is used to map the distribution of various seafloor substrate types. Sub-bottom profiling was performed to determine the thickness of areas covered by unconsolidated sediments. Bathymetric surveys were performed to determine the water depths in surveyed areas.

A total of four tracklines were acquired for the side-scan survey. Tracklines were run in an upcoast/downcoast orientation (Figure 1-1) and were approximately 150m apart. Side-scan surveys began just offshore of the kelp beds and extended 2000m alongshore and 1,000m offshore. The dual-channel sonar scale selection was 100m per channel, thus covering a swath of 200m. The side-scan was towed off the starboard quarter on a cable length of 7.6m (25 ft). Data acquisition employed Chesapeake SonarWiz 5.

A total of 35 tracklines were acquired during the bathymetric survey. Tracklines were run in an onshore/offshore orientation (Figure 1-1) and were 50m apart. Eighteen bathymetric survey lines were conducted on the existing sub-bottom survey lines. Seventeen bathymetric survey lines were run between each sub-bottom survey line. Bathymetric surveys began just seaward of the kelp beds and extended 1,000m offshore. The echosounder is located underneath the vessel, at about 1m or less below the surface. Bathymetric data were acquired with a Trimble Hydropro.

A total of 18 tracklines were acquired for the sub-bottom profiler survey. Sub-bottom tracklines were conducted in an onshore/offshore orientation (Figure 1-1) and were 100m apart. Sub-bottom surveys began just seaward of the kelp beds and extended 1,000m offshore. The sub-bottom profiler was towed off the starboard quarter on a cable length of 2m (6.5ft). Data acquisition was with Chesapeake SonarWiz 5.

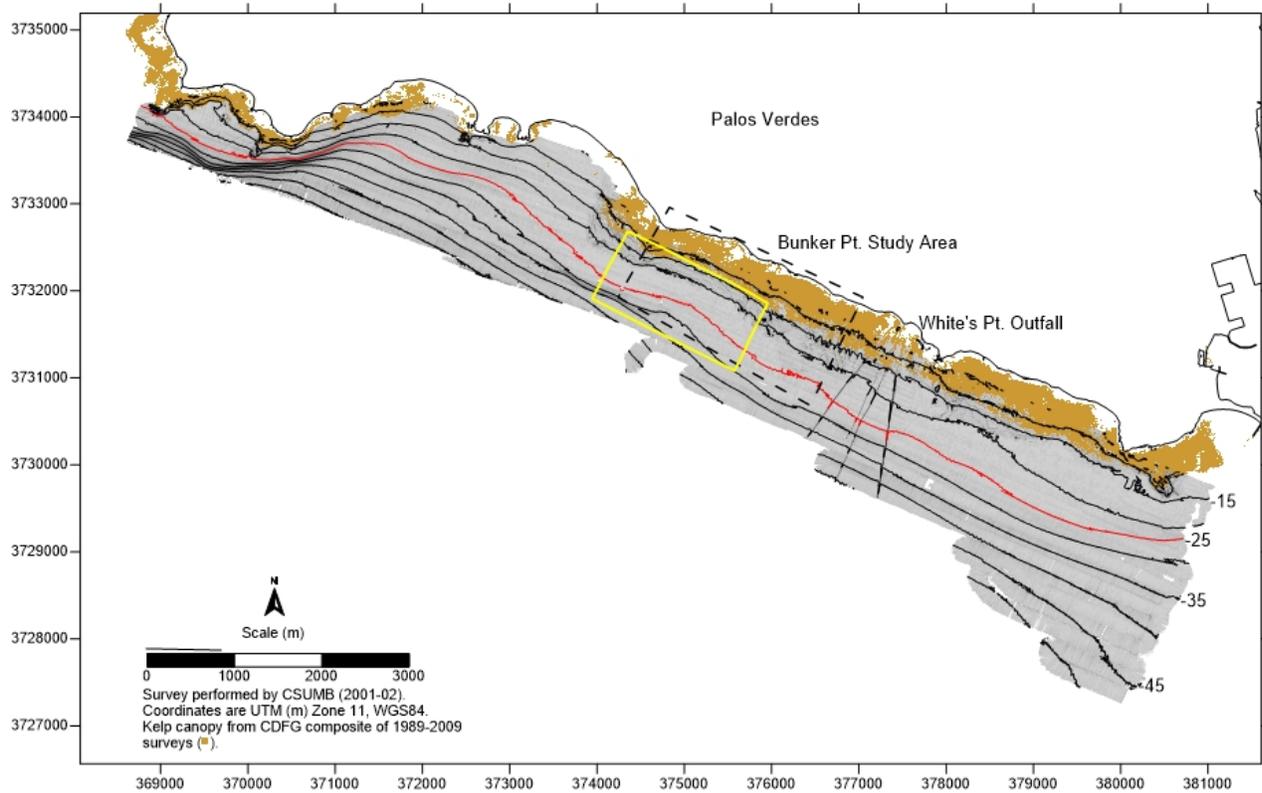
Figure 2-1. Location of kelp canopy at Palos Verdes near the survey area (yellow box). The kelp data is a composite of kelp data from 1989-2009 collected by the CDFW.

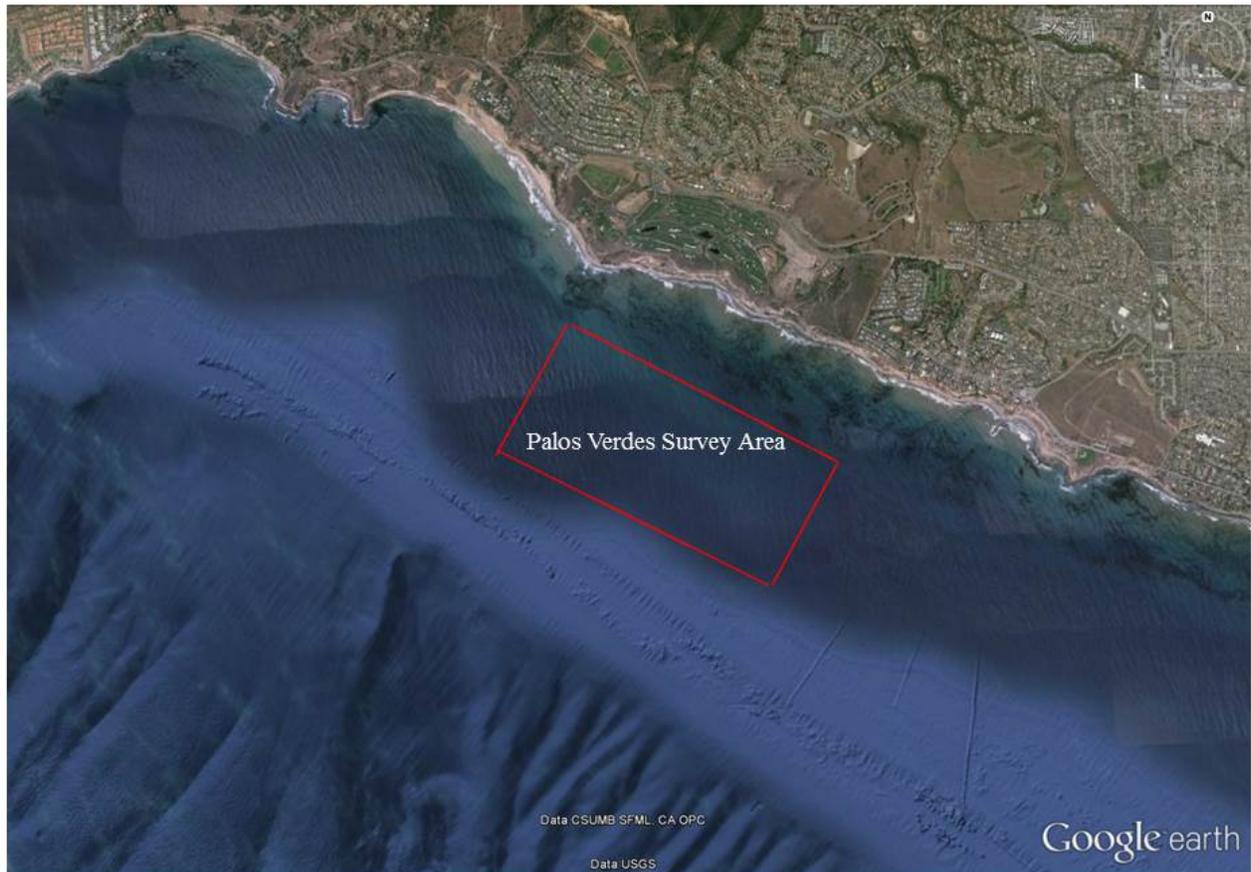
Figure 2-2. Satellite image of Palos Verdes survey area showing the location of kelp canopy.

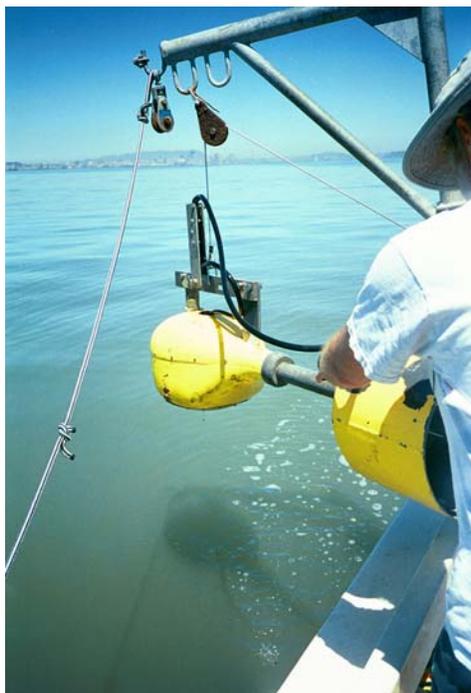
Photo 2-1. Sub-bottom profiler tow fish being lowered into the water from the lifting hoist.

Sub-bottom profiler equipment (Photo 2-1) allows for the detection and characterization of objects buried below the seafloor. The 3.5 kHz sub-bottom profiler was effectively used for this project and provided excellent records.

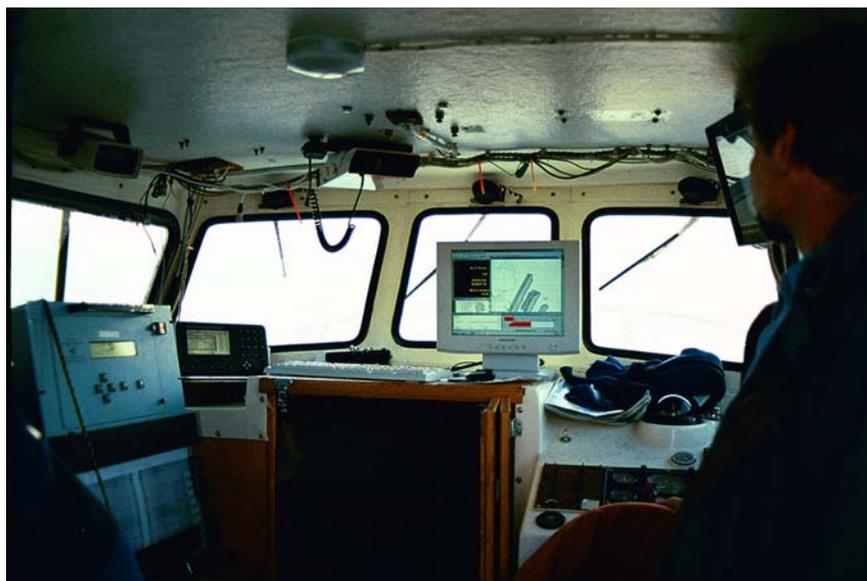
Photo 2-2. The helmsman steering display, seen in the photograph, shows pre-plotted survey lines.

The survey was conducted using a 27' Farrallon trailerable survey boat. The boat is powered by a Panther Marine 350 HP engine with dual counter-rotating props. The boat is equipped with DGPS, RADAR, echosounder, and related electronics with a lifting hoist for deployment of sonar fish and other marine instrumentation (Photo 2-2).

The survey parameters (i.e., area coordinates, line, and cross-line spacings) were entered into the Chesapeake SonarWiz5 Navigation Software creating a “pre-plot.” With this pre-plot, it is possible to ensure that adequate survey line coverage has been obtained. The navigation system records the shot point number, x/y position, date, time, and geophysical information at each selected data point. Position and time data were automatically stored on a computer hard drive, and digital back-up storage was used. In addition, a real-time Helmsman Correct Course Steering Display helped keep the vessel on the pre-plotted survey lines (Figure 2-2). Simultaneously with the collection of positioning data, an event mark was sent to the recorders, which was annotated with shot point number, time, and date.

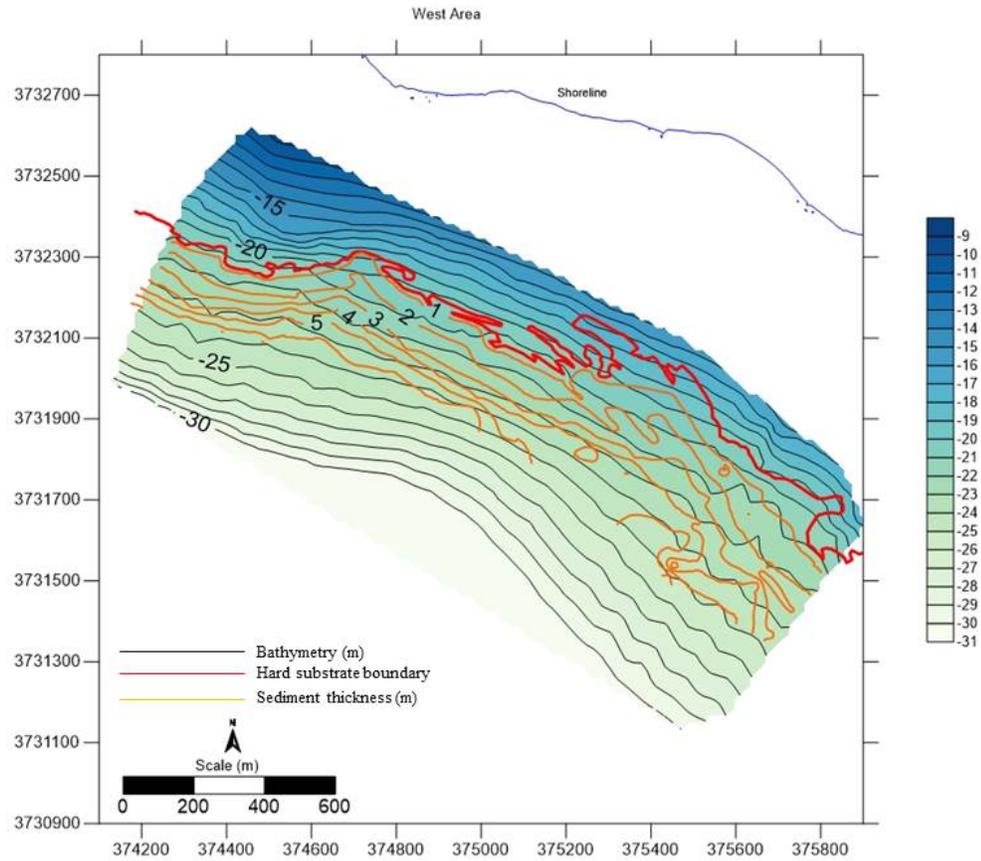
Coordinates are in UTM zone 11N (m) WGS84

Figure 3-1. Results of the Palos Verdes seismic survey performed on 6-7 January 2014. The red line indicates the hard substrate outcrop, which was determined from the side-scan sonar survey. The orange lines and 1-6 numbering indicate the sediment depth (m) over bedrock, determined from the sub-bottom profile survey. The black lines indicate the bathymetry (m) of the survey area, determined by the echosounder survey.

The results of the survey are shown in Figure 3-1. Figure 3-1 shows the hard substrate outcrops from the side-scan survey, sediment thickness from the sub-bottom profiler survey, and isobaths from the bathymetric survey.

Side-scan survey data confirmed that the survey area consisted of unconsolidated sediment bottom habitat. The hard substrate outcroppings were determined from the side-scan survey data (red line in Figure 3-1). This red line indicates the boundary of hard substrate to unconsolidated sediment bottom areas. These data indicate that the line of hard substrate is located at approximately the 20m isobath. The sub-bottom profile survey determined that the sediment thickness in bottom areas ranged from 1-5m, with sediment thickness increasing with increasing water depth.

The existence of unconsolidated sediment bottom habitat suggests that the area surveyed may be conducive to reef placement. However, a limited area exists where the sediment thickness is shallow enough to allow for ideal reef placement. This is located in the narrow band between the hard substrate outcrops and the area with 2m sediment thickness. Within this area, however, there is sufficient space for the placement of an approximately 40-acre artificial reef.
