**SUPPLEMENTAL MARINE HABITAT SURVEY AND MAPPING  
FOR THE BROAD BEACH RESTORATION PROJECT**

**Moffatt & Nichol**  
Attn: Mr. Chris Webb  
3780 Kilroy Airport Way  
Long Beach, CA 90806  
*Phone: (562) 426-9551*

**Merkel & Associates, Inc.**  
5434 Ruffin Road  
San Diego, CA 92123  
*Phone: (858) 560-5465*  
*Fax: (858) 560-7779*

**June 2014**

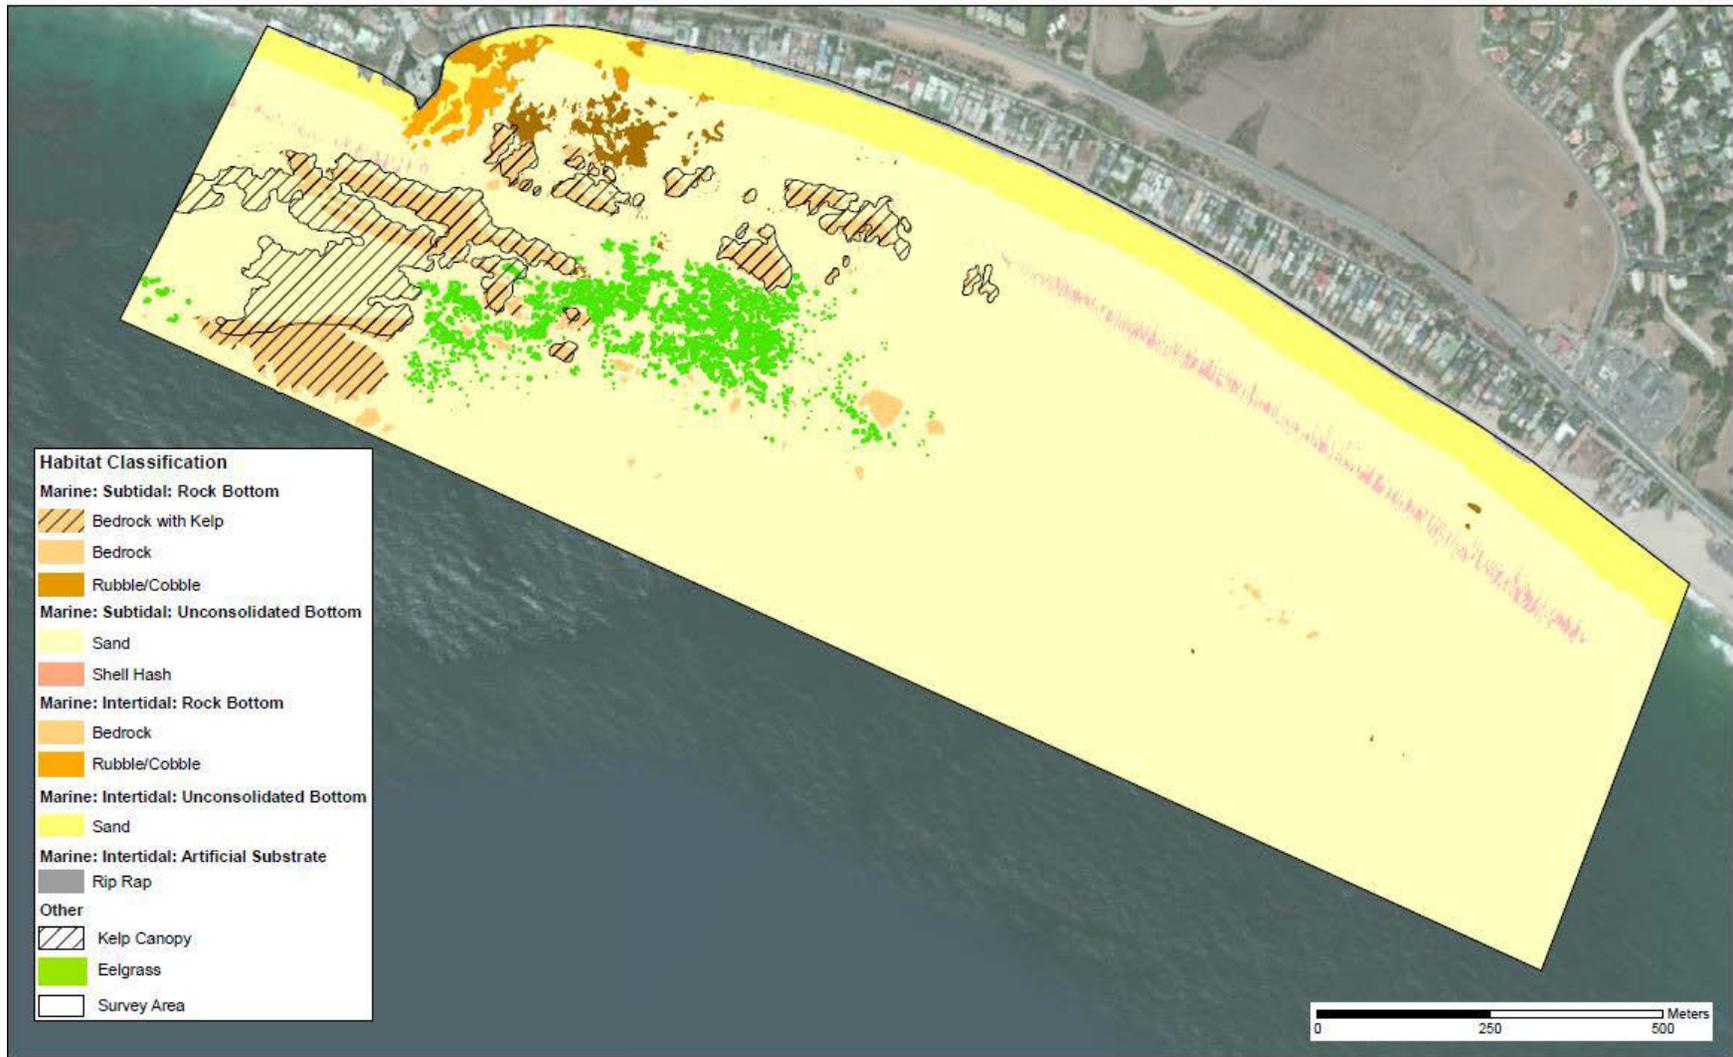
Figure 1. Benthic Habitat Map for Broad Beach Survey Area (May 2014).

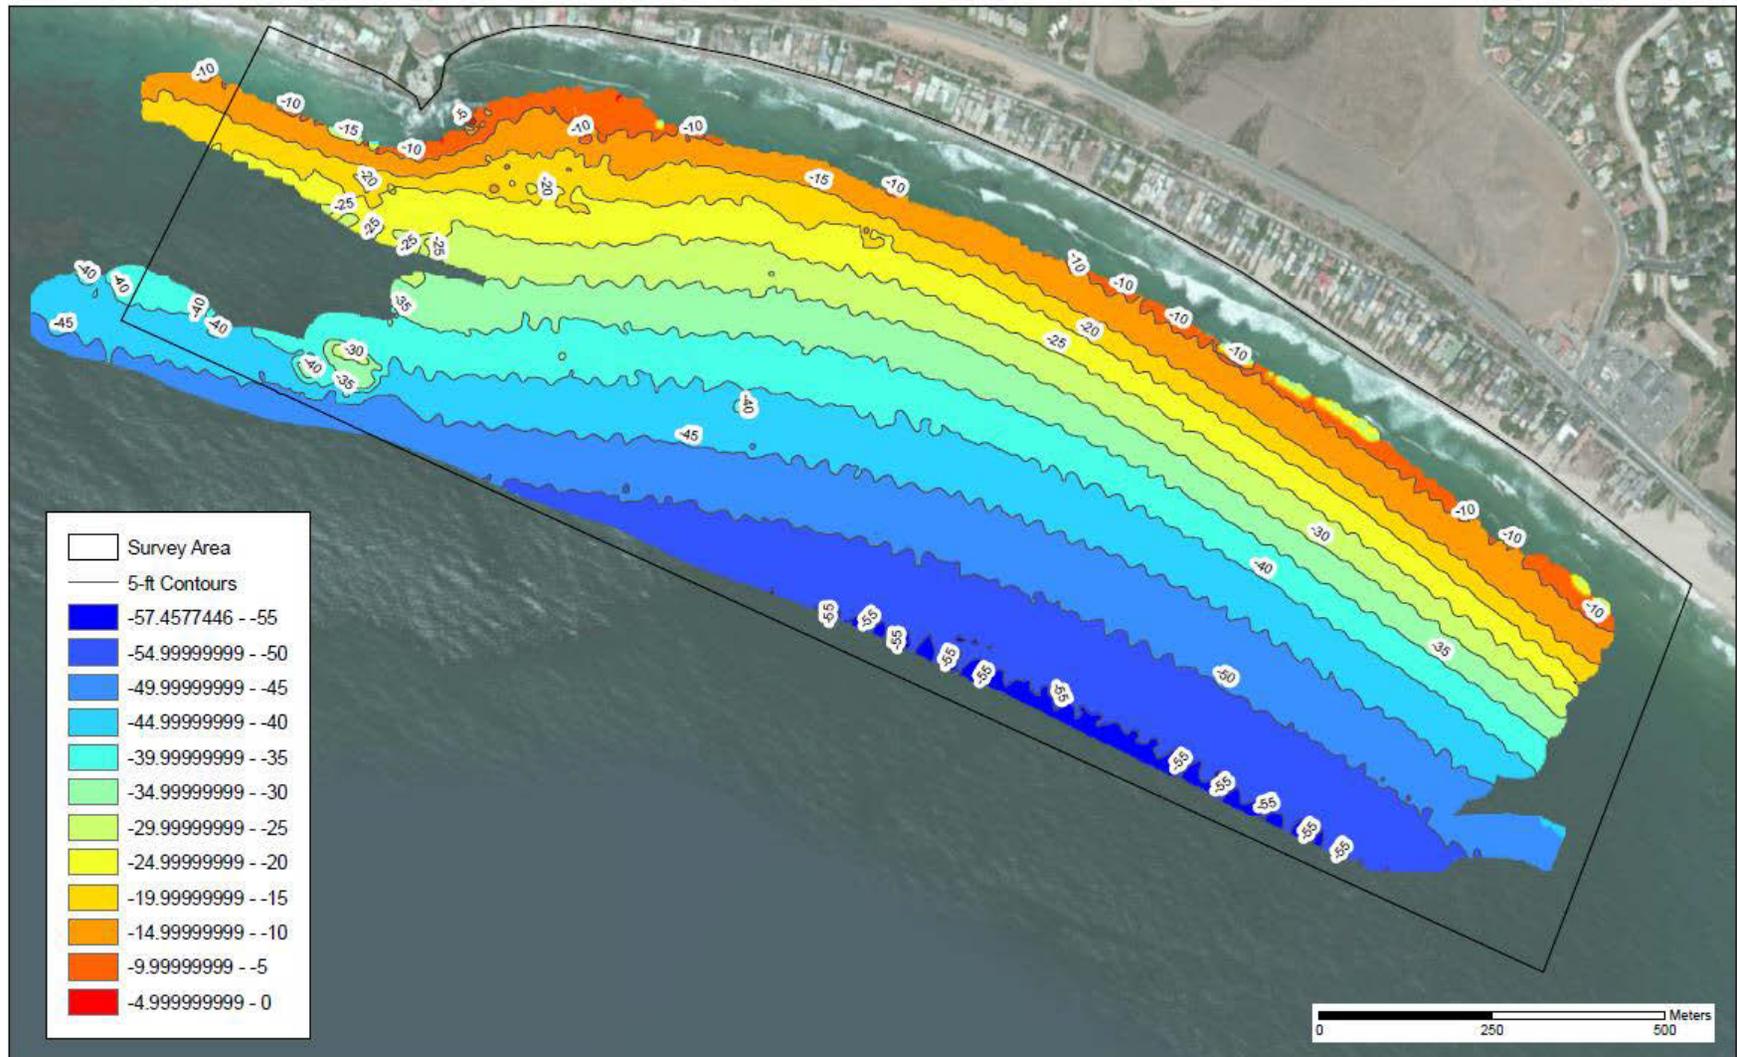
Figure 2. Bathymetry for Broad Beach Survey Area (May 2014).

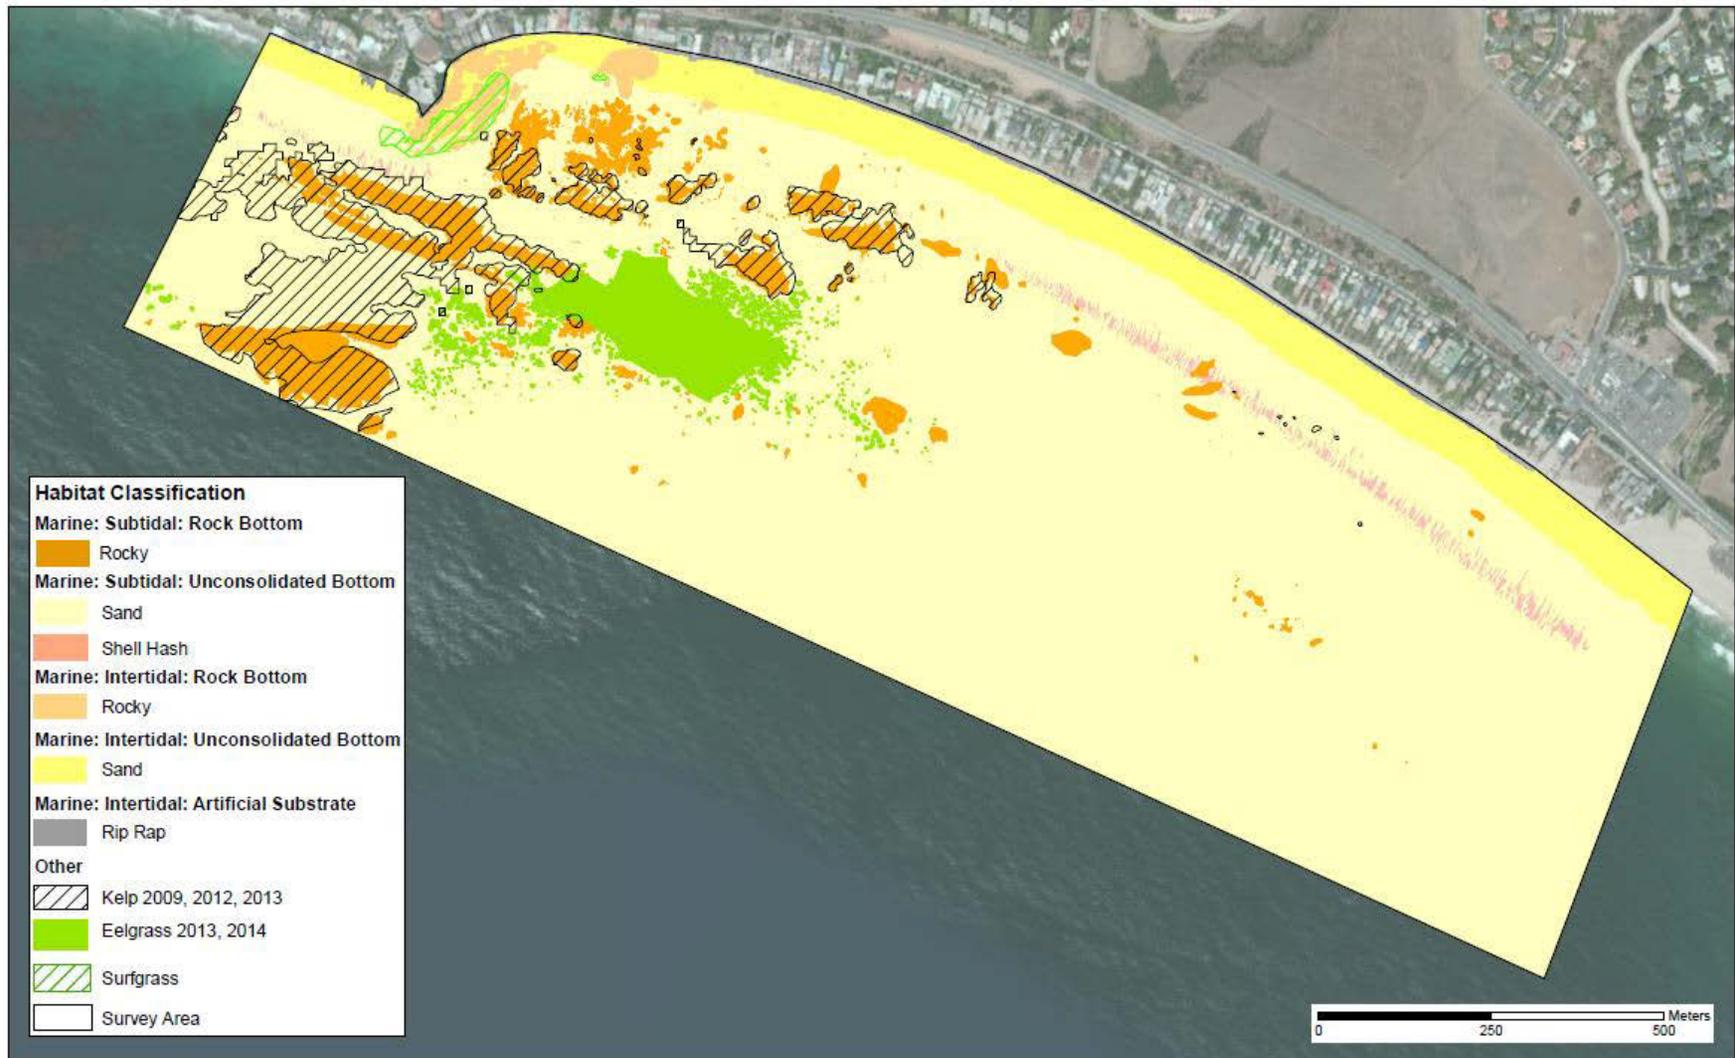
Figure 3. Benthic Habitat Map for Broad Beach Survey Area (Combined Data Sources).

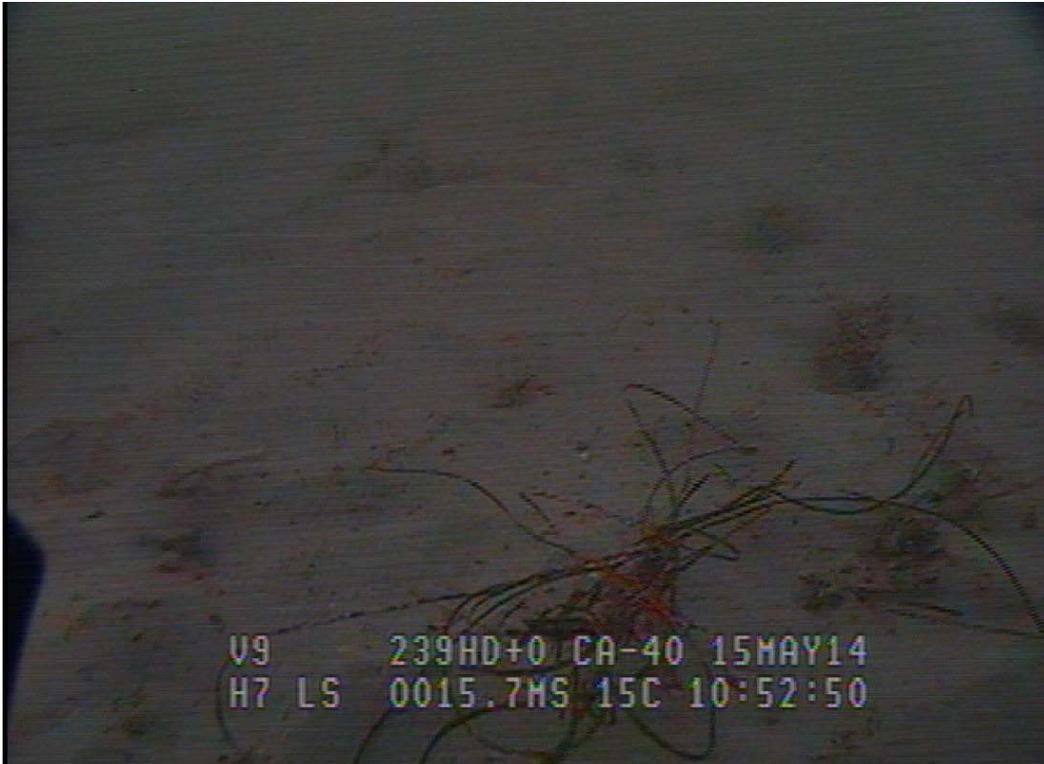
**Figure 4. Sandy subtidal habitat.**

The dominant habitat type detected both in the intertidal and subtidal zones was sand. Compacted medium and fine sands were generally observed in the deeper offshore waters (Figure 4). Moving inshore, areas with significant sand waves and coarser sand were often observed. Sand habitat was generally observed to be devoid of significant epifauna and observations of fish were rare (during ROV surveys). The mapped coarse sediments/shell hash comprised 3.7 acres of the mapped area. This habitat type can be classified as part of the sand habitat, but was mapped separately because the shell hash had a higher reflectance in the backscatter data. This made shell hash stand out, and in some cases, the shell hash appeared similar to cobble reef until the ground truth effort made it possible to distinguish the two habitats.

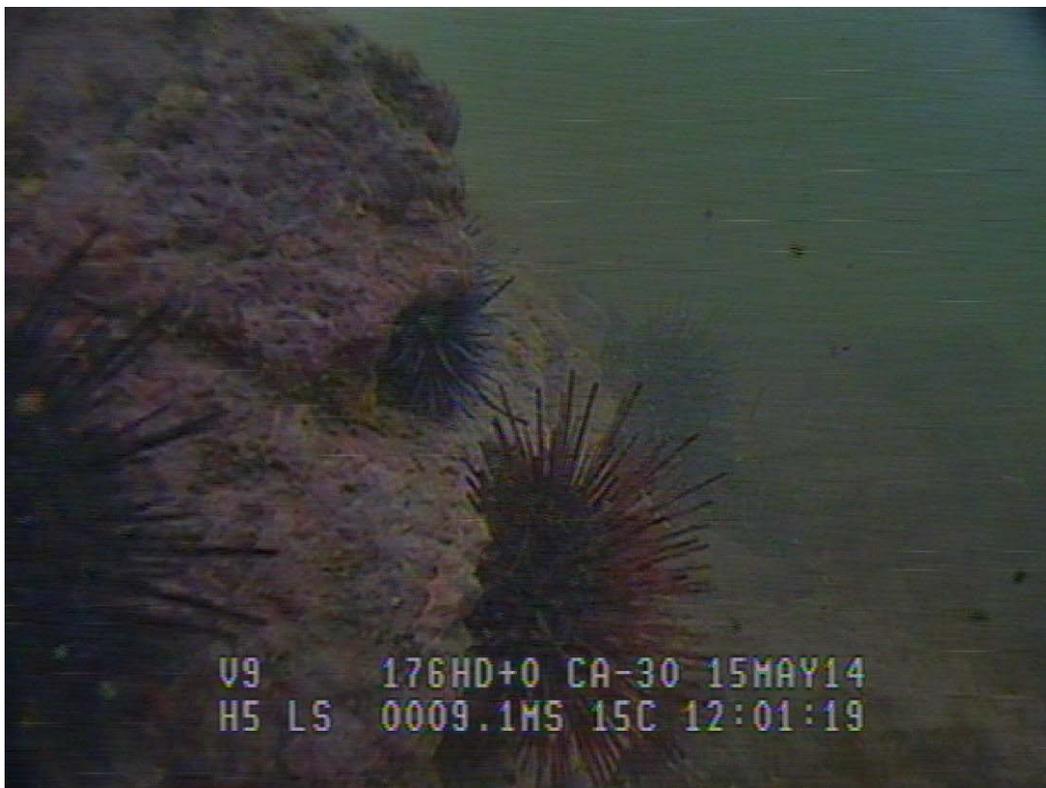
**Figure 7. Rocky reef subtidal habitat with sea urchins.**

The second most abundant benthic habitat type mapped in May 2014 was bedrock/boulder/cobble habitat (approximately 23.5 acres). The substrate generally consisted of areas with small and medium sized cobble, occasional boulders, as well as large rock outcroppings. Some of the lower-relief (< 1m high) boulder/cobble areas were generally characterized as having a low cover of foliose and sheet forms of red and brown algae (Figure 5), while areas with larger rock outcroppings and higher relief (> 1m high) were observed to support understory kelp species such as *Pterygophora californica* as well as canopy forming giant kelp, *Macrocystis pyrifera* (Figure 6). Some rocky areas also supported relatively high densities of purple and red sea urchins (*Strongylocentrotus purpuratus* and *S. francisanus*) (Figure 7).

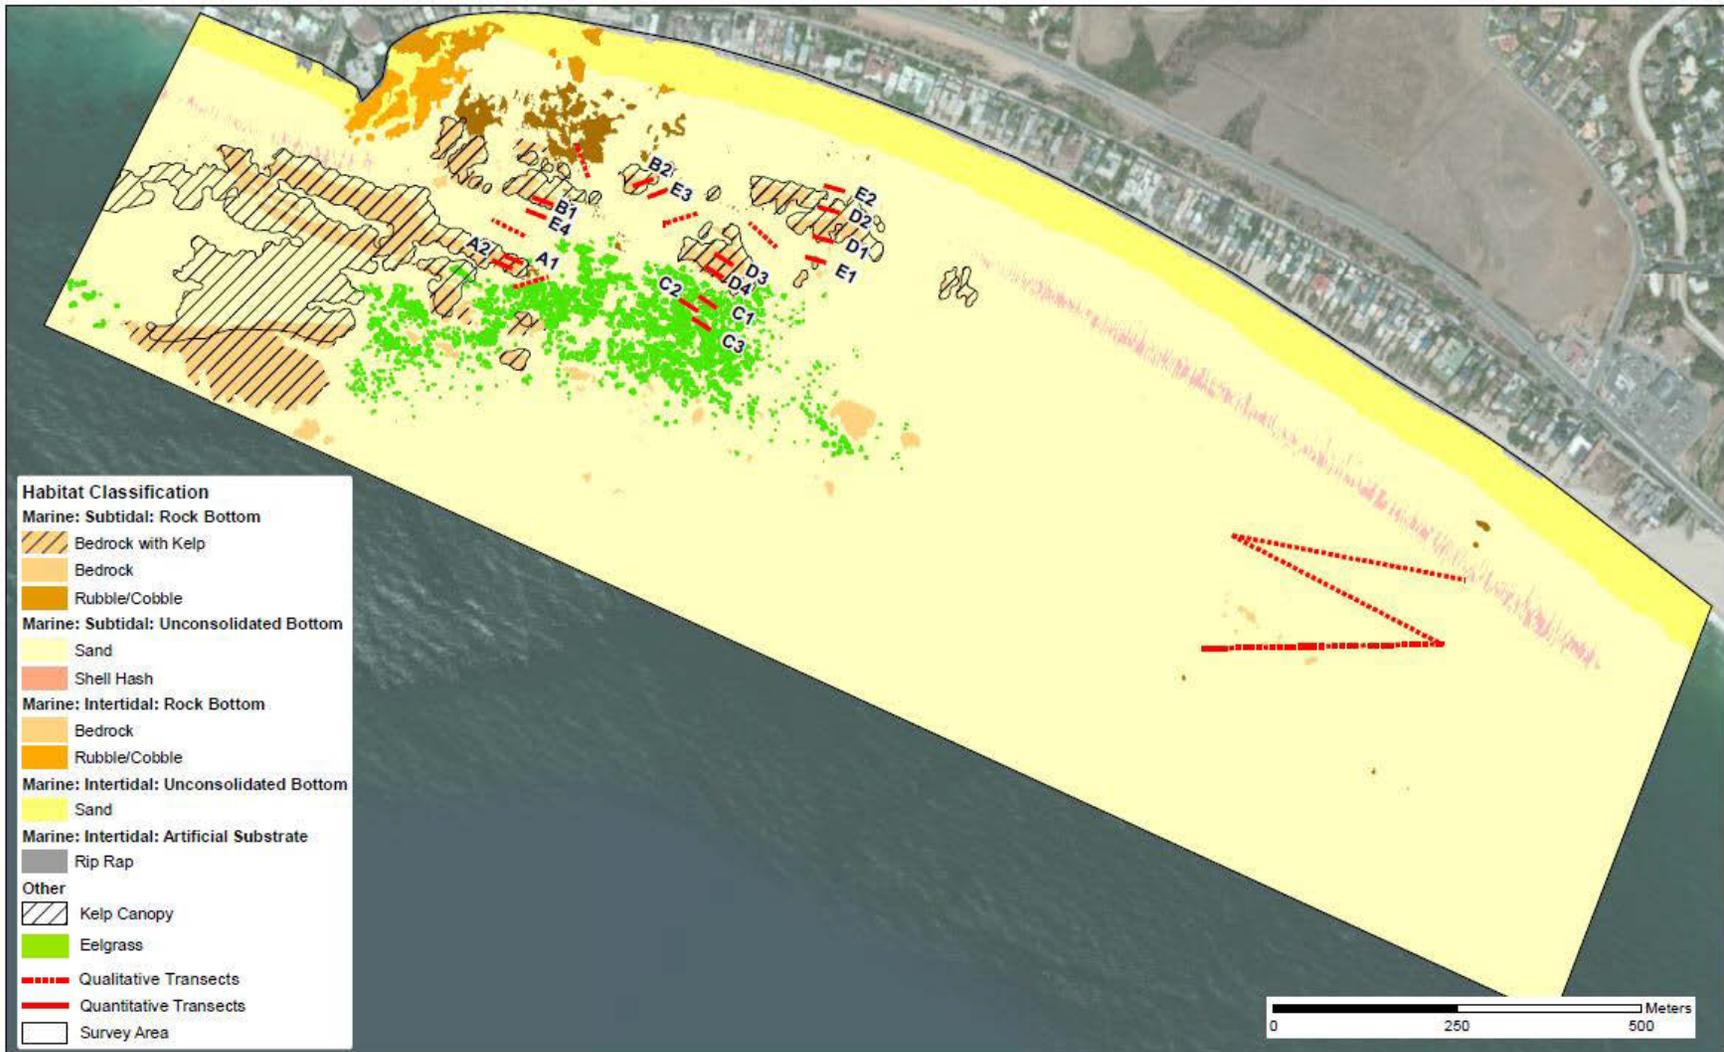
Figure 9. Transects sampled for subtidal community study.

As noted previously, the methodology was implemented based on habitat type and is summarized in Table 2 and depicted in Figure 9. In addition to the quantitative transects, additional qualitative transects were conducted to provide a more comprehensive species list (Figure 9).

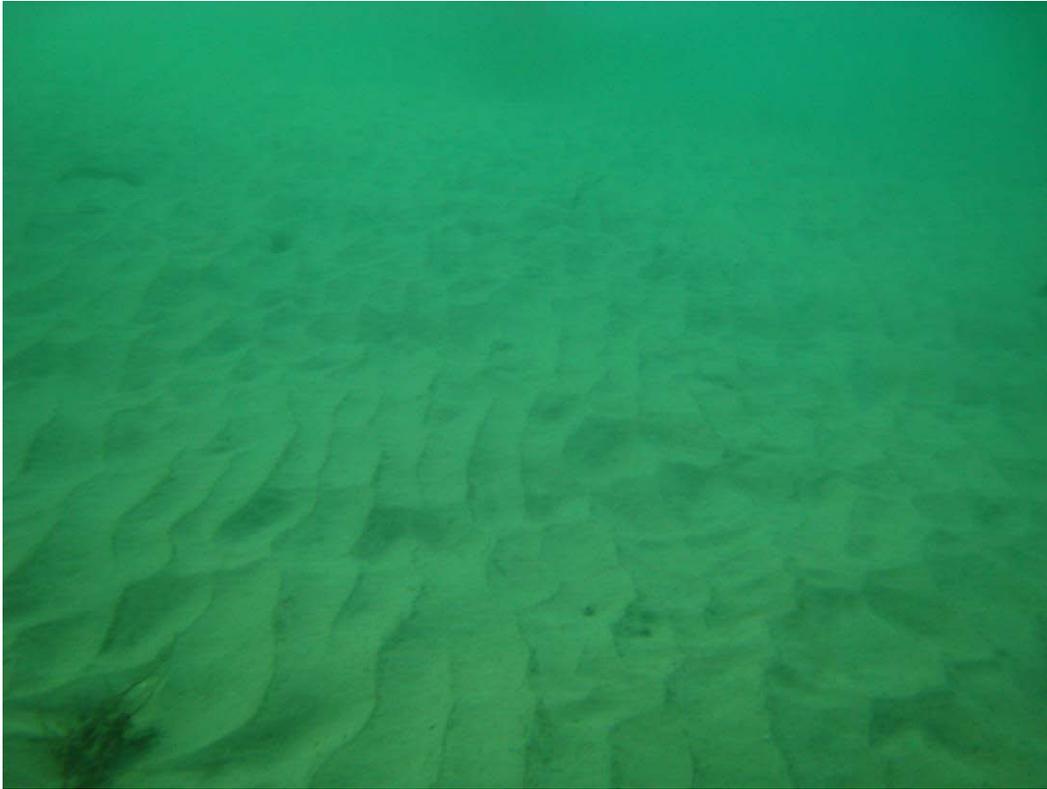
**Figure 10. Sandy subtidal habitat.**

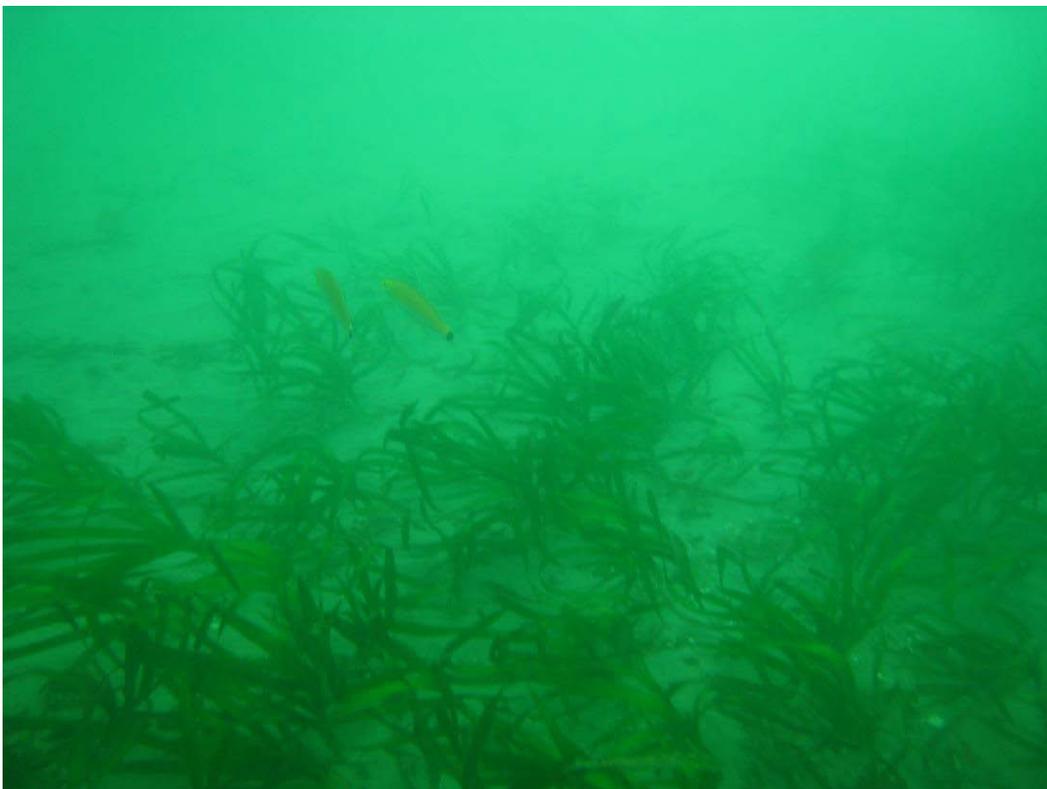
**Figure 11. Eelgrass habitat located in approximately 30 ft of water.**

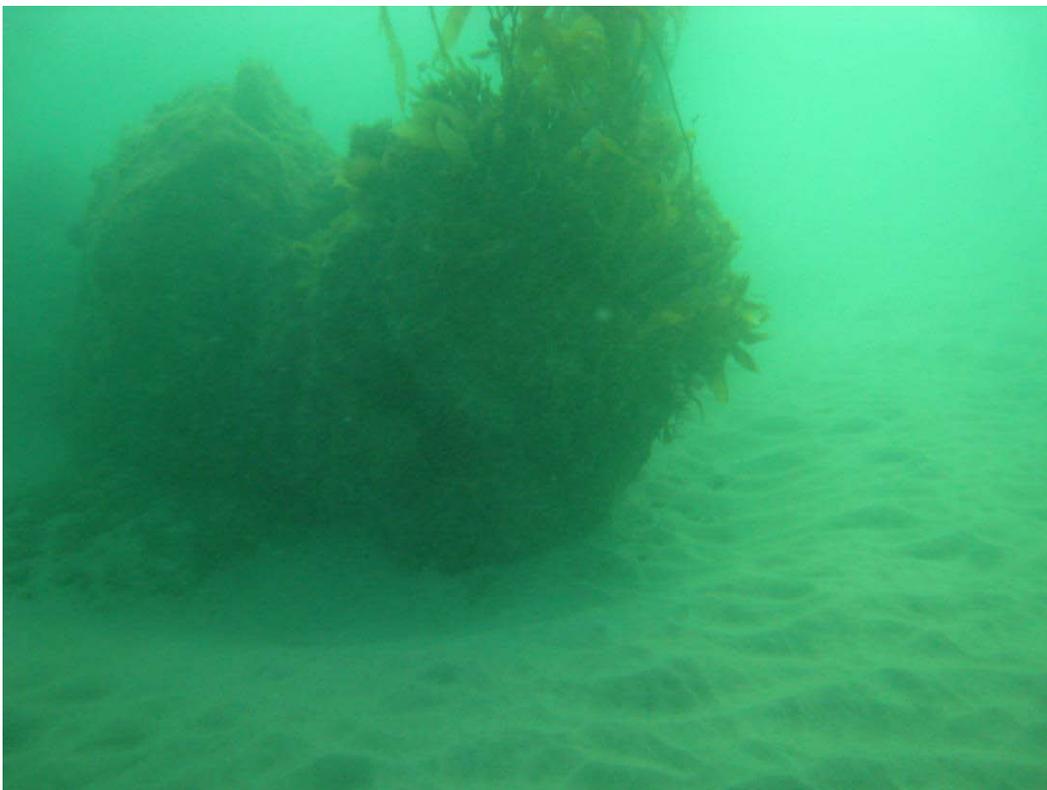
**Figure 15. High-relief rocky substrate supporting giant kelp.**

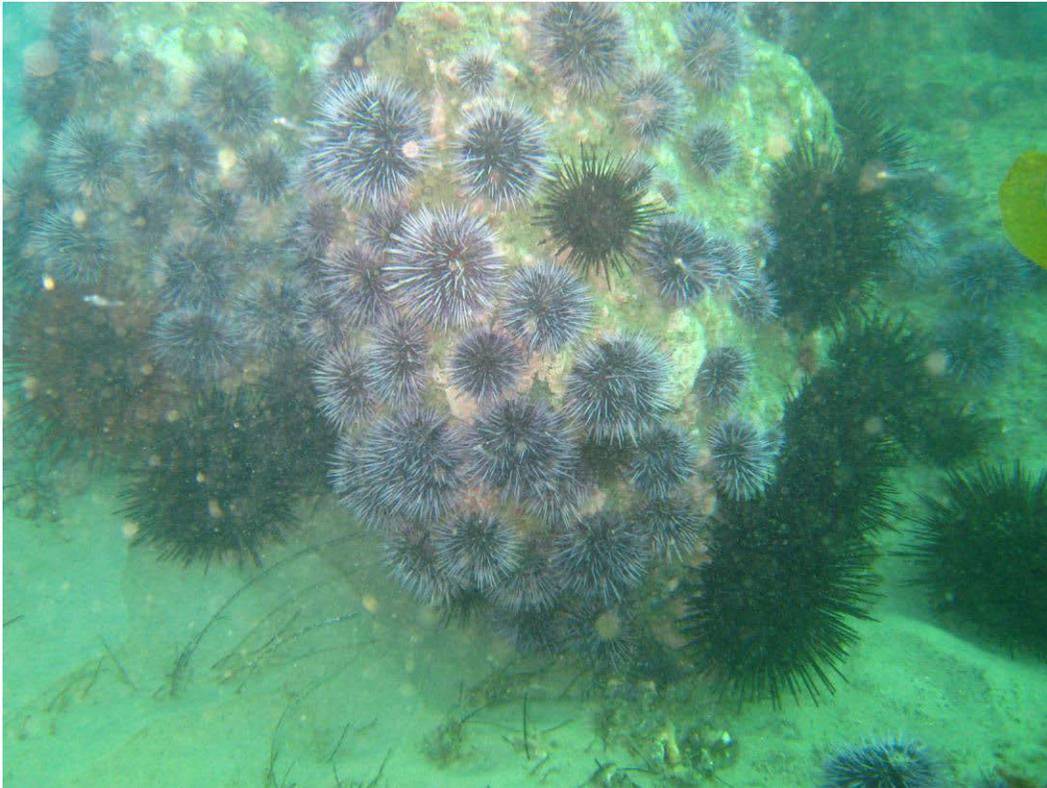
**Figure 16. High-relief rocky substrate supporting purple and red sea urchins.**

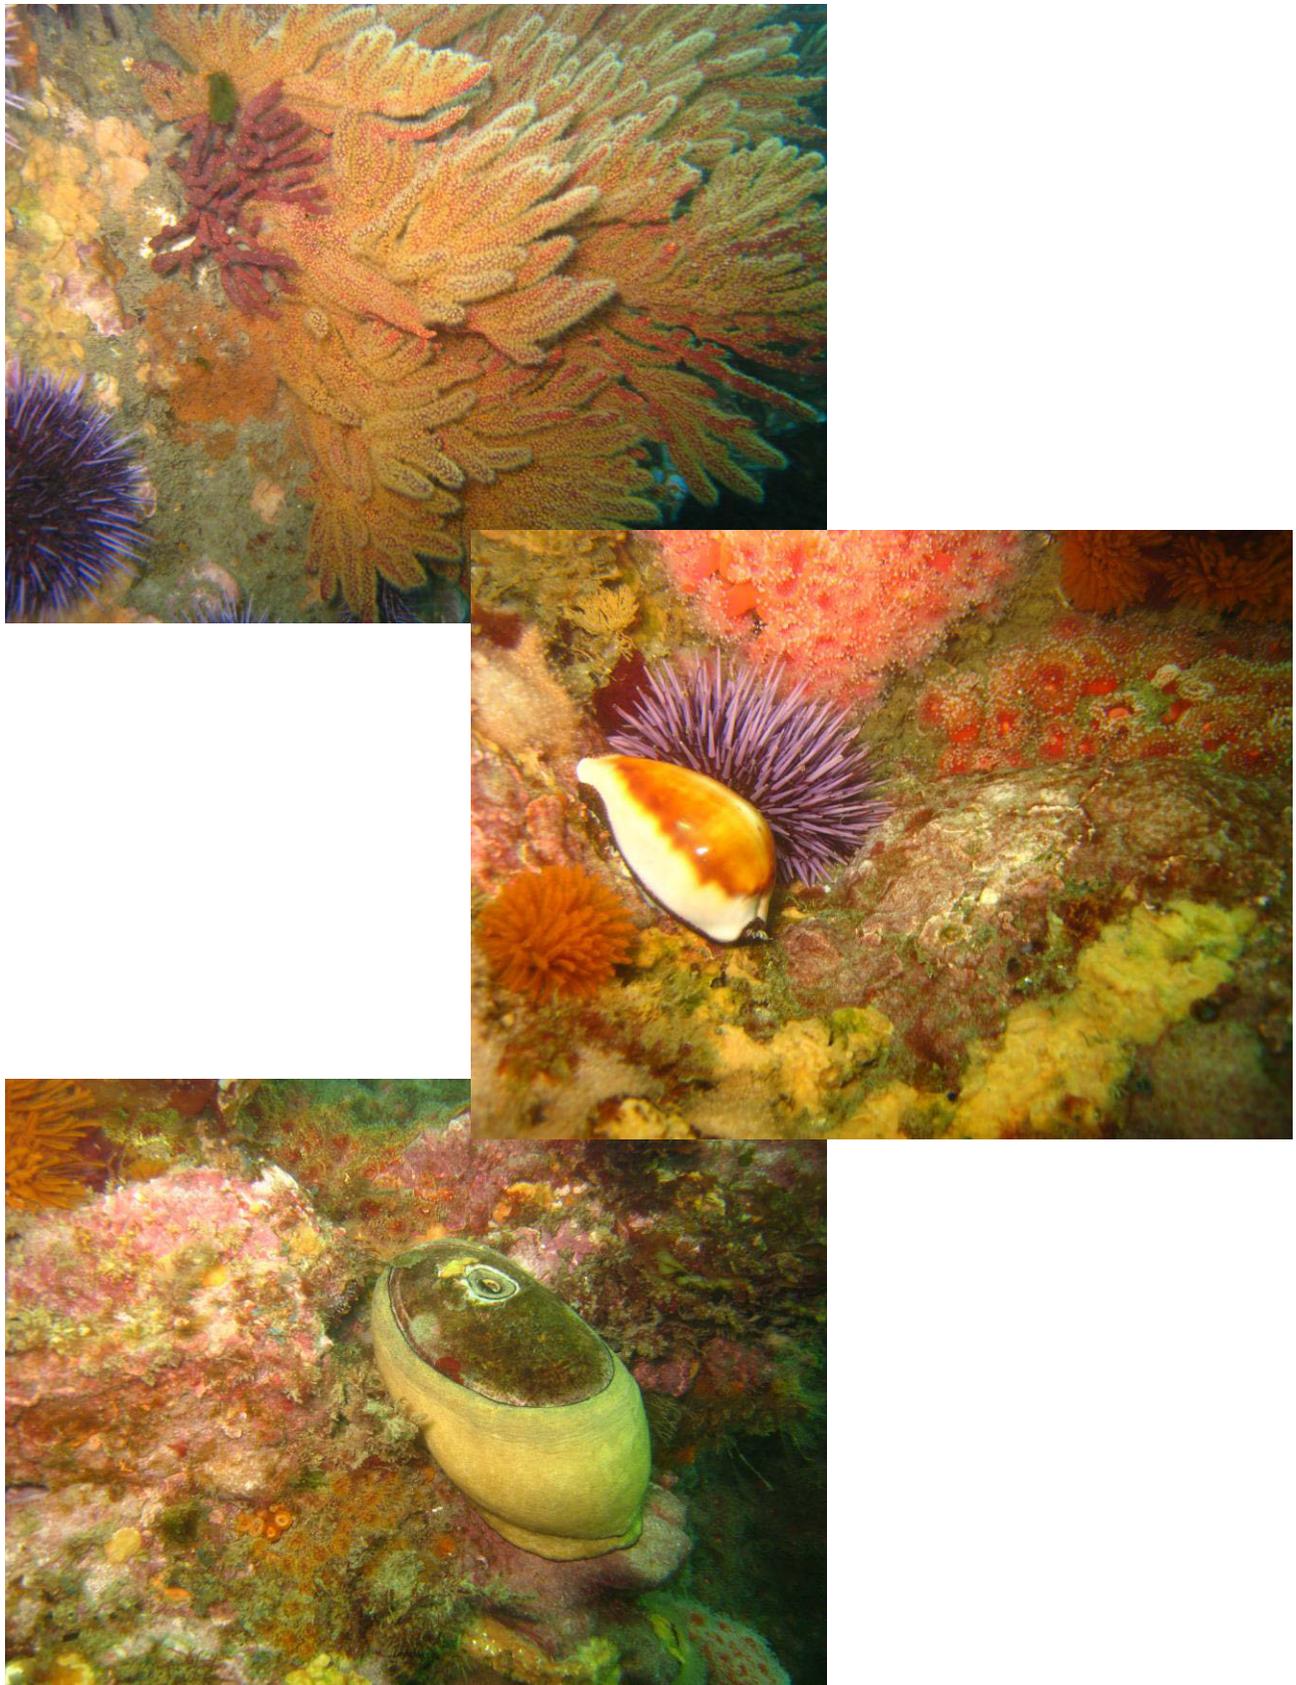
**Figure 17. High-relief rocky substrate supporting sessile and mobile invertebrates.**

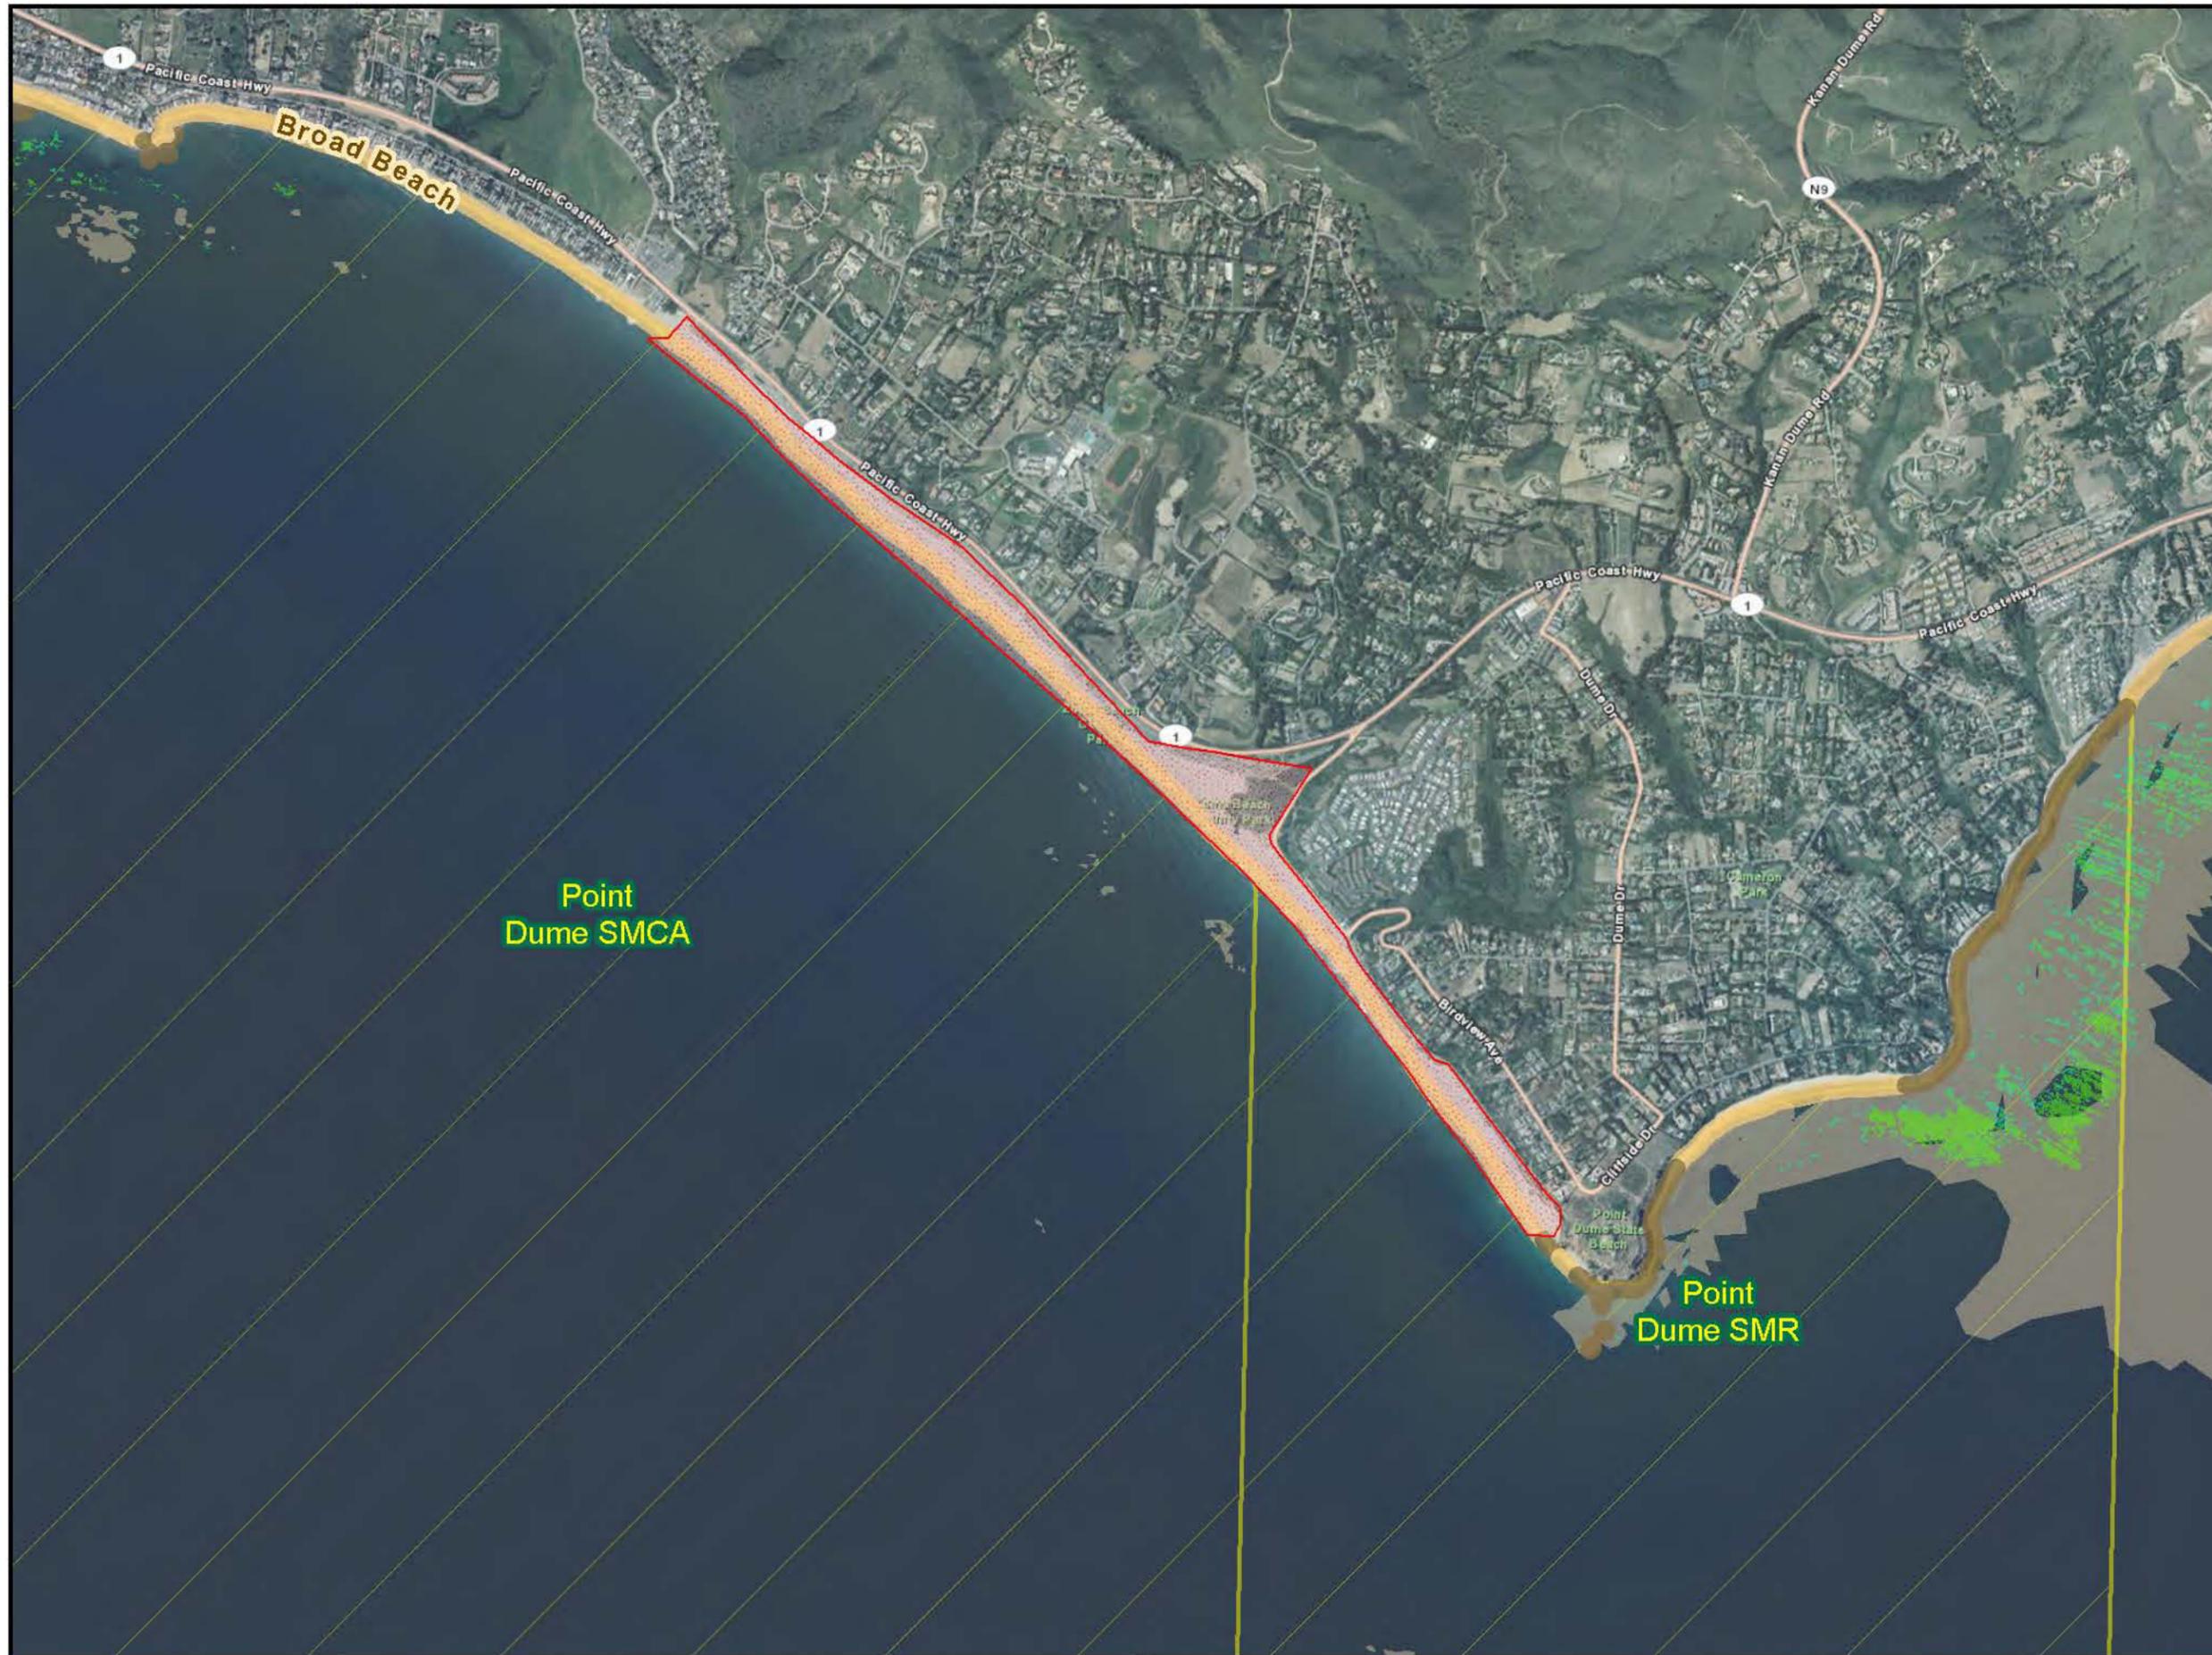
**Figure 5**  
Habitat Types Between Lechuza Point and Point Dune

Figure 5, based on California Department of Fish and Game GIS layers, is an overview of habitat types between Lechuza Point and Point Dune. Subtidal hard bottom, kelp beds and rocky shores are found at the western end of Broad Beach and from Point Dume to the east. Critical Habitat for the federal threatened western snowy plover is found between the extreme southeastern end of Broad Beach and Point Dume. The discussion below focuses on marine biological resources in the vicinity of the sand source and sand placement sites for the Broad Beach Restoration Project.
