**SUPPLEMENTAL MARINE HABITAT SURVEY AND MAPPING  
FOR THE BROAD BEACH RESTORATION PROJECT**

**Moffatt & Nichol**  
Attn: Mr. Chris Webb  
3780 Kilroy Airport Way  
Long Beach, CA 90806  
*Phone: (562) 426-9551*

**Merkel & Associates, Inc.**  
5434 Ruffin Road  
San Diego, CA 92123  
*Phone: (858) 560-5465*  
*Fax: (858) 560-7779*

**June 2014**

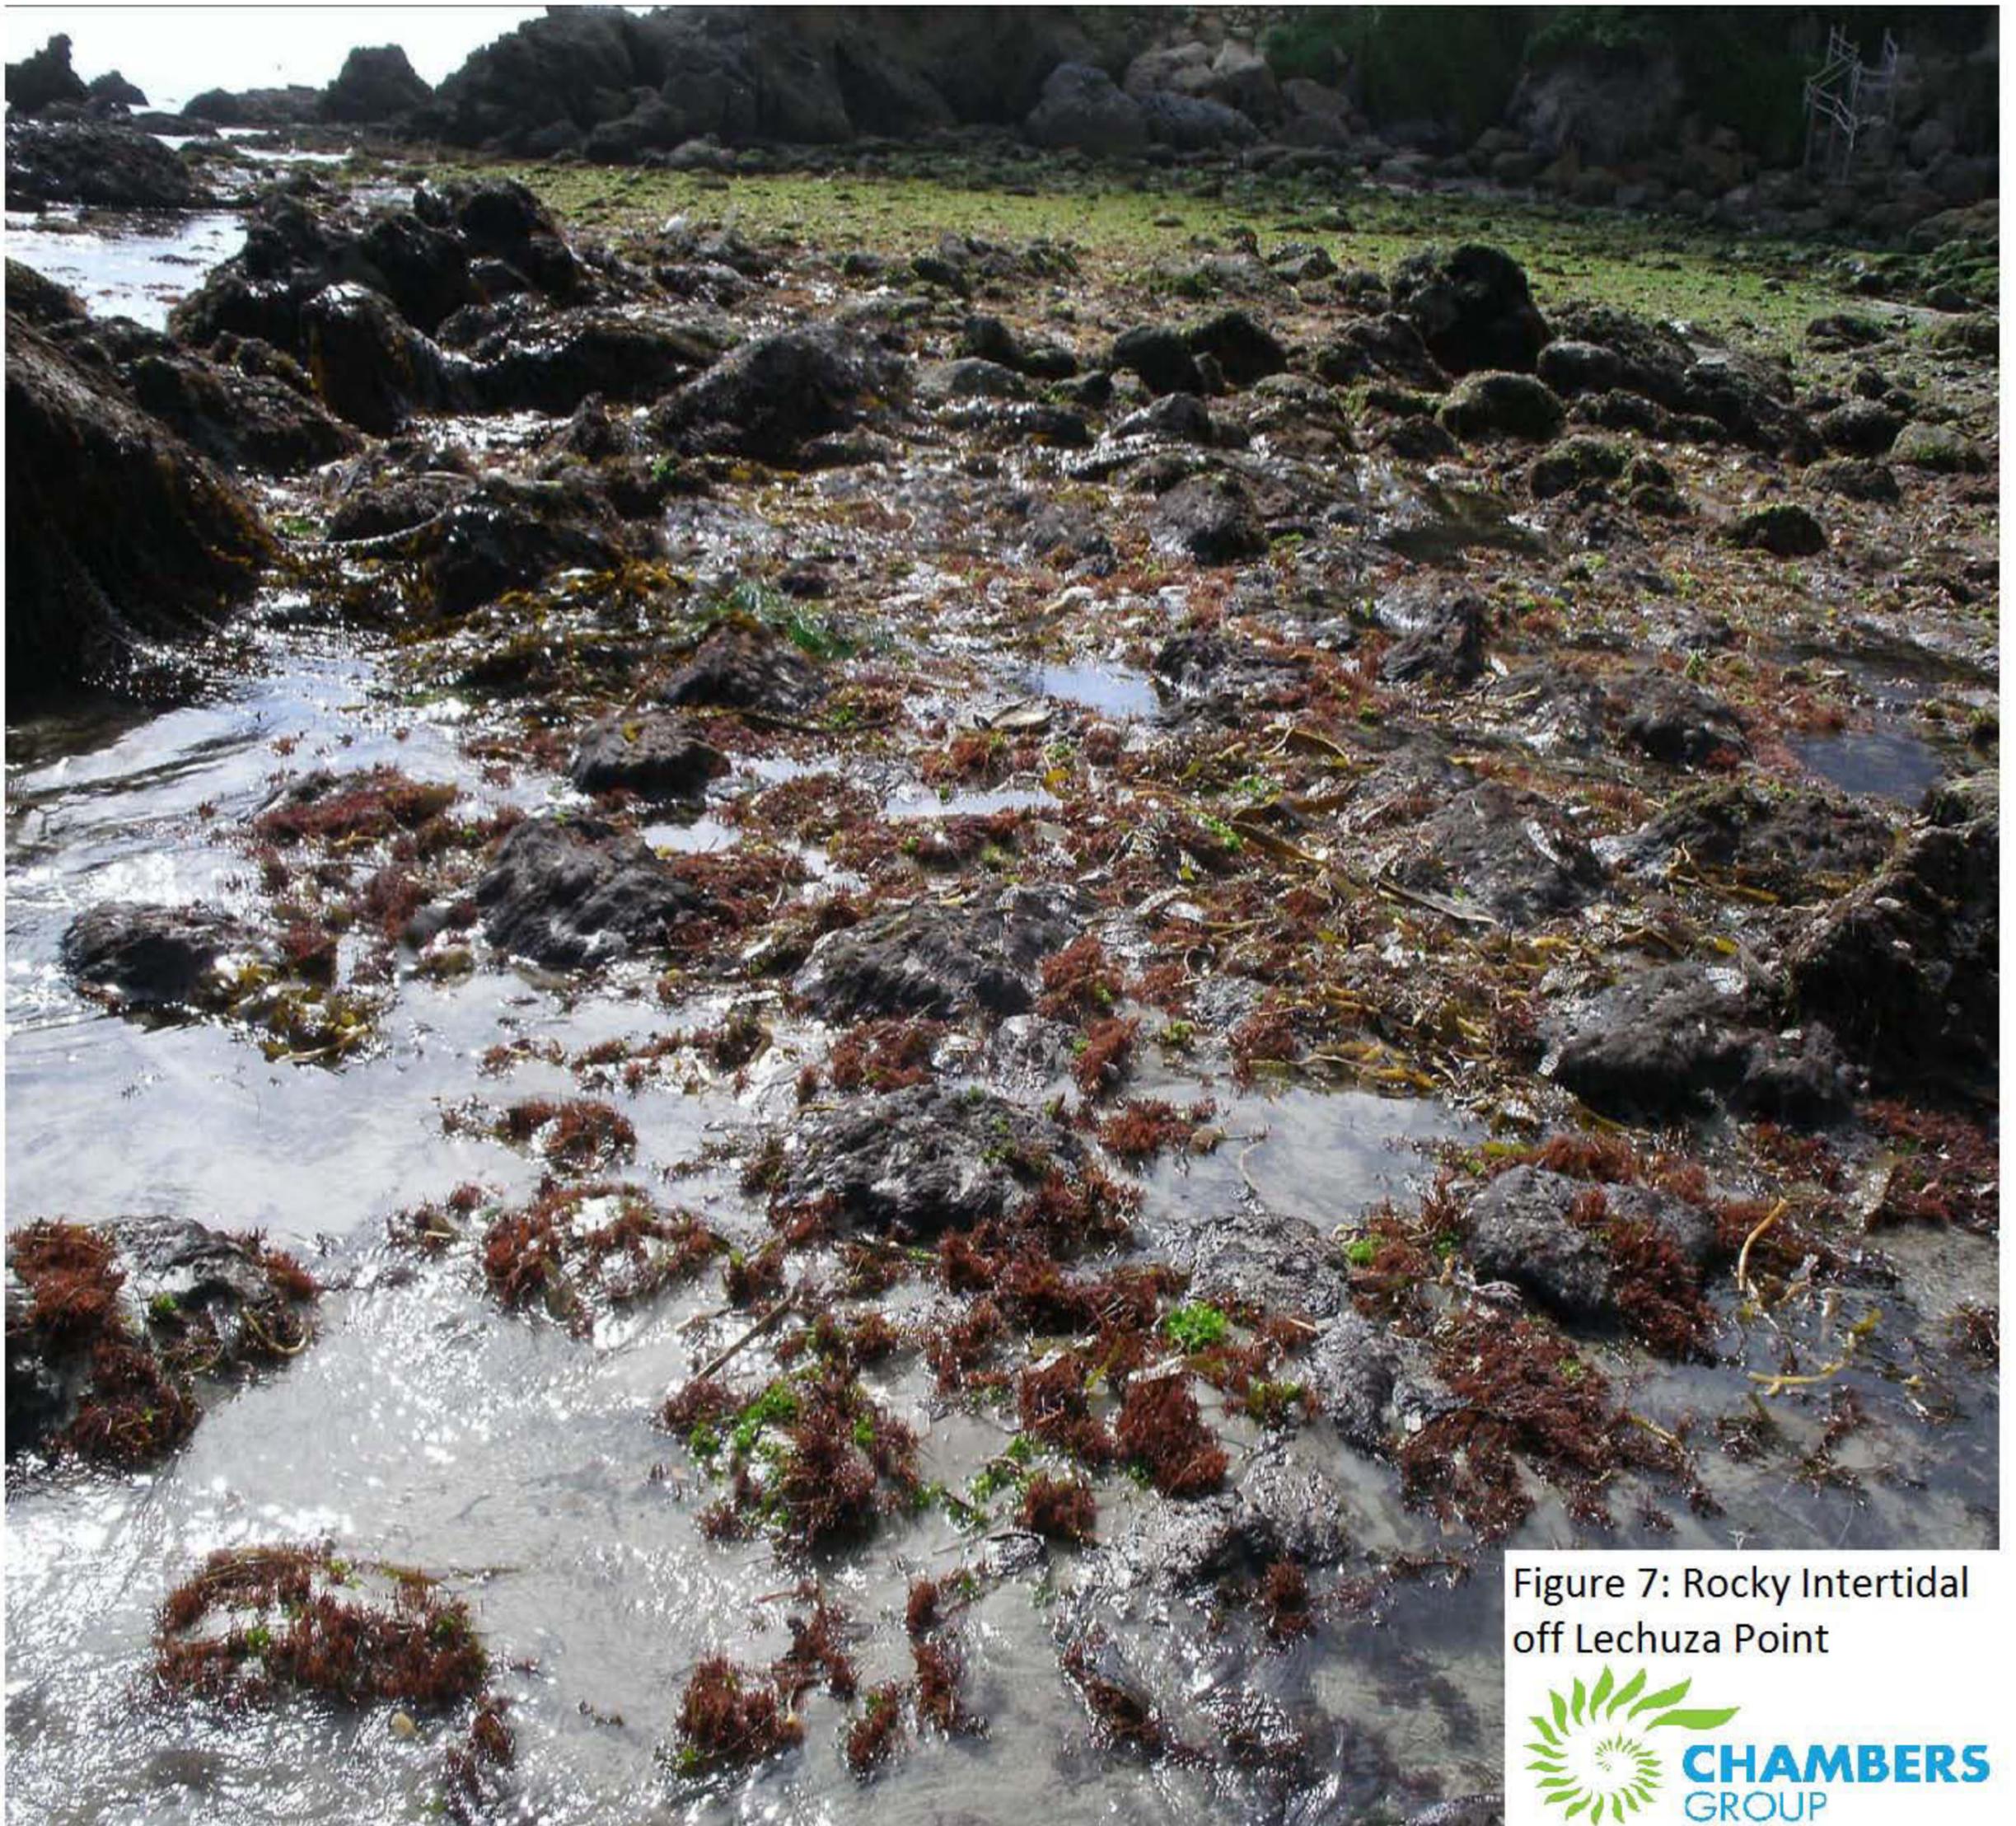
**Figure 6**  
Rocks and Surf Grass Mapped in October 2010

Figure 6 shows rocks and surfgrass mapped in the project area in October 2010. The area off Lechuza Point and in its lee was almost all rocky intertidal substrate during that survey. Substantial amounts of surfgrass were observed from about MLLW down into the shallow subtidal. Figure 7 shows the rocky intertidal area in the lee of Lechuza Point in October 2010. From Lechuza Point east, the continuous rocky intertidal dwindled to scattered outcrops and boulders with one substantial area of intertidal boulders and cobble about 800 feet east of Lechuza Point (Figure 8). These boulders apparently are often covered by sand because they do not appear on many aerial photographs of the project area, and they supported sparse biological growth.

Some patches of surfgrass were observed on the scattered rocks in the low intertidal southeast of Lechuza Point. Feather boa kelp also was common throughout this rocky intertidal area. No intertidal rocks were observed from about 2500 feet east of Lechuza Point to the end of the project area at Trancas Creek. Figure 9 shows the isolated rock outcroppings east of Lechuza Point. In addition to surfgrass and feather boa kelp, other conspicuous organisms observed in the rocky intertidal in the project area included California mussels (*Mytilus californianus*), gooseneck barnacles (*Pollicipes polymerus*), acorn barnacles (*Chthamulus* spp. and *Balanus glandula*), limpets, aggregate anemones (*Anthopleura elegantissima*), ochre sea stars (*Pisaster ochraceus*), tube worms (*Phragmatopoma californica*), sea lettuce (*Ulva* spp.), and various species of red algae (including *Corallina* sp., *Mastocarpus papillatus*, and *Mazzaella leptorhynchus*).

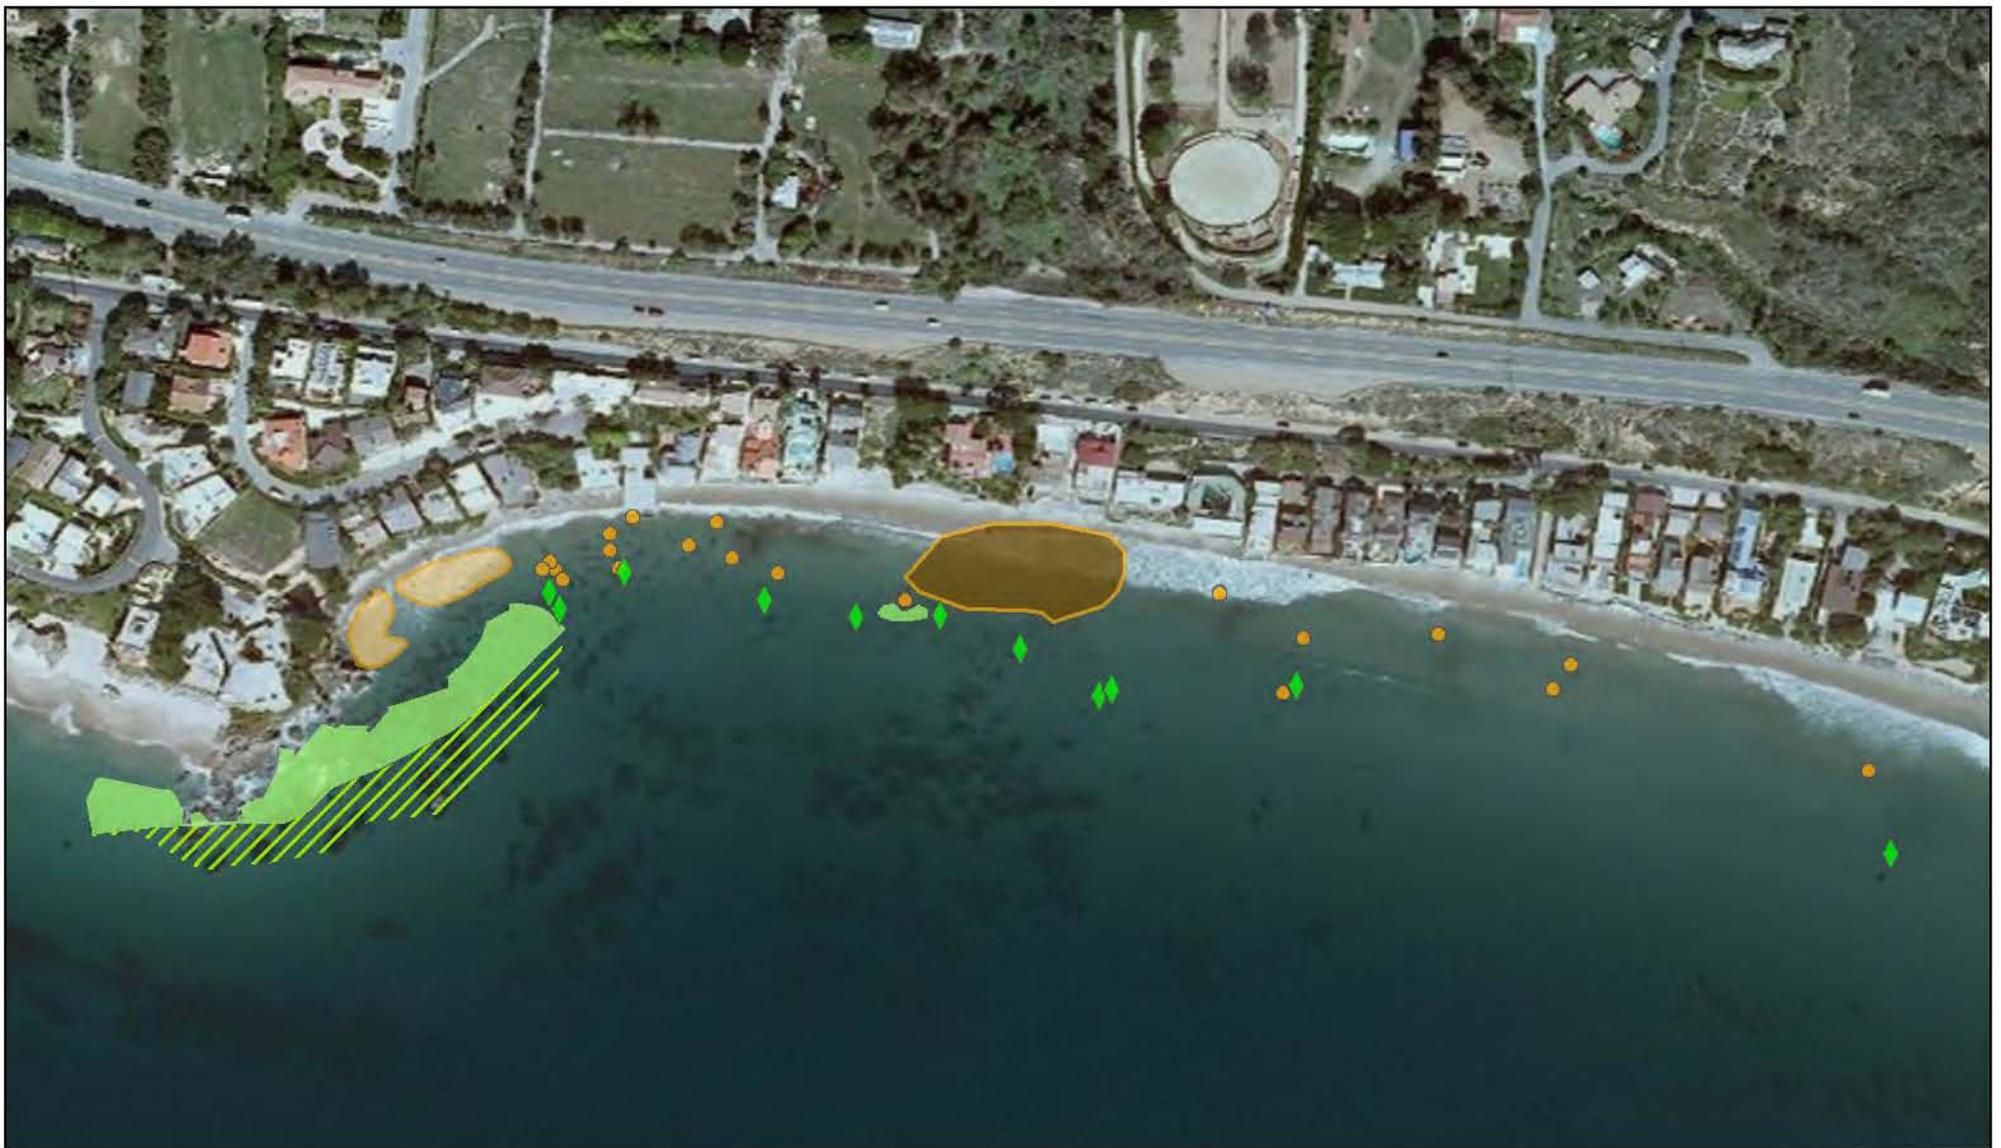
**Figure 9**  
**Surfgrass Survey**  
**Broad Beach**

To obtain comparative information on seasonal sand movement, a second intertidal survey was done on April 10, 2012. Figure 9 shows the surfgrass and rocky intertidal mapped during this survey. The outer edge of the surfgrass, shown by green lines on the figure, was extrapolated based on the presence of rocky habitat and the occasional glimpse of surfgrass on the top of rocks when waves receded. Frequent patches of surfgrass were observed during the April, 2012 survey in the vicinity of Lechuza Point in approximately the same location they were observed in the October, 2010, survey. However, the rocky area near Lechuza Point observed in October, 2010, had experienced considerable sand inundation (Figure 10). The tidepools observed in October, 2010, were sanded in and the rocks were buried or partially buried (Figure 11). Some of the most inshore surfgrass observed in October, 2010, also may have been buried. Some surfgrass was observed with just blades sticking out of the sand. The list of species observed during the April 2012 survey are shown in Appendix B.

In April, 2010, scattered rocks and surfgrass southeast of Lechuza Point were similar to those observed in October, 2012 (Figure 9, Figure 12). The boulder field observed in October, 2010, was also observed in April, 2012, but the most landward portion of it was covered with more sand than in October, 2010 (Figure 13).

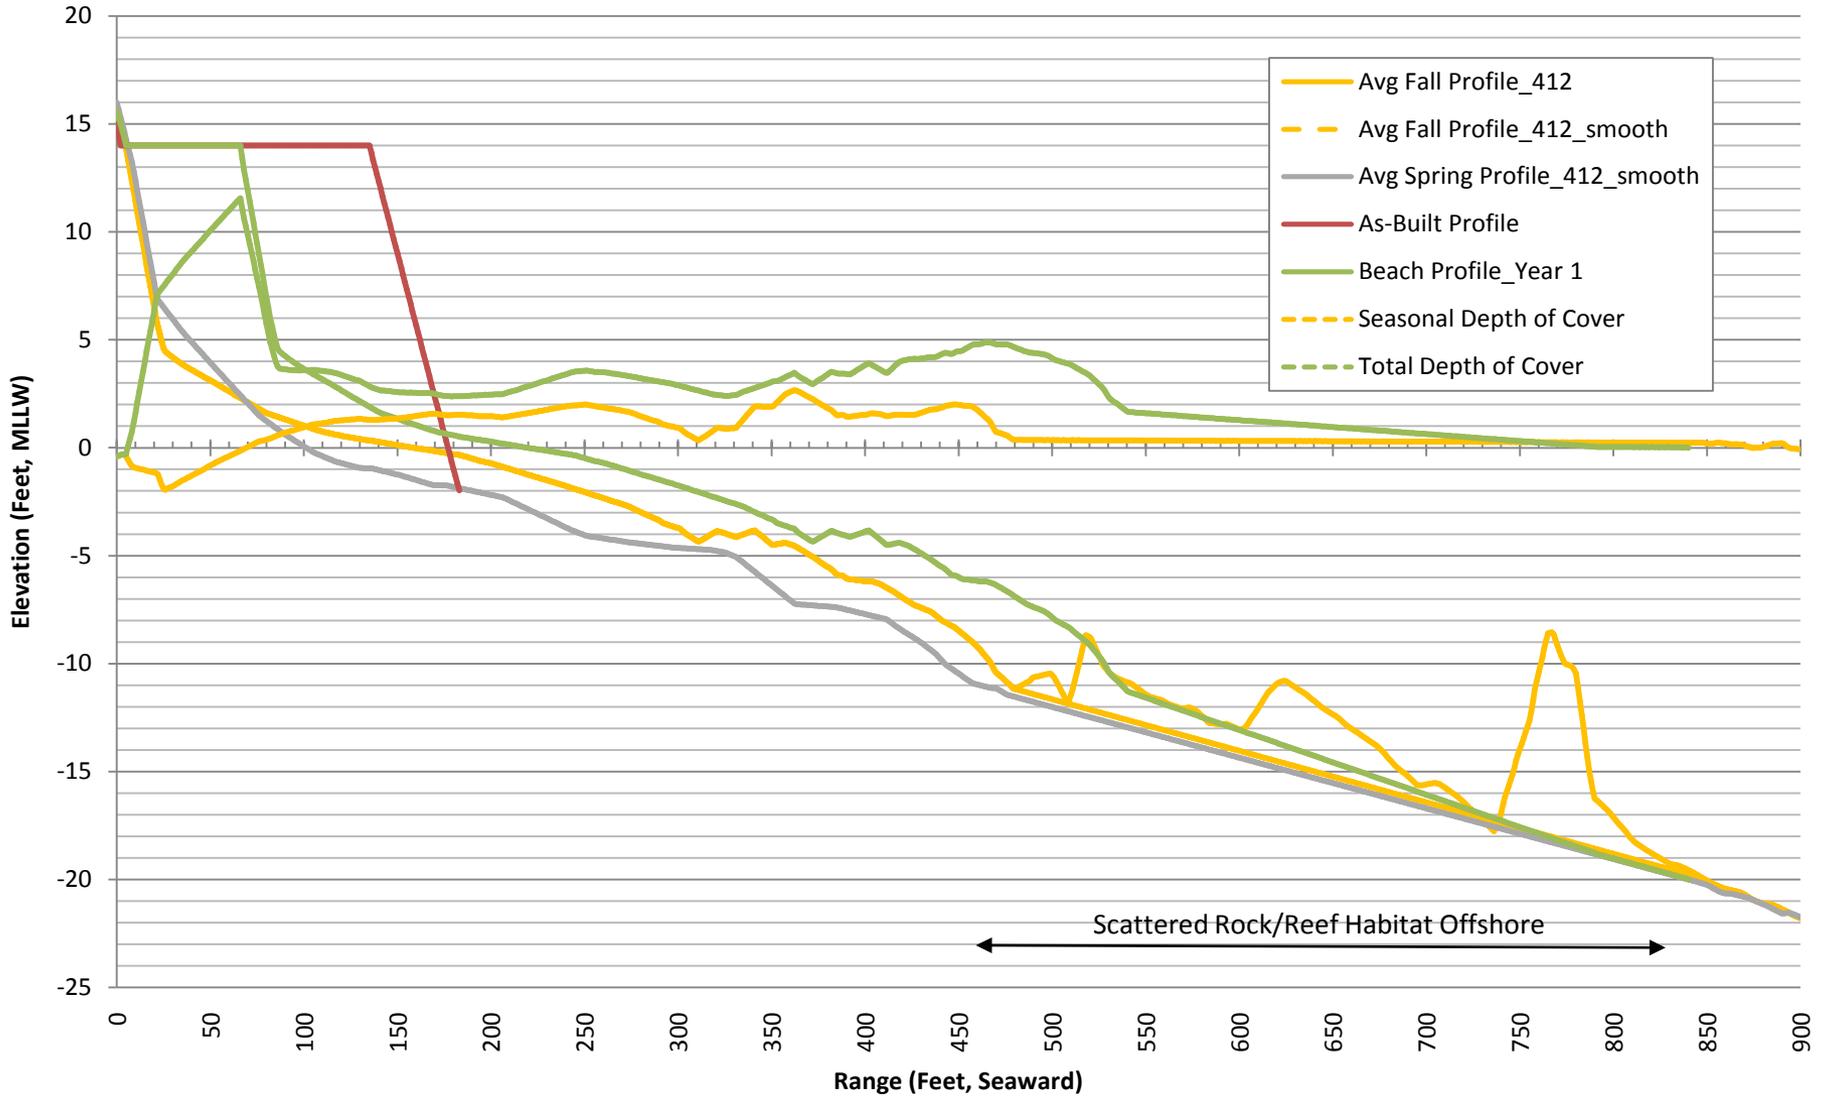
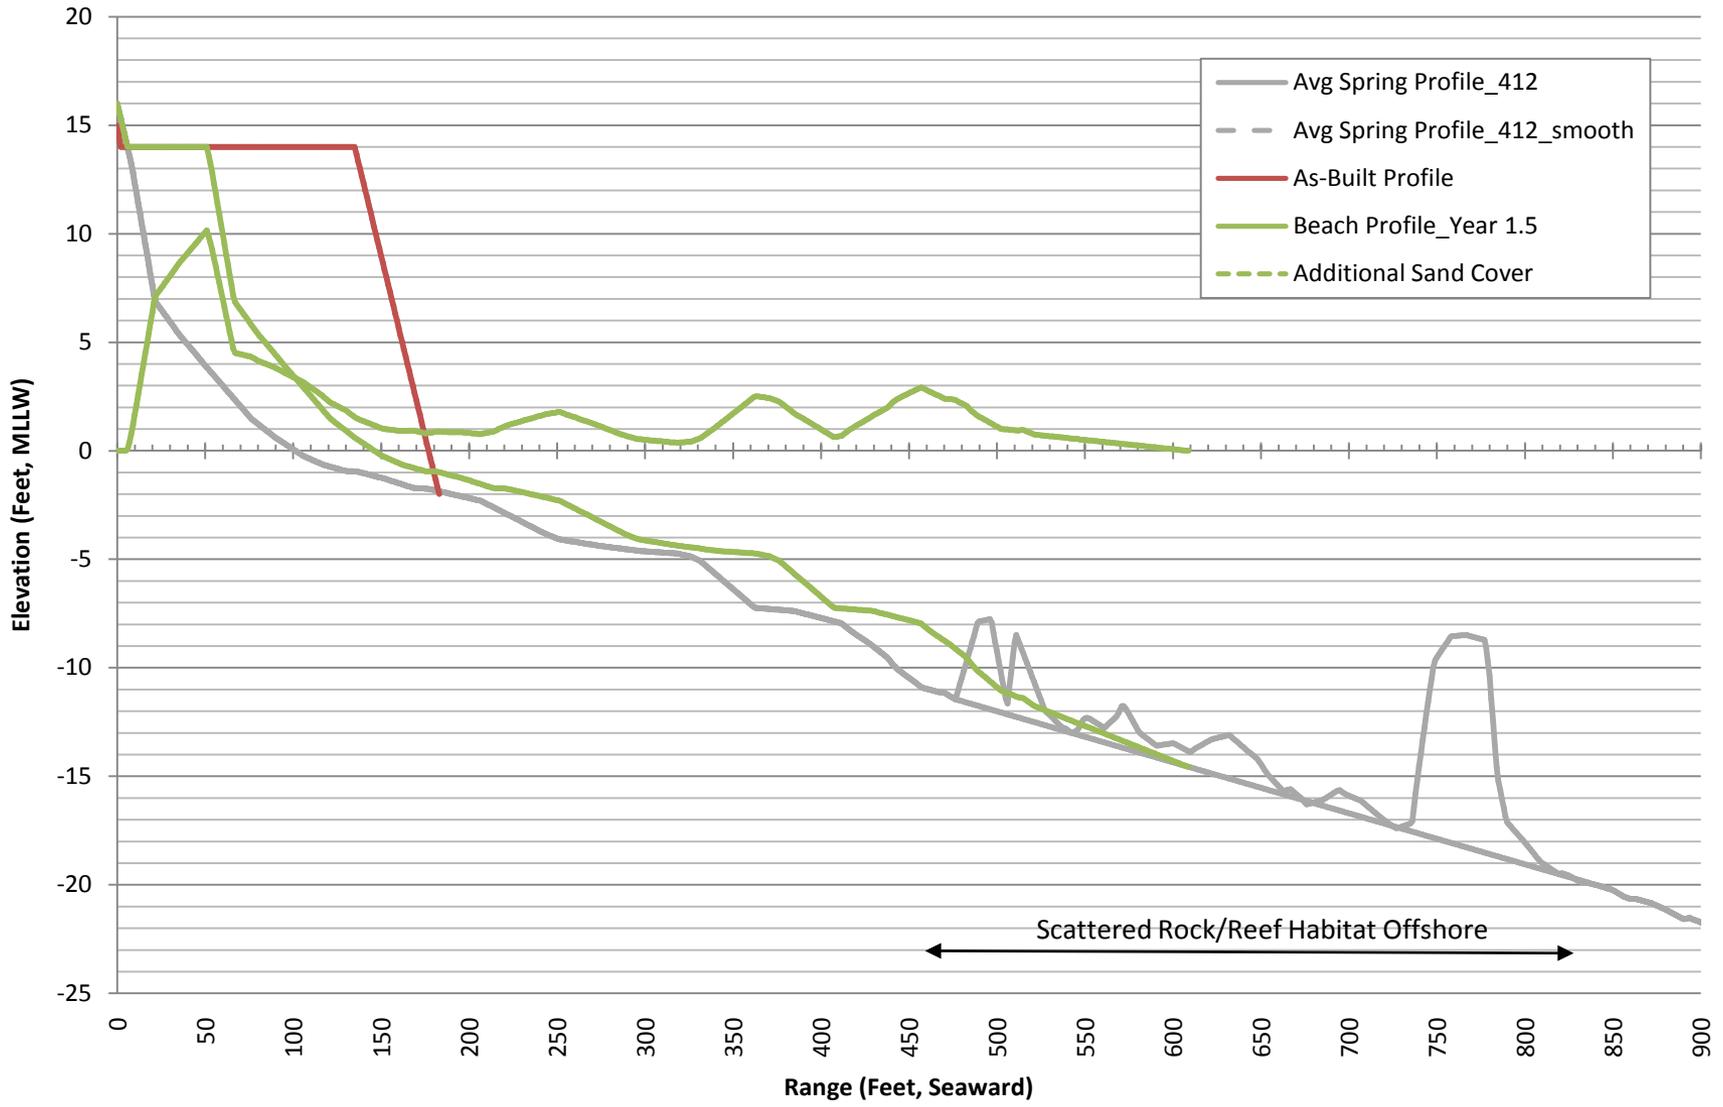
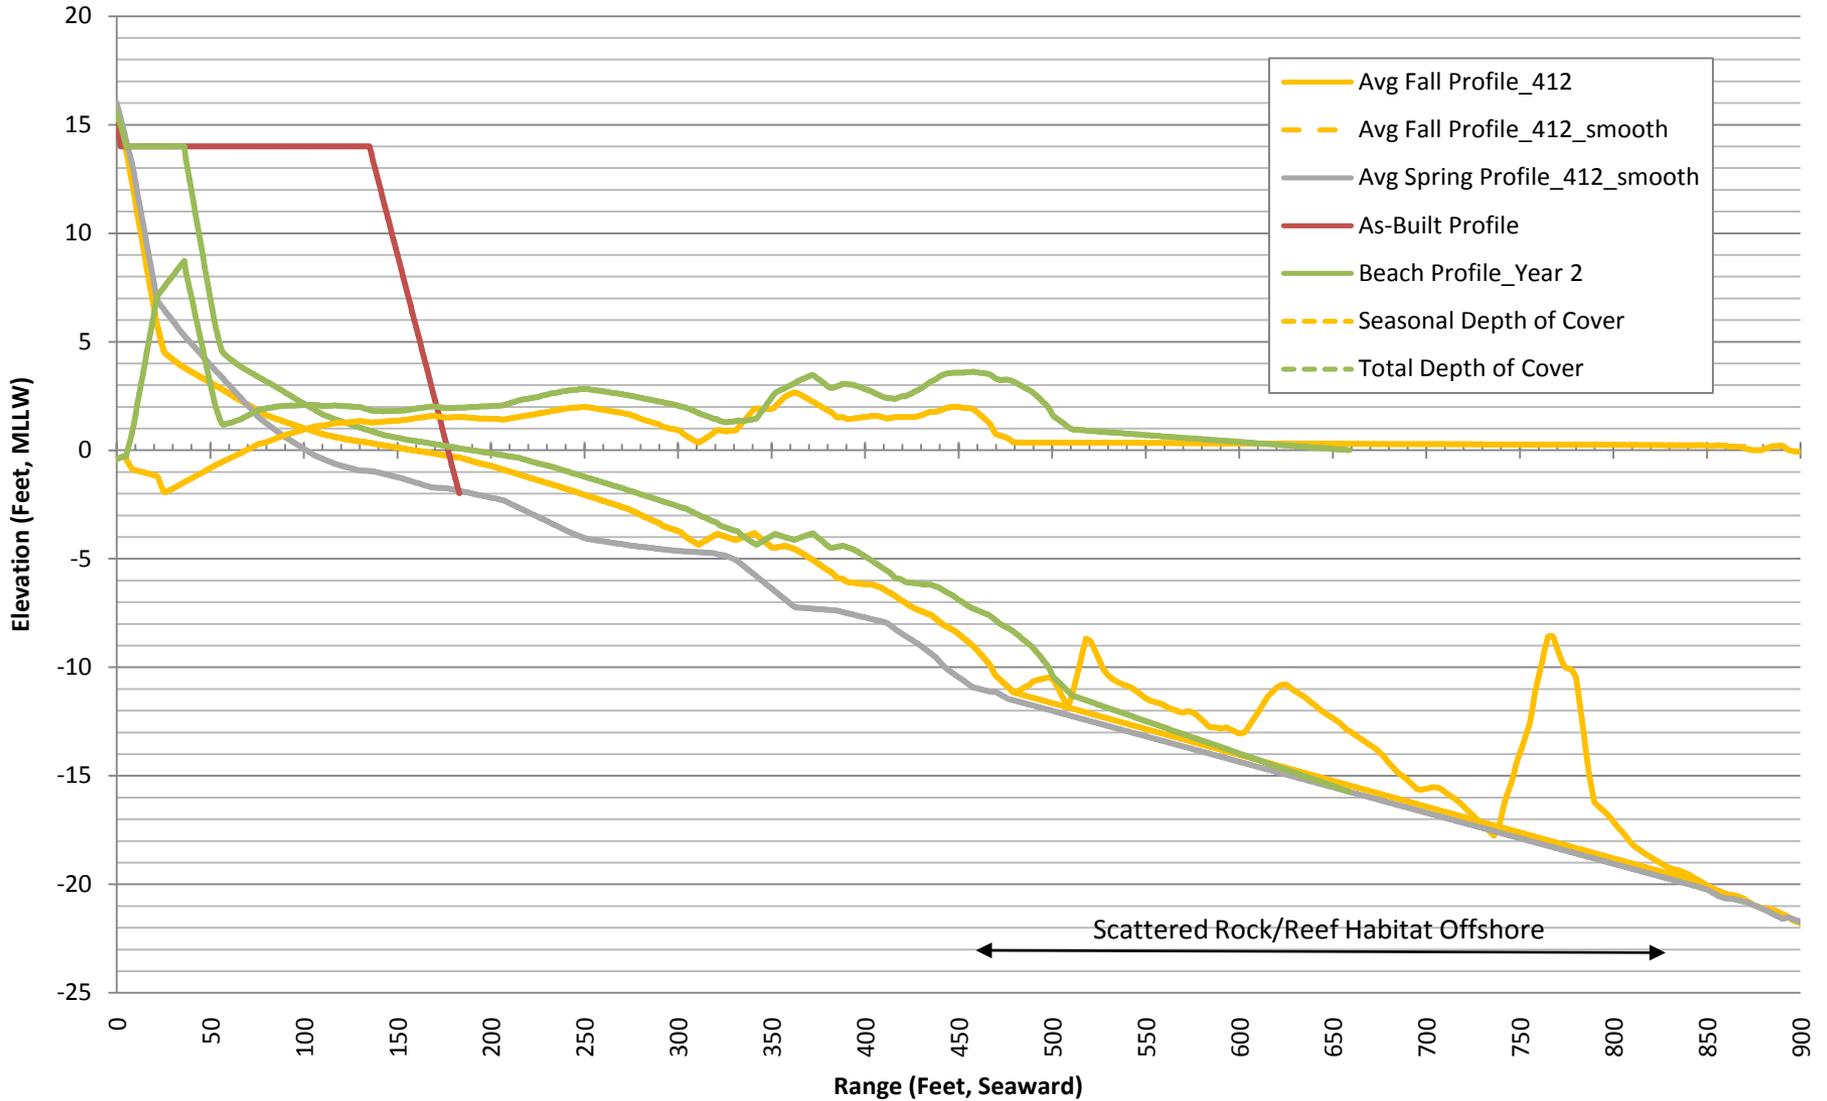
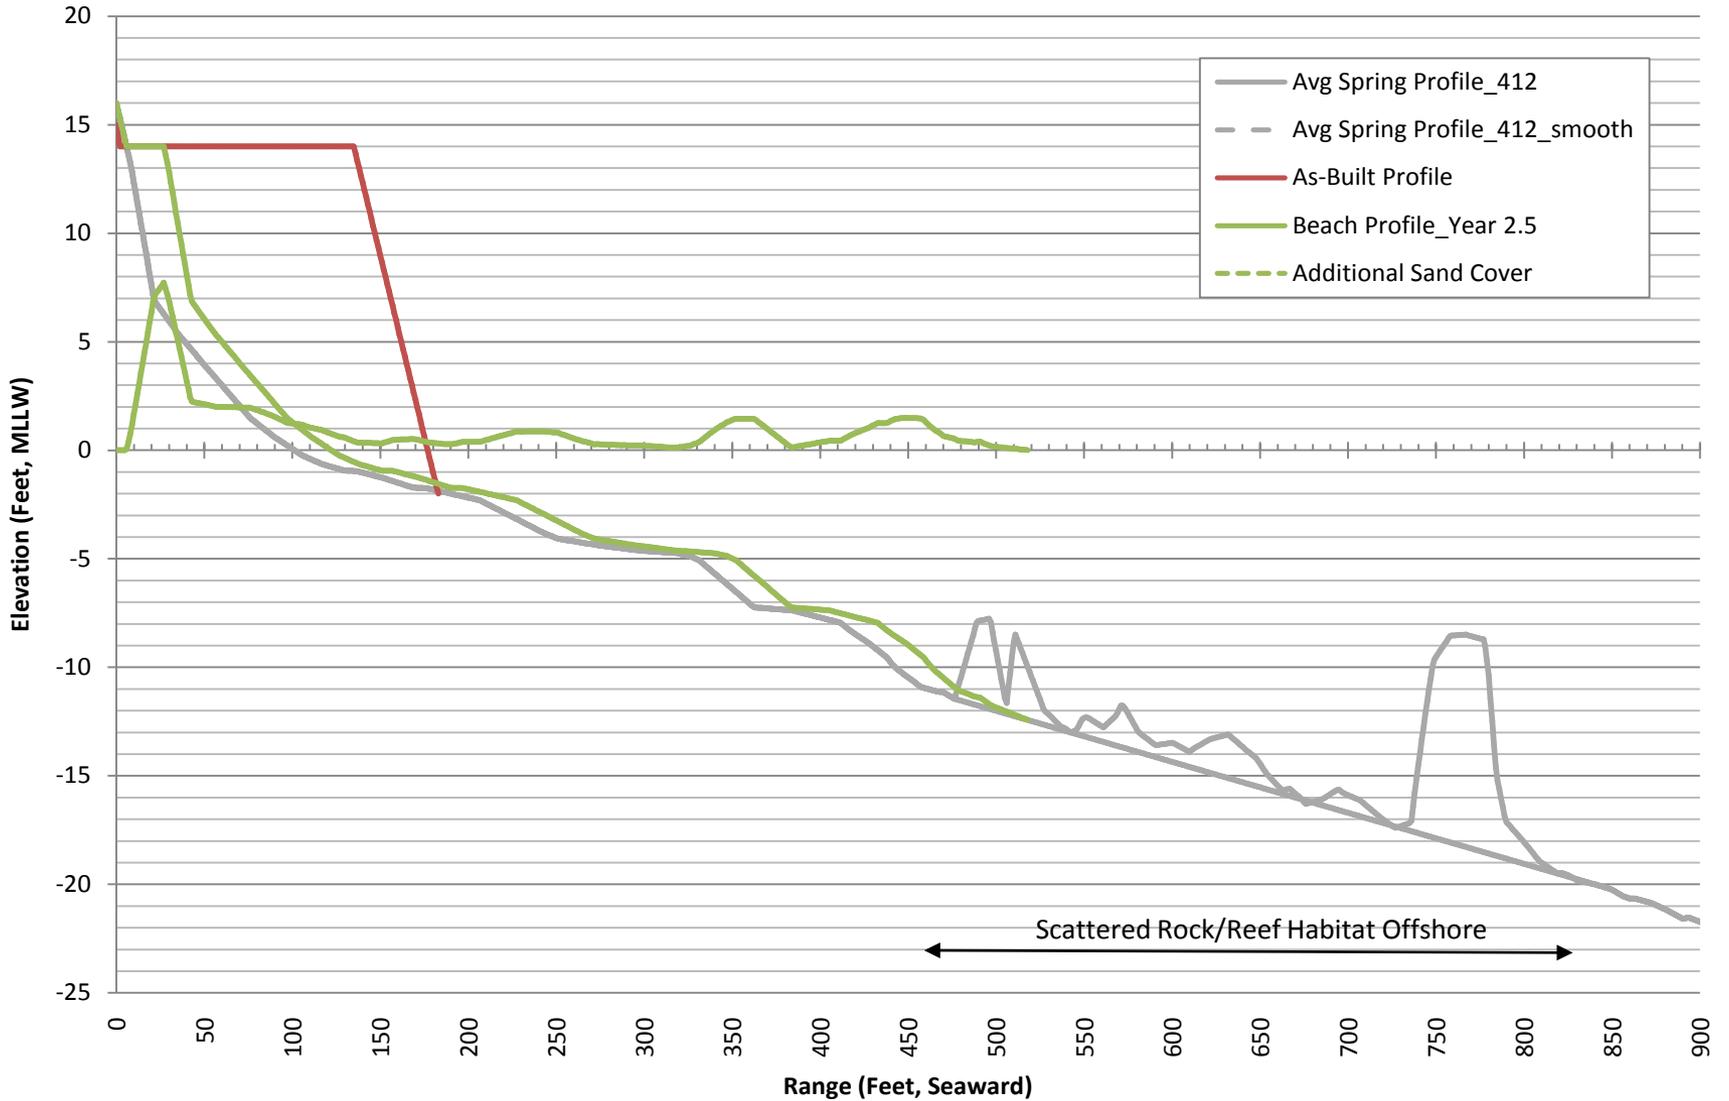
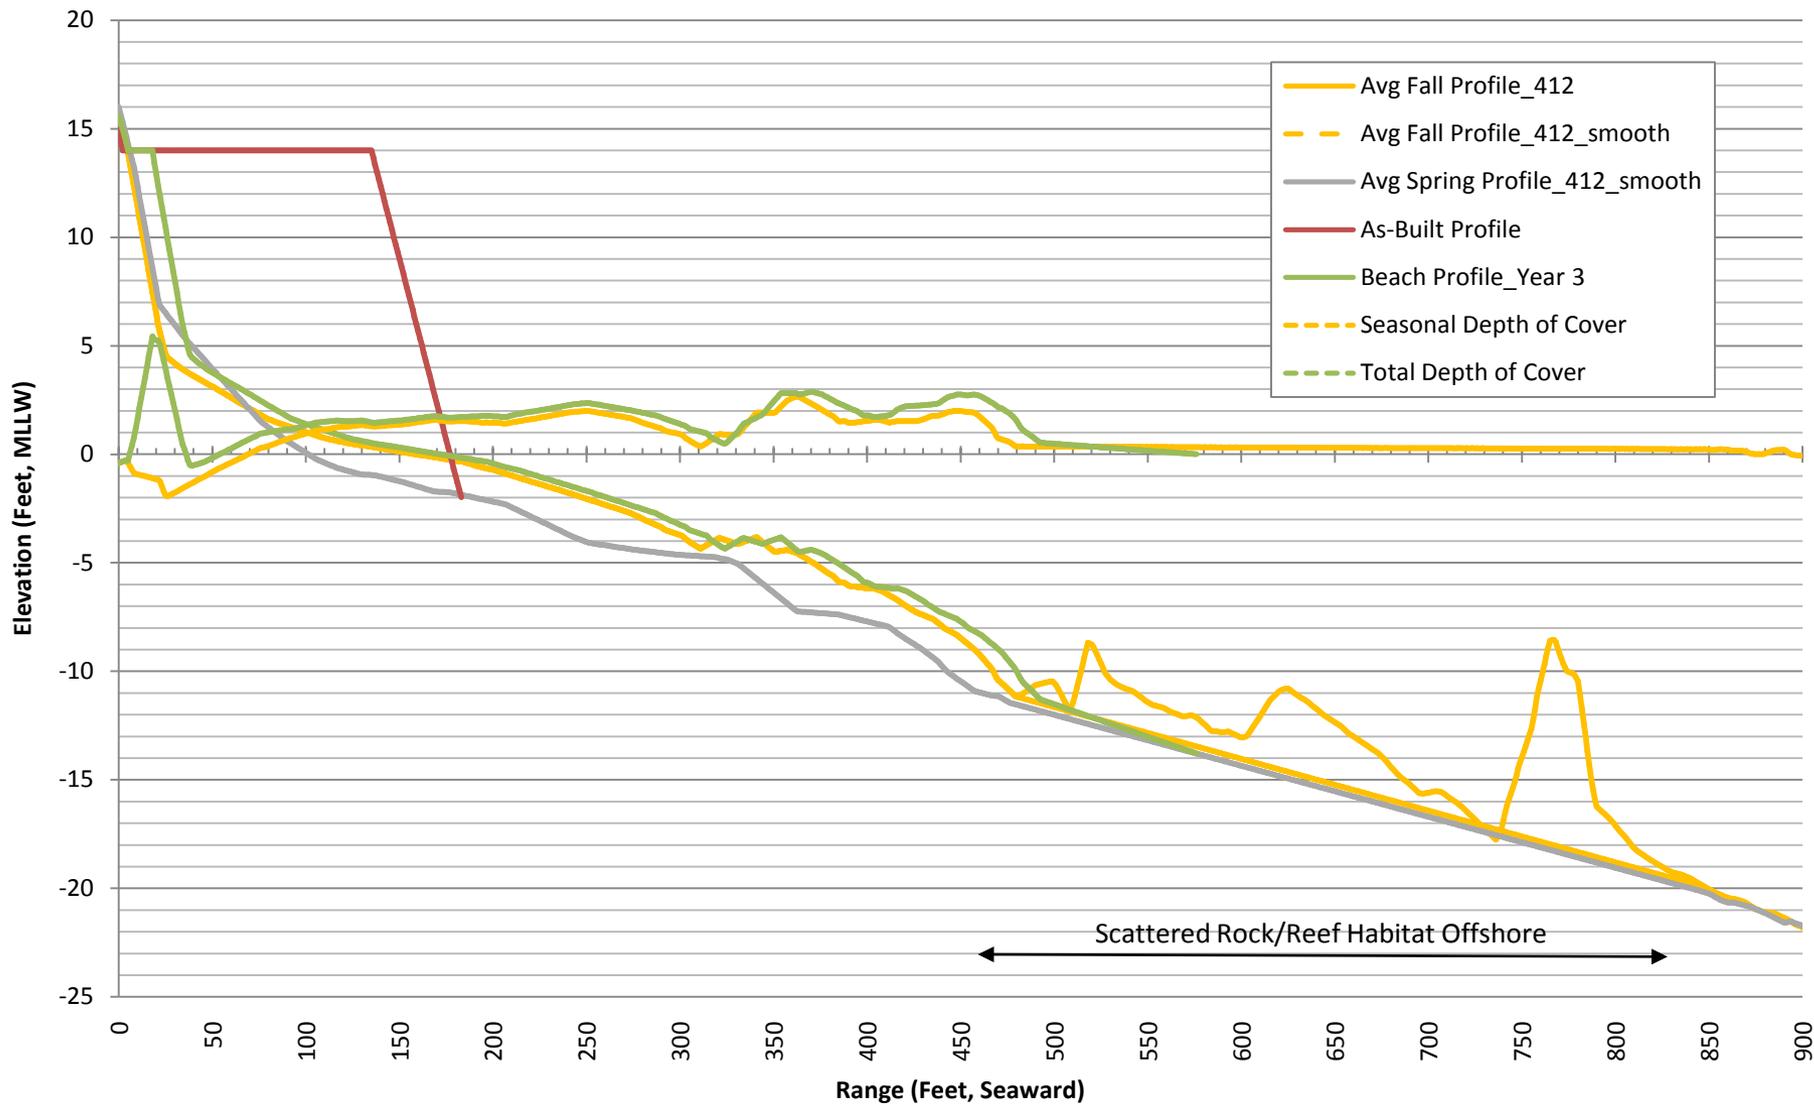
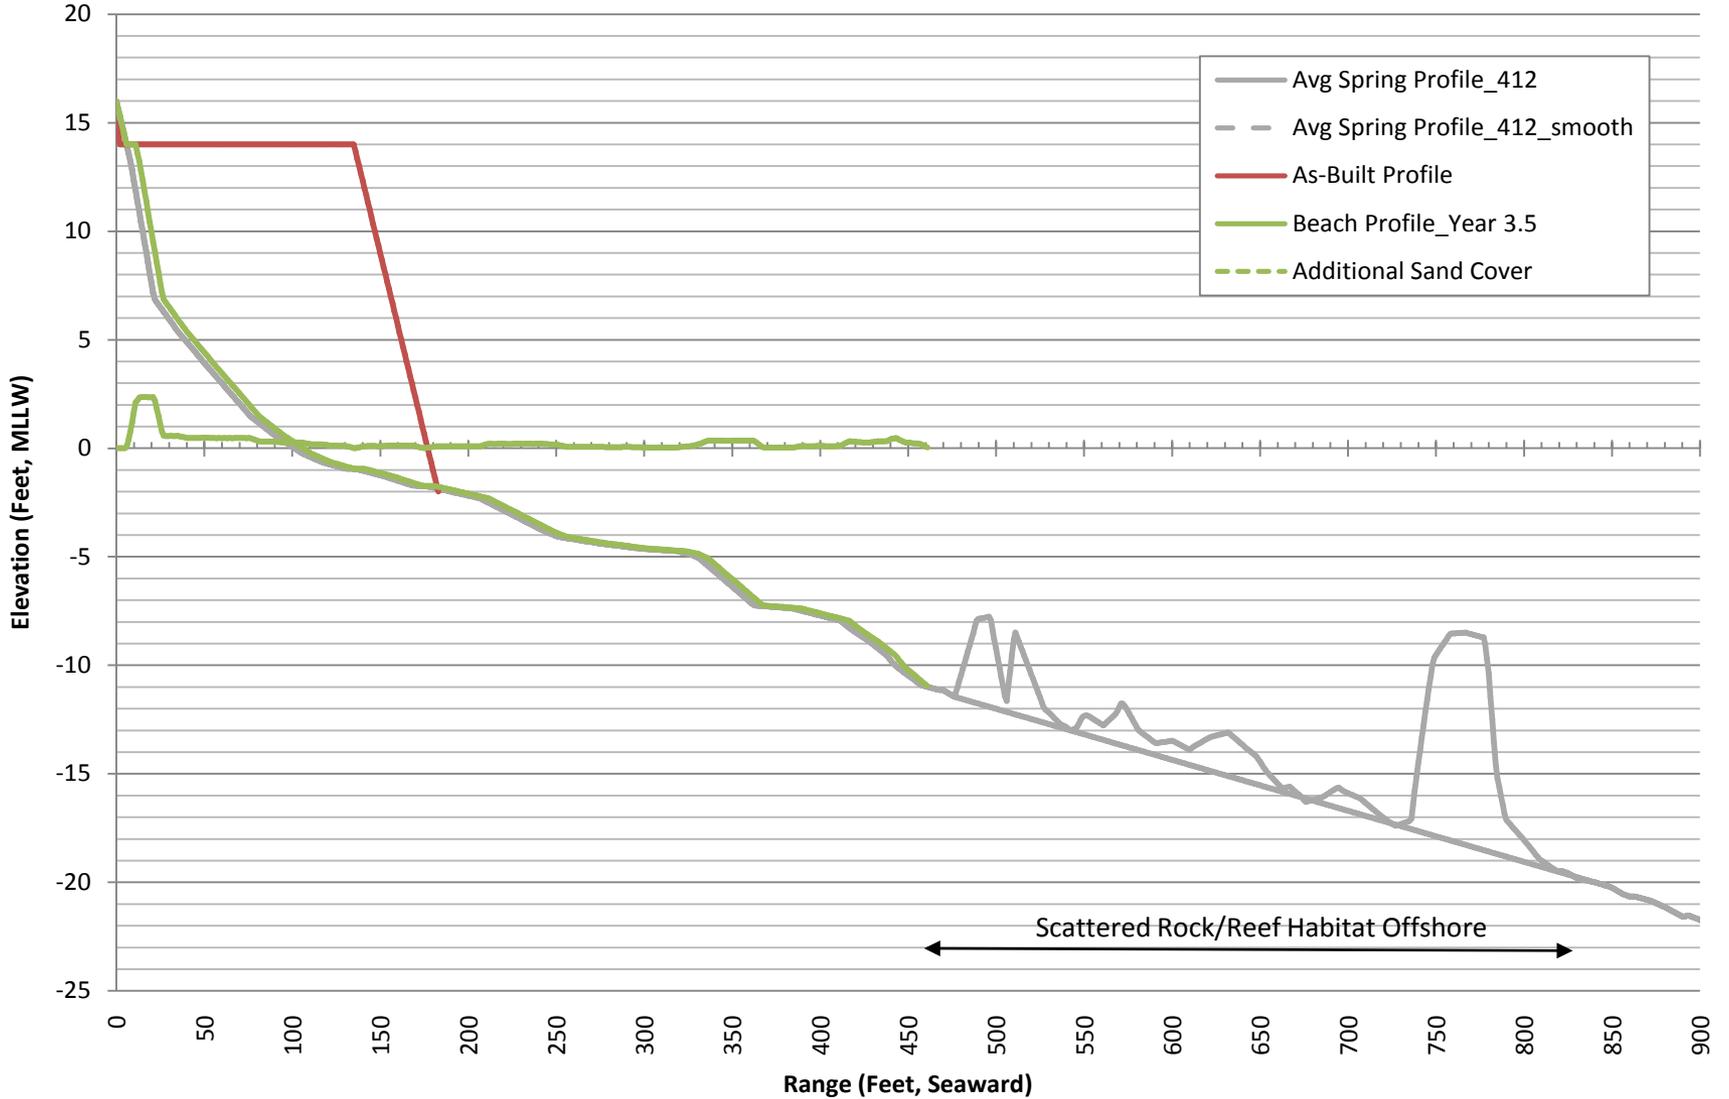
Figures 16 c through 16 h show the predicted sand cover at the western end of Broad Beach from about 1.5 years after sand placement to 4 years following beach fill. By the second spring following beach construction (Figure 16 c, 1.5 years after beach fill) sand levels between 0 MLLW and -12 feet MLLW would be 1 to 3 feet greater than the average spring profile. At these levels of sand cover some of the lower relief rocks would still be buried and there may still be partial burial of some surfgrass, but the tops of the higher relief rocks would be uncovered. In the second fall (Figure 16 d, year 2) sand cover above normal fall profiles would range from no additional cover to about 2 feet above average seasonal levels. From 2.5 years after beach fill to 4 years after the fill, increases in sand cover over existing profiles are minimal.

In summary, in the first 8 or 9 months to one year following beach fill the additional sand placed on Broad Beach will result in considerably greater seasonal sand cover to intertidal and shallow subtidal rocks and surfgrass habitat. The most landward rocks will be permanently buried. Upper to mid-intertidal rocks will be gradually exposed and will support rapid colonizers. By the second spring sand cover is predicted to decrease. It is unknown what effect the additional sand cover will have on marine resources. Surfgrass is adapted to seasonal sand movement and has been observed to recover from complete burial (Chambers Group 2008). However, the duration that surfgrass can withstand burial is unknown. Although rocky habitat and surfgrass existed at Broad Beach during the 1970's when the beach was wider (Egstrom 1974), it is possible that the predicted levels of burial following beach fill could have an adverse impact on the surfgrass and other rocky intertidal organisms at the western end of Broad Beach. Because sand transport primarily would be offshore and downcoast, the eastern portion of the surfgrass habitat near Lechuza Point may be affected. Potential impacts could occur to approximately 0.98 acres of surfgrass habitat. Although some sand from the beach fill may be transported upcoast to the western portion of the surfgrass habitat, sand deposition would not be expected to be substantial enough to have adverse impacts. About 0.98 acres of surfgrass habitat on the western side of Lechuza Point would not be expected to be affected by the beach fill. Therefore the beach fill could impact about half of the surfgrass habitat at Lechuza Point. Observed impacts to surfgrass habitat from beach nourishment projects in San Diego (SAIC 2011) and Santa Barbara (Chambers Group 2008) has been limited to minor transitory effects even though models predicted an increase in sand cover. Therefore, it is probable that impacts to the surfgrass at Broad Beach would be less than predicted by the model. In addition, the model does not consider sand grain size. Sand for nourishment will be very coarse-grained if taken from the Dockweiler site and will therefore remain higher on the beach profile and assume a steeper foreshore slope. The steeper slope will remain farther landward than a flatter slope of finer sand, and the position of the toe of the slope will be higher on the beach profile and impact less mid-tidal and sub-tidal habitat.
