E-11: Line 407 West Valley Elderberry Longhorn Beetle Survey

**PG&E Line 407 West Natural Gas Transmission Pipeline
Yolo and Sutter Counties, California**

August 2007

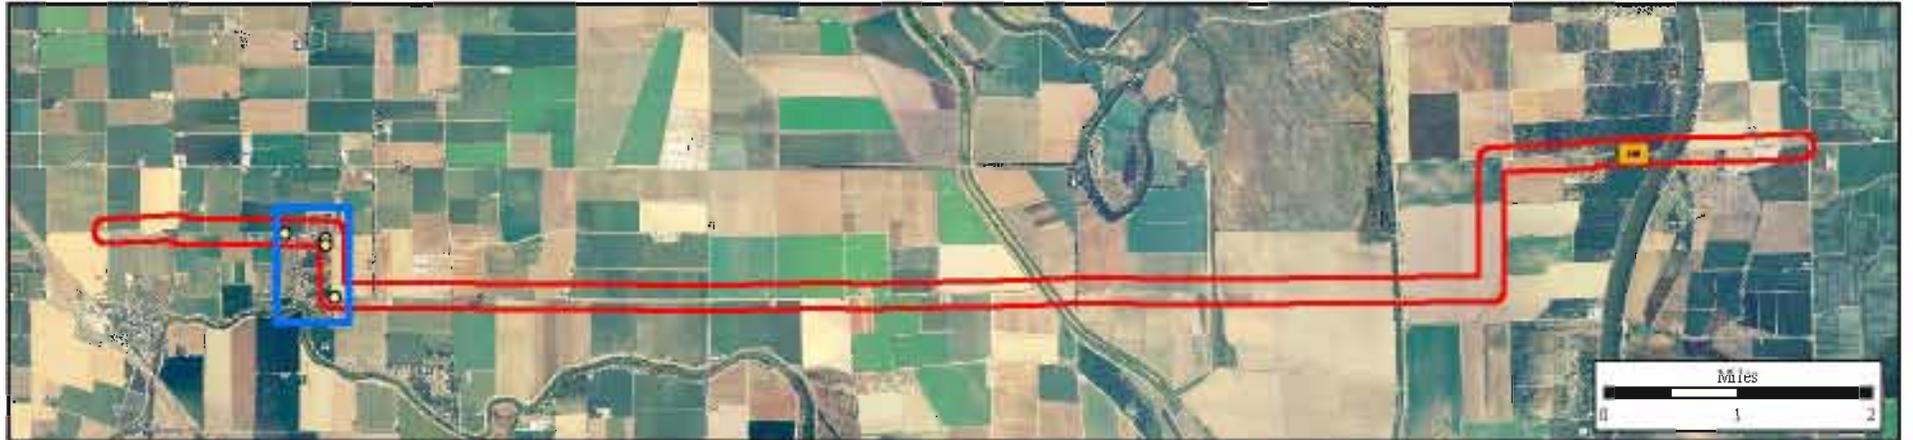
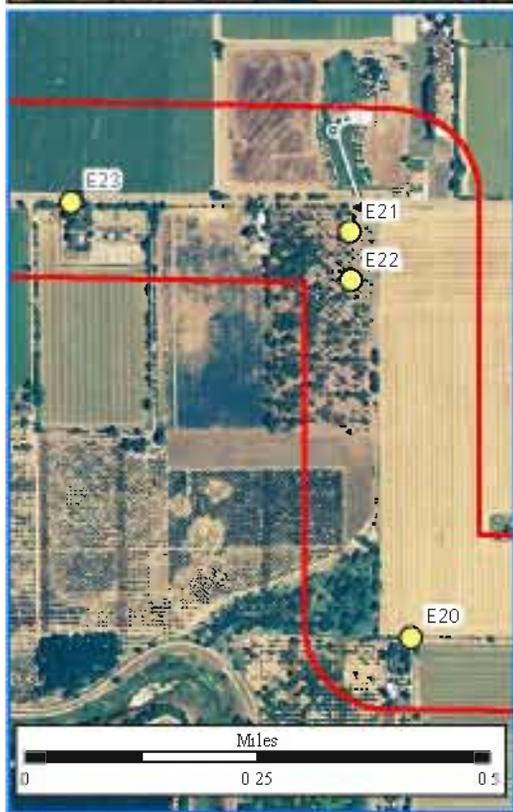
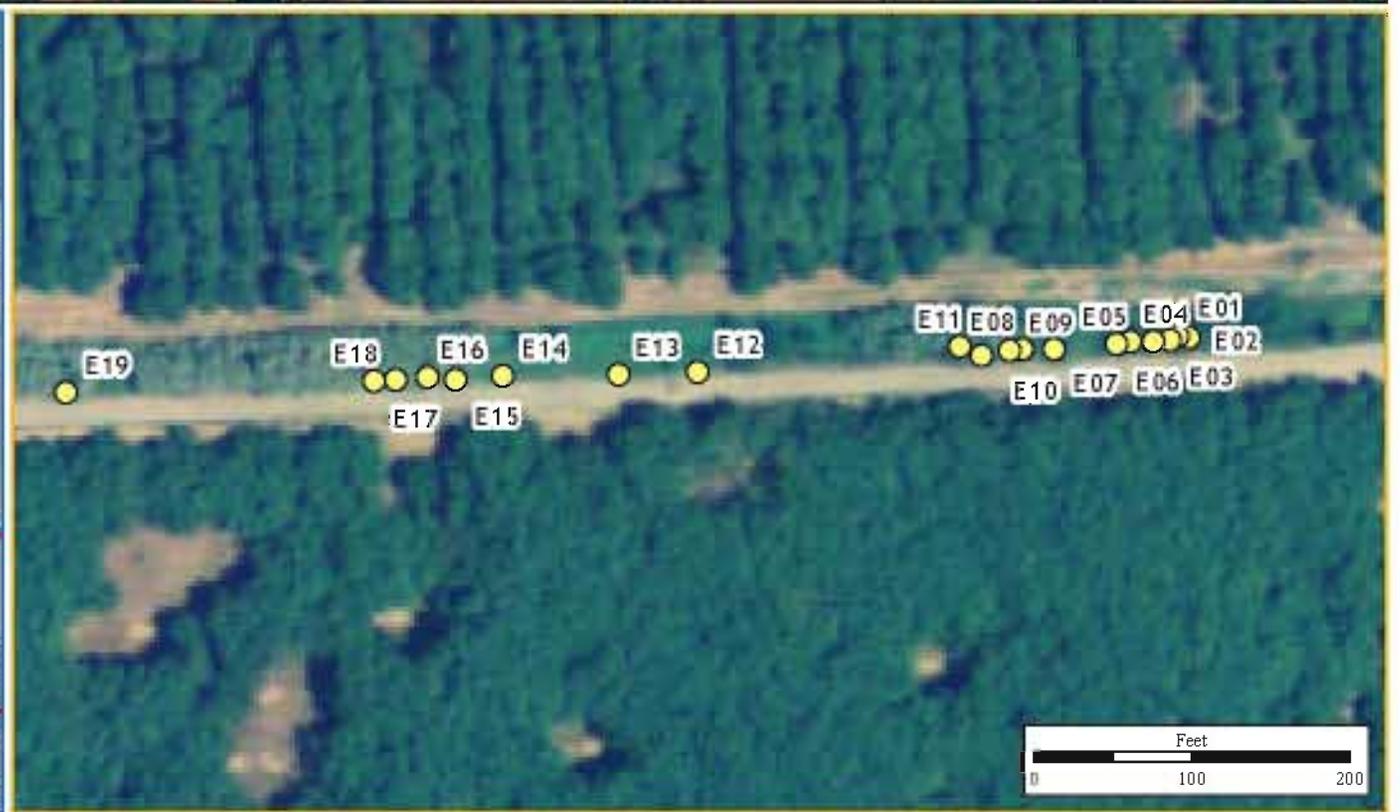
Figure 2

Elderberry stem counts and VELB surveys were conducted within the BSA on May 8 and 14, 2007 by Brooks Taylor, biologist, and Elena Alfieri, botanist. Twenty-three elderberry bushes occur within the BSA. Twenty-two elderberry bushes were evaluated for the potential presence of VELB, and one bush (**E23**) was not evaluated for potential presence of VELB due to its location within a homeowners yard. **Figure 2** depicts the location of elderberry bushes in relation to the Project area. Of these 23 bushes, 19 occurred along a canal adjacent to the Sacramento River in riparian habitat and four shrubs were within upland areas, one was inaccessible. Also, the survey area is not within designated critical habitat for VELB.

Elderberry surveying by EA, BT
Aerial Feb 2005 (NAIP)
Map Date June 27, 2007

Emergence holes were detected on a total of 10 elderberry shrubs within the BSA.
