2.0 PROJECT DESCRIPTION

This section of the Revised *Analysis of Impacts to Public Trust Resources and Values* (APTR) document prepared by the California State Lands Commission (CSLC) describes the history and details of the Broad Beach Restoration Project (Project) proposed by the Broad Beach Geologic Hazard Abatement District (BBGHAD or Applicant). Section 2.1 presents the Broad Beach area history and an overview of previous efforts to address beach erosion, damage to structures, and potential damage to private sewage disposal systems. Section 2.2 provides a detailed description of the components of the Project, and Section 2.3 describes construction activities associated with the Project. Basic Project information is presented in Table 2-1.

Table 2-1. Broad Beach Restoration Project By the Numbers (Proposed Project)

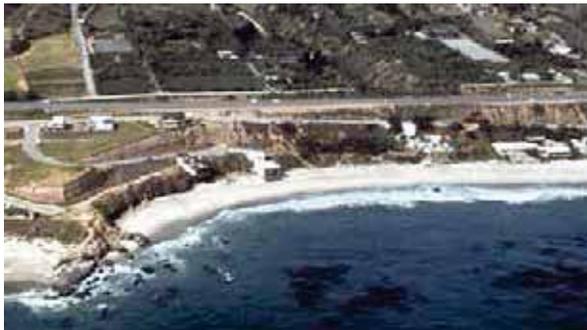
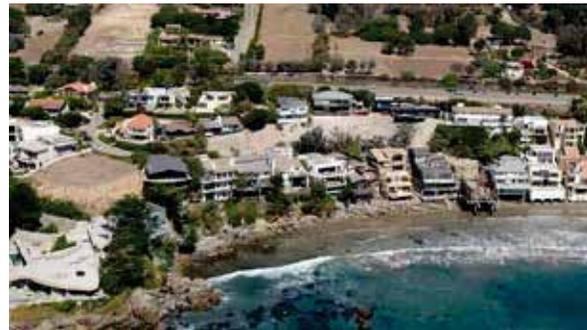
Western reach of Broad Beach, 1972

Western reach of Broad Beach, 2013

Illustration 2-1. Recent analyses (Everts Coastal 2010, Coastal Frontiers 2011) indicate that Broad Beach has been subject to considerable sand loss over the last 40 years, while new home construction during this period has exposed many more structures to damage and erosion hazards (Photos: California Coastal Records Project 2013). The majority of the sand moved east to nourish Zuma Beach and other locations down coast (Everts Coastal 2009). The area of greatest beach erosion occurred near Lechuza Point, with less erosion occurring to the east towards Trancas Creek.

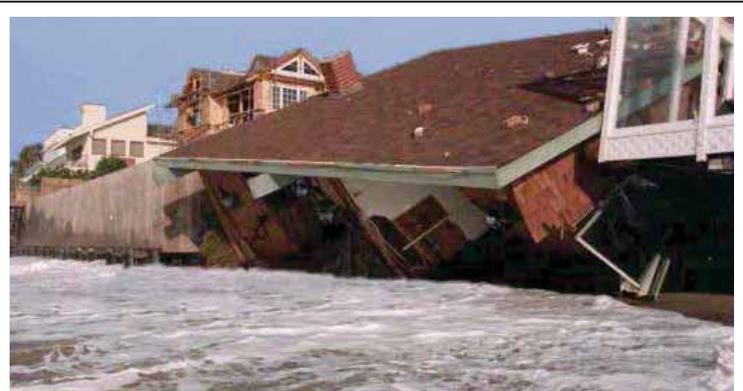
Illustration 2-2. Wave action in the 1997-1998 El Niño led to major structural damage to one Broad Beach home (source: Norton Karno, February 1998).

21 The 1997-1998 El Niño storm
 22 seasons caused considerable
 23 shoreline erosion. The related
 24 storm wave damage along the
 25 California coast also threatened
 26 many Broad Beach homes.
 27 Some homeowners constructed
 28 temporary sand bag revetments
 29 to protect residential structures
 30 and septic leach fields. One
 31 home suffered major structural
 32 damage (Illustration 2-2).

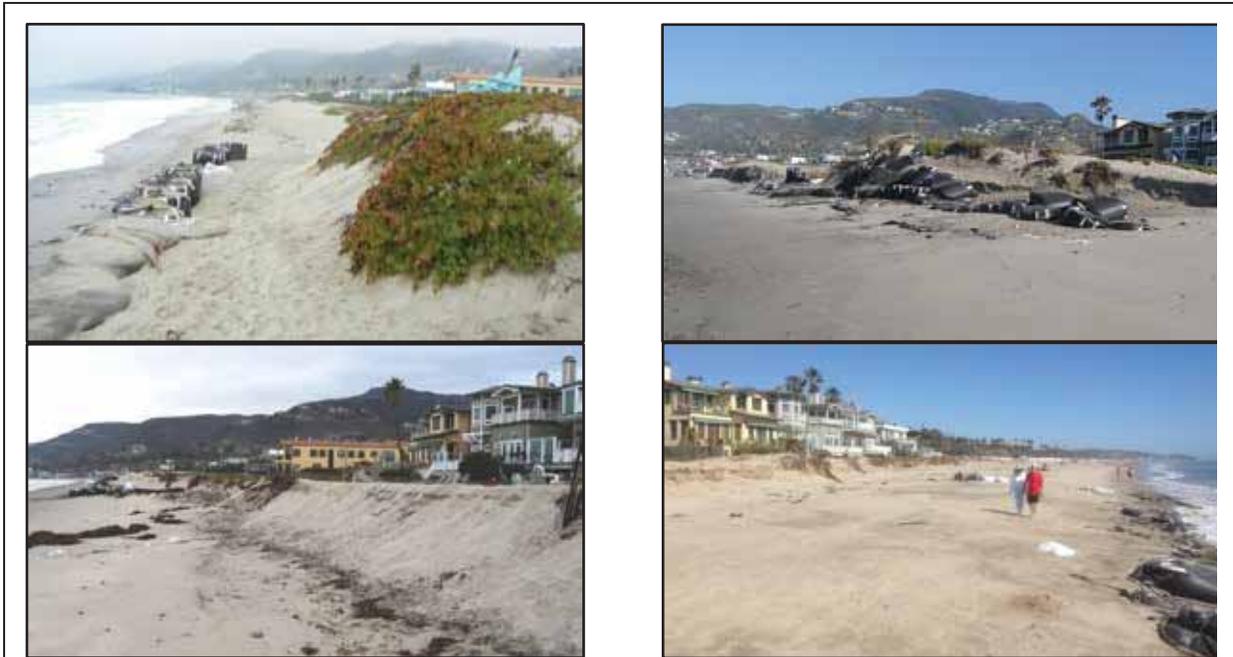
Illustration 2-4. Winter storms in 2013-14 eroded the beach and dunes along the east end of Broad Beach where no emergency rock revetment exists. The remnant dunes and temporary sand bag revetment present at 30708 Broad Beach Lane (top left, Sept. 2011) were eroded and the beach face shifted landward by about 50 feet (bottom left, Feb. 2014). The beach and dune system fronting houses at Broad Beach’s east end ranged from 125 to 150 feet and was protected by temporary sand bag and Sakrete revetments (top right, Mar. 2012). During the 2013-14 winter storms, the beach was severely eroded, leaving 30 to 50 feet of beach fronting these homes; the area where dry beach berm was lost to erosion is visible between the destroyed revetments and new beach scarp (bottom right, Mar. 2014).

15 Since 2010, the east end of Broad Beach has eroded by approximately 80 to 100 feet.
16 In 2010, the beach berm along the east end of Broad Beach generally extended laterally
17 from the east end of the revetment, and the properties in this area had approximately
18 125 to 150 feet of beach and dunes fronting their homes, which were protected by
19 geotextile, sand bag, and Sakrete revetments (fabric bags filled with concrete, often
20 stacked or keyed back into a bluff or dune). Between that time and February 2014,
21 these properties experienced approximately 50 feet of erosion. In March 2014, a large
22 storm event resulted in severe erosion along this section of Broad Beach, resulting in
23 approximately 50 feet of additional erosion (Illustration 2-4). This erosion resulted in the
24 loss of substantial portions of the beach and dune system at the east end of the beach,
25 which had previously protected the homes on these properties. Additionally, the sand

26 bag and Sakrete revetment that previously existed was either washed away or largely
27 destroyed. The properties at the east end of Broad Beach are now exposed to potential
28 damage from future large wave events as only 30 to 50 feet of beach and low dunes
29 now fronts these houses.

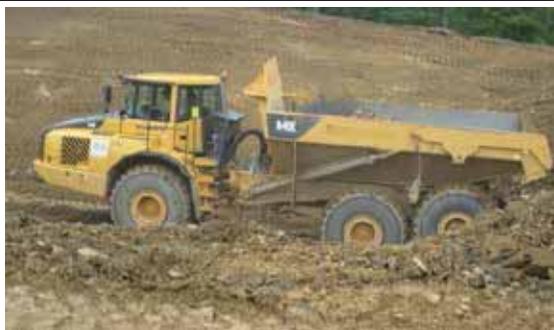
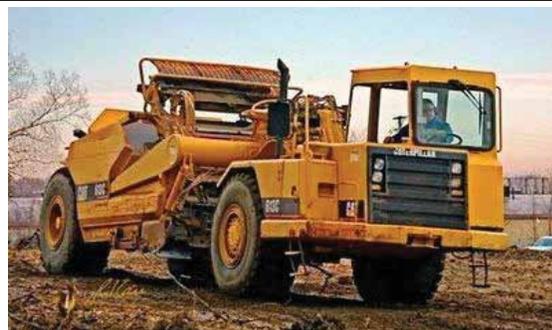
Illustration 2.7. Sand would be delivered to Broad Beach from Zuma Beach using high-capacity 40-ton off-road haul trucks (left) capable of operating in a beach environment. Approximately 7 of these trucks would transit Broad Beach several times each day. Heavy-duty scrapers (right) would distribute sand on Broad Beach once deposited by the haul trucks. Such scrapers may also be used to transport sand from Zuma to Broad Beach and during backpassing operations.

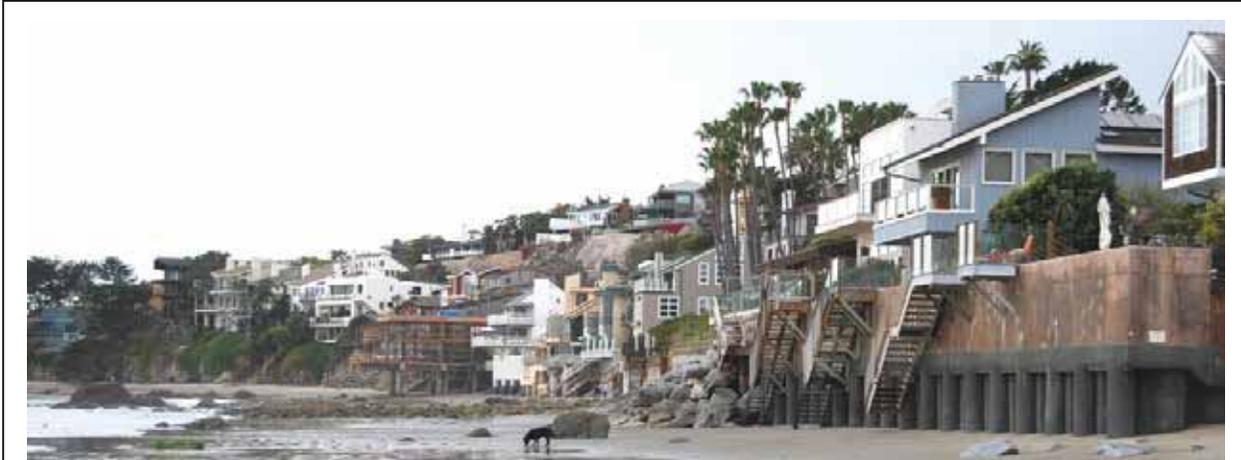
Illustration 2-8. Many of the houses along the west end of Broad Beach are constructed on pilings or include other coastal protection structures. Houses on the far west end along Lechuza Cove are constructed on bluffs that range from 20 to 40 feet in height.

- 27 • Reach 6 extends 935 feet from Lot 31418 to Lechuza Point. This reach is not
28 protected by the 2010 revetment; many homes here are constructed on pilings or
29 have seawalls to provide shoreline protection, while others are constructed about
30 20 to 40 feet up on the bluff backing Lechuza Cove (Illustration 2-8). This reach
31 includes the area that supports environmentally sensitive rocky intertidal habitat,
32 rocky outcrops, offshore reef, and associated surf grass and kelp habitats.

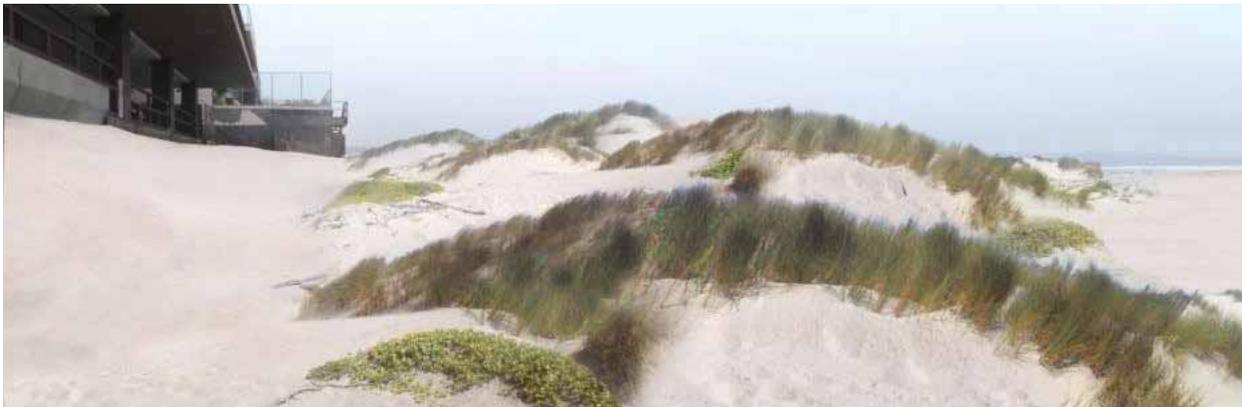
Figure 2-8. Conceptual Rendering of Dune System

5 Using variations in footprint and shape, the Applicant's design of the proposed dunes
6 would replicate existing dunes at the beach's eastern end and former dunes that existed
7 along Broad Beach. Dune construction would be undulated along the beach modeled
8 after the natural and historic dune composition in order to accommodate both
9 unobstructed residential views of the ocean and Applicant-proposed private pathways
10 from residences to the shoreline. In areas where constructed dunes would abut existing
11 dunes on the landward side, the constructed dune would meet or exceed the elevation
12 of the existing dune. The proposed dune restoration includes measures to restore native
13 coastal dune habitats through removal of non-native plants, restoration of dune
14 geomorphology, and establishment of appropriate native dune vegetation (Figure 2-8).

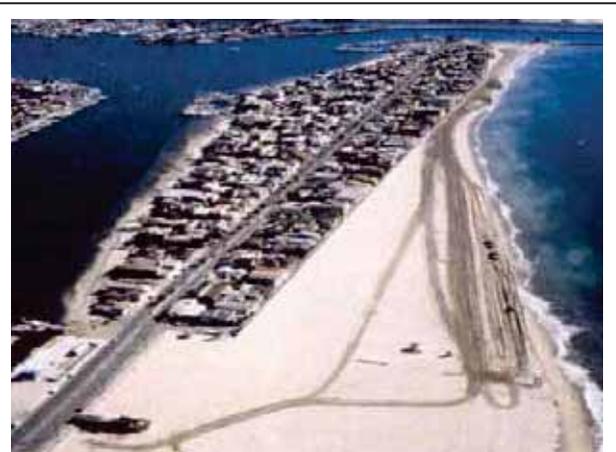
Illustration 2-9. Sand backpassing operations such as this one in Long Beach typically involve the use of bulldozers and scrapers to excavate sand from wider downdrift areas for movement updrift to narrow eroded beaches. Backpassing at Broad Beach would likely occur annually and involve moving approximately 25,000 to 35,000 cy of sand from the beach's east end to its west end.

19 During backpassing, heavy equipment (i.e.,
20 scrapers, bulldozers) would excavate sand
21 from the downdrift "sand rich" end of Broad
22 Beach (anticipated to be the eastern reach)
23 and transport the sand back to the eroding
24 updrift end of Broad Beach (anticipated to
25 be the western reach) (Illustration 2-9). The
26 Applicant anticipates that backpassing
27 would extend the practical lifetime of this
28 beach nourishment project by recycling
29 sand back within the littoral cell, thereby
30 delaying the need for major beach
31 renourishment. The BBGHAD proposes to
32 backpass annually, in between
33 nourishment events, for the Project life.
34 Each backpassing event would occur over
35 an up to 3-week period.

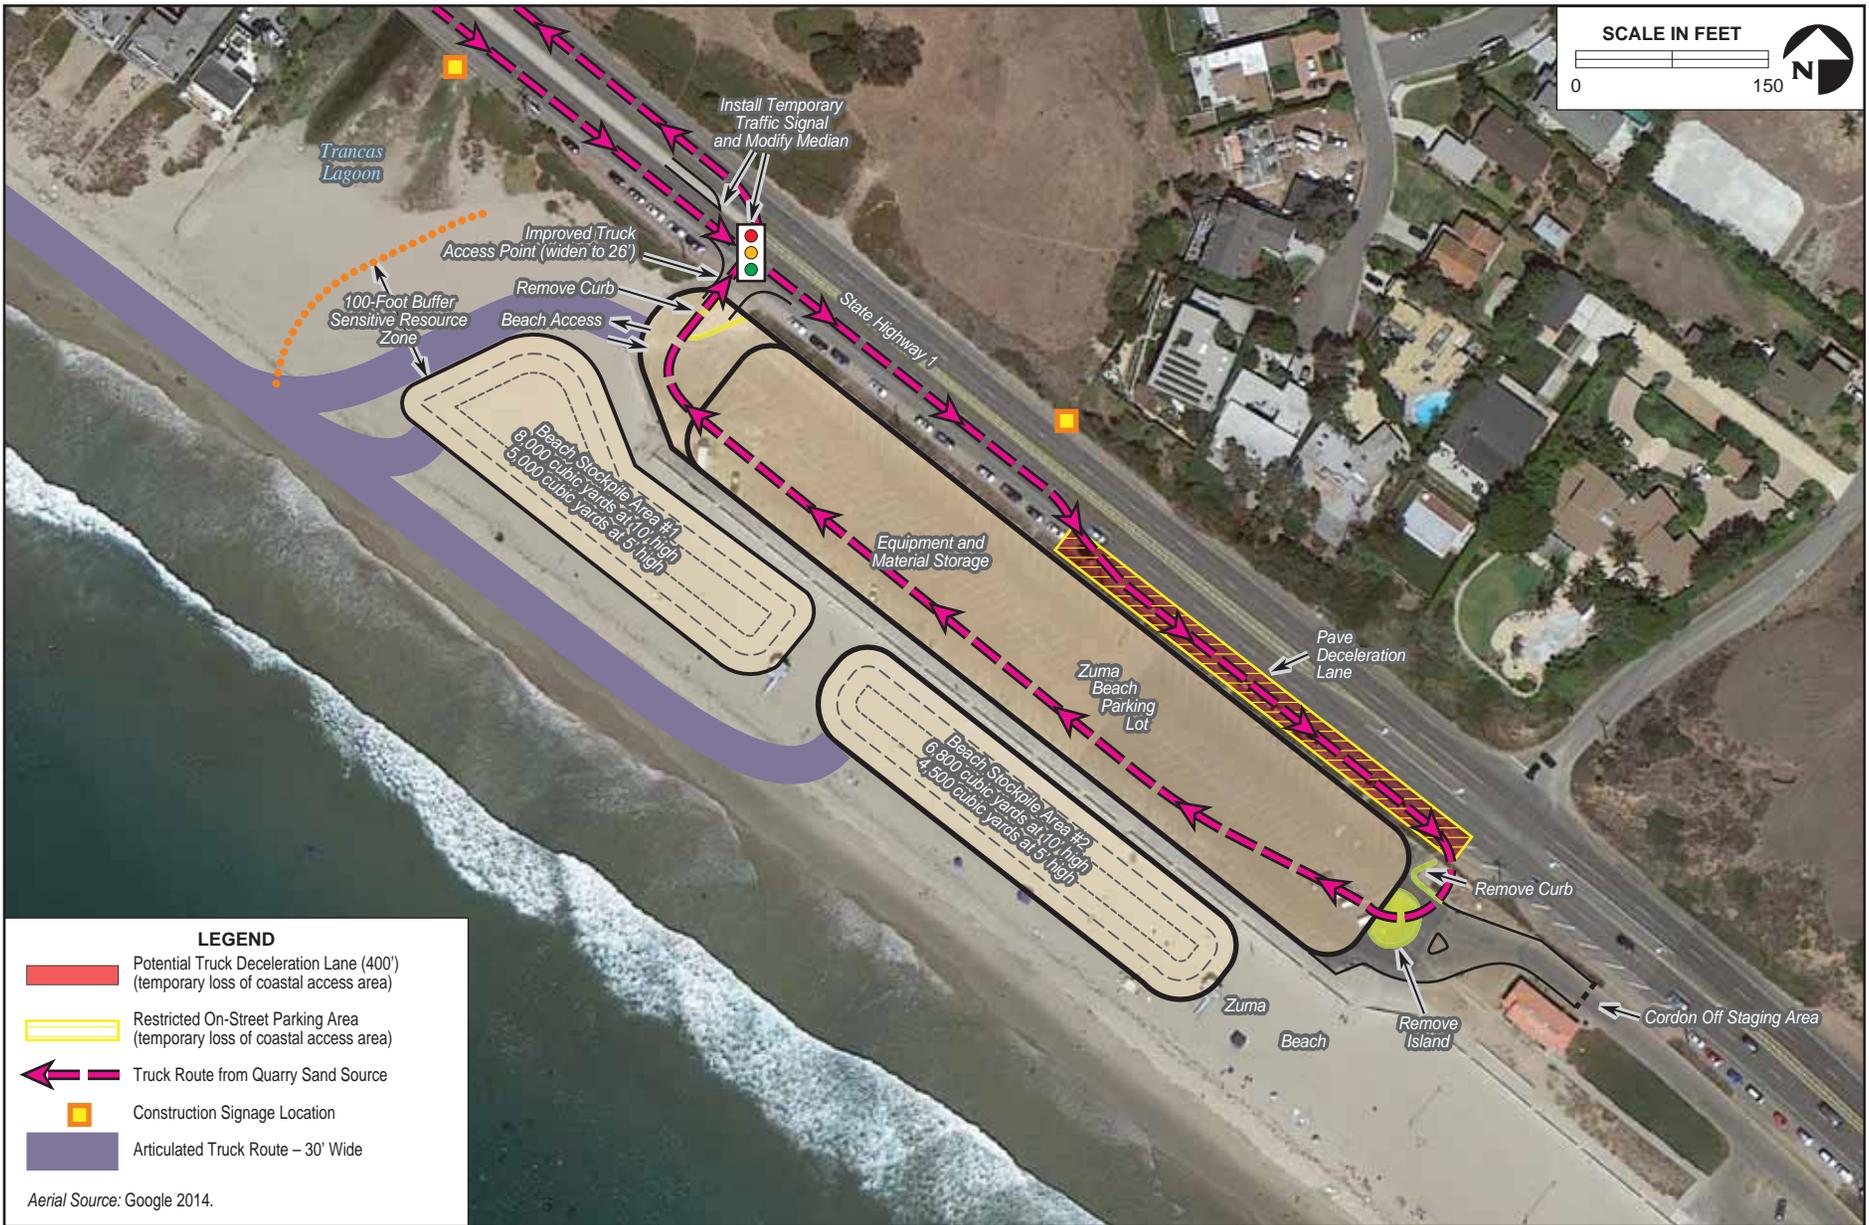
29 To facilitate traffic operations into and out of the site, additional temporary traffic
30 improvements are proposed. First, a temporary eastbound right-turn/deceleration paved
31 lane will be installed at the existing Guernsey Avenue/PCH intersection to ensure that
32 Project truck traffic will safely and efficiently slow to turn right into Lot 12 and not impede
33 eastbound PCH through traffic. In addition, at the Project's outbound PCH driveway, a
34 temporary traffic signal is proposed to be installed to facilitate the safe and efficient
35 movement of outbound haul trucks onto westbound PCH. The circulation and temporary
36 traffic improvements at the staging area are illustrated in Figure 2-15.

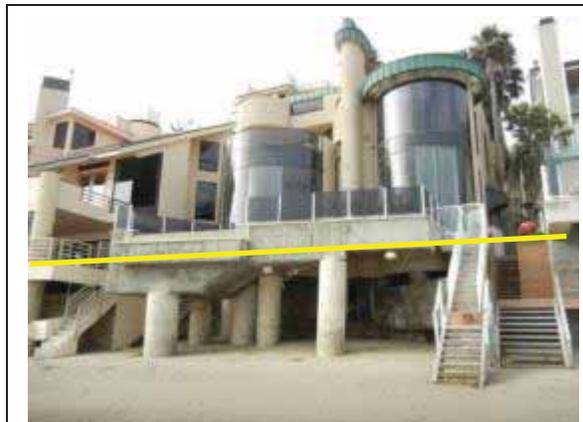
Illustration 2-10. The proposed new sand dunes of 17 to 20 feet above MLLW (up to 8 feet above the beach, represented generally by the yellow line) would partially cover existing pilings, seawalls, foundations and lower segments of stairways of homes at Broad Beach’s west end.

13 Sand would be graded and spread over the existing revetment on the east and up
14 against existing foundations and seawalls in the west to an approximately 50-foot-wide
15 dune field of 17 to 22 feet in height using smaller bulldozers (Illustration 2-10). The 6
16 existing large-diameter storm drains which currently terminate at the revetment would
17 be protected with a new concrete weir box structure and integrated into the revetment.
18 These drains would issue under the dune and through the beach by percolation.
19 Following sand placement and planting of approved native dune flora, public access
20 would be provided through existing vertical
21 access ways owned and operated by Los
22 Angeles County and private access would
23 be channeled through approved pathways
24 at each property (refer to Section 2.2.4 for
25 details on access restrictions).
