1 **3.1 COASTAL PROCESSES, SEA LEVEL RISE, AND GEOLOGIC HAZARDS**

2 This section of the Revised Analysis of Impacts to Public Trust Resources and Values
3 (APTR) describes and analyzes the coastal processes, climatic conditions, and
4 geological hazards present at Broad Beach in the city of Malibu, Los Angeles County
5 (see Figure 1-1). The analysis focuses on issues that are relevant to the objectives and
6 potential impacts of the proposed Broad Beach Restoration Project (Project) on public
7 trust lands, resources, and values. As noted in Section 2, *Project Description*, the Broad
8 Beach Geologic Hazard Abatement District (BBGHAD or Applicant) has identified
9 actions to prevent, mitigate, abate and control geologic hazards at Broad Beach in order
10 to protect homes, septic systems, and other structures from coastal erosion. The Project
11 proposed by the BBGHAD would implement a shoreline protection plan along Broad
12 Beach, including: (1) retention of the existing 4,100-foot-long emergency rock and

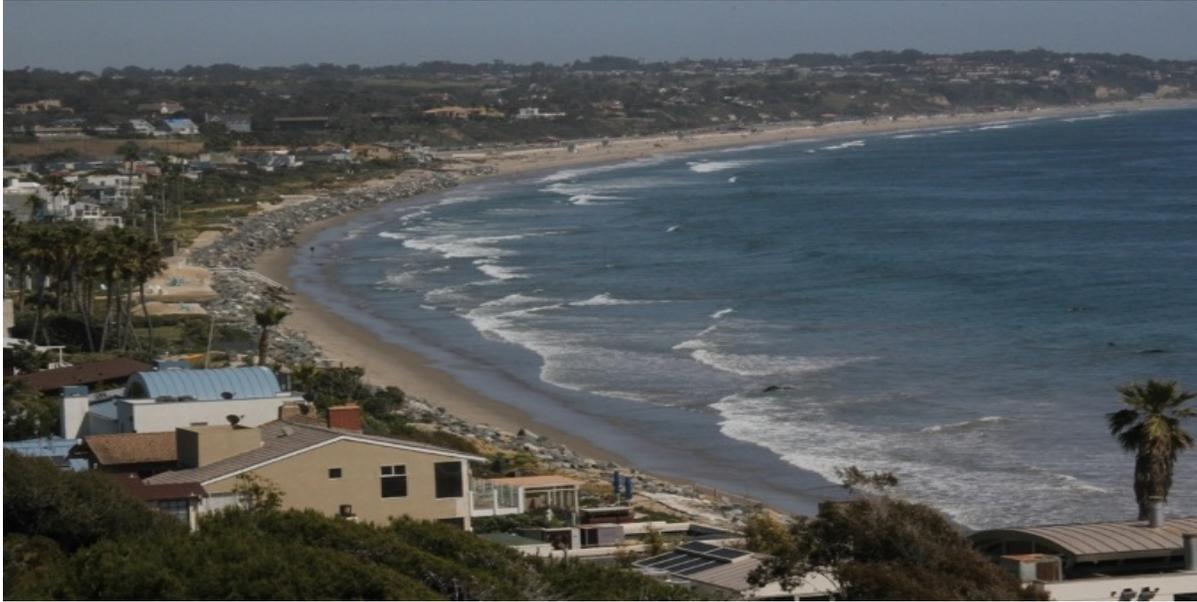
Illustration 3.1-1: Broad Beach and immediate down coast beaches extend for approximately 4 miles along the Malibu coast. These areas include Broad Beach and its narrow low-tide, generally sandy beach backed by the emergency rock revetment (foreground), and the wide sandy beaches at Zuma Beach and Point Dume State Beach located down coast and further south and east (background).

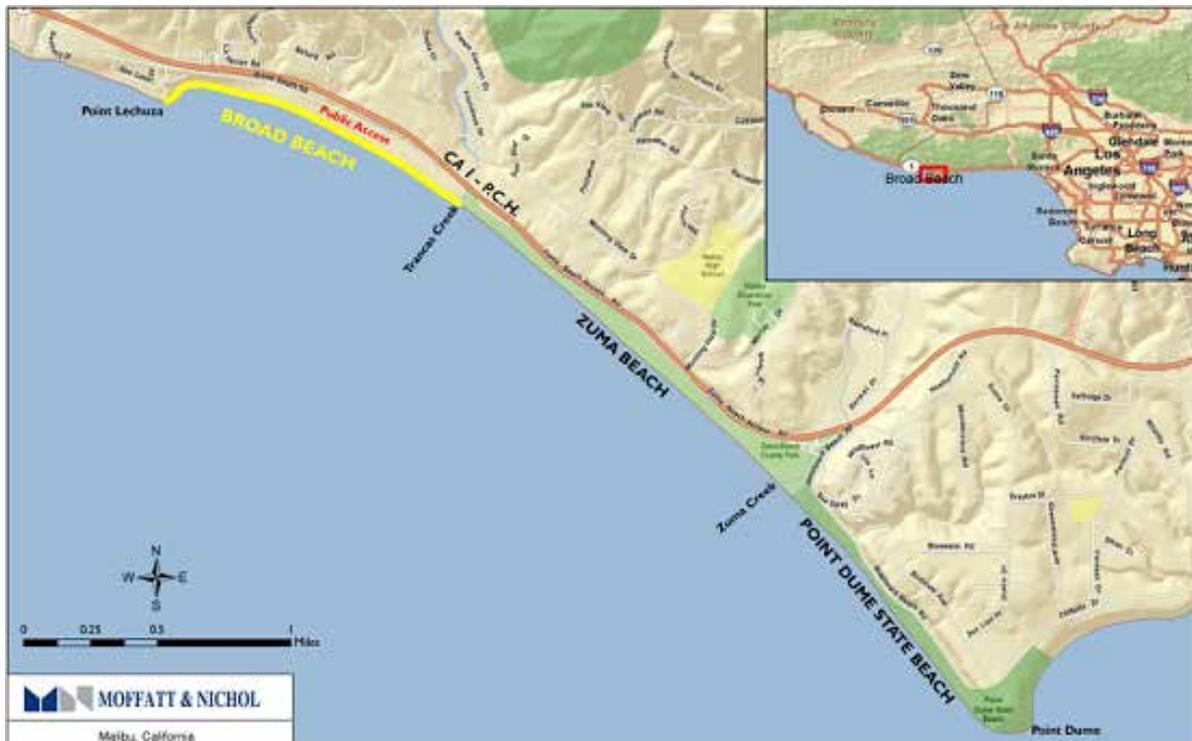
Illustration 3.1-2: The Zuma Littoral Subcell encompasses the Broad Beach area and down coast area beaches and offshore areas extending for approximately 4 miles from Point Lechuza to Point Dume.

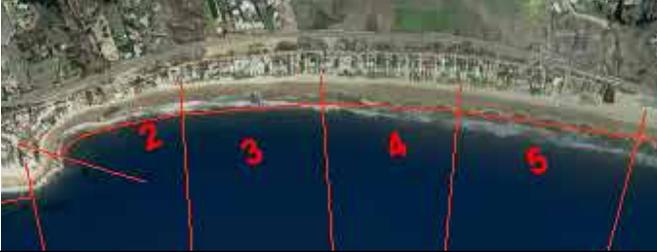
Table 3.1-3. Description of the Four Beach Bins of Broad Beach

Bin	Beach Description	Length (feet)	Distance from Point Lechuza (feet [miles])

2 West Broad Beach_1	1,420	1,420 [0.3]
	3 West Broad Beach_2	1,500	2,920 [0.6]
	4 East Broad Beach_1	1,450	4,370 [0.8]
	5 East Broad Beach_2	1,945	6,315 [1.2]

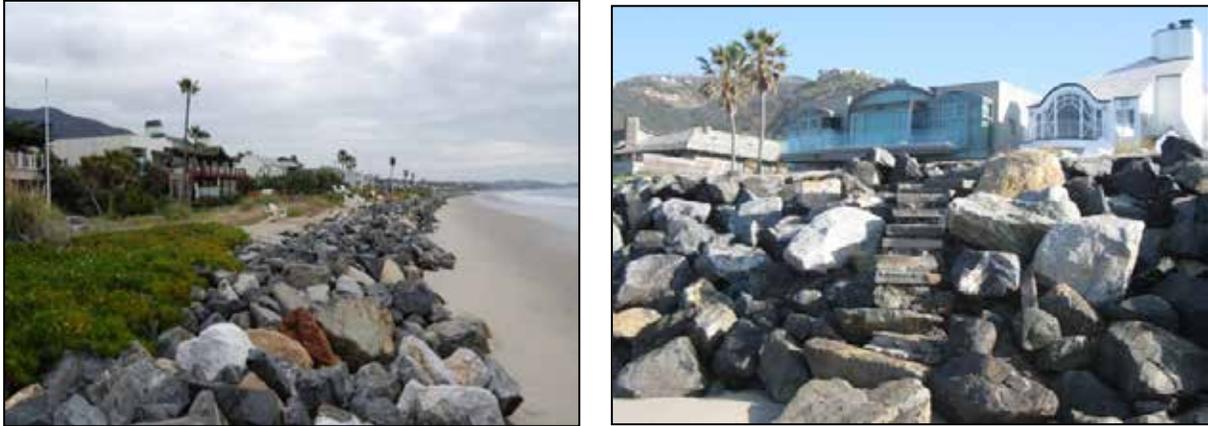
Illustration 3.1-4: The existing revetment extends for 4,100 feet along Broad Beach fronting the majority of private properties within the area. The majority of the existing emergency revetment is generally comprised of 0.5- to 2-ton boulders, intermingled with smaller rock. The use of such smaller rock could expose the revetment to wear and damage by wave action over the long term.

31 The existing revetment extends from 30760 Broad Beach Road, approximately 600 feet
32 west of Trancas Creek, to 31346 Broad Beach Road, just west of the western public
33 access point for Broad Beach and 1,500 feet east of Lechuza Point (Illustration 3.1-4).

1 Approximately 36,000 tons of rock was used to construct the revetment in 2010. The
2 revetment varies in width from 22 to 38 feet, and rises 12 to 15 feet above MLLW with
3 an average crest elevation of 13 feet above MLLW.³ Individual boulders for the majority
4 of the revetment are between 0.5 and 2 tons in weight, although many smaller rocks
5 were used during construction. The portion of the revetment between 31302 and 31346
6 Broad Beach Road was designed to be more robust and incorporated larger boulders
7 (i.e., up to 4 tons per rock). Most of the revetment is on private land. However, portions
8 of the seaward side of the revetment totaling approximately 0.86 acre are located on
9 public trust lands below the Mean High Tide Line (MHTL) as surveyed by CSLC staff in
10 January 2010; an additional 0.73 to 1.04 acre overlies Lateral Access Easements
11 (LAEs) which were granted to the public for lateral coastal access along Broad Beach

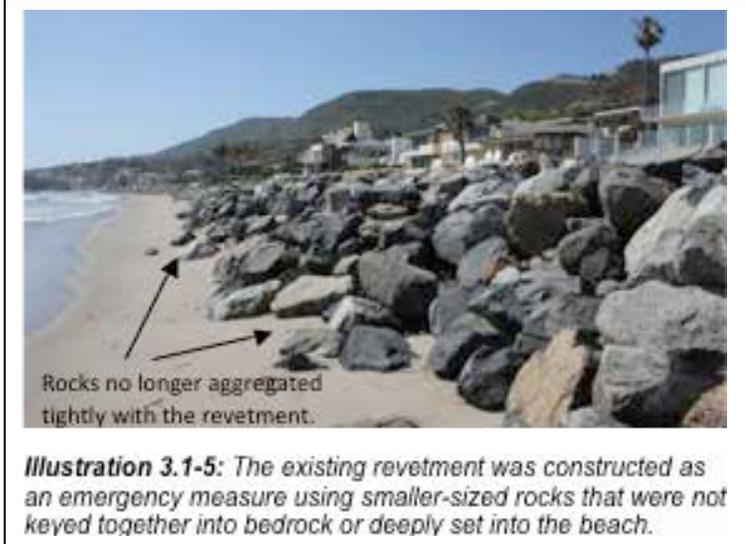
1 wall appeared stable with no
2 obvious perturbations in the
3 overall linear shape of the wall.
4 In these areas the geotechnical
5 field team did not note any
6 deflections in the top of the wall
7 that could indicate settlement of
8 the overall wall. At the western
9 end of the wall where the larger
10 rocks exist, the field survey team
11 did not note any rock pieces that
12 had been detached from the rock
13 mass. The rock sizing indicates
14 relative stability of the rock mass;
15 however, the detached stones suggest that use of a larger size stone would be
16 warranted. Field reconnaissance performed by AMEC staff in 2014 confirmed that the
17 revetment remains intact with little evidence of damage (26 February 2014).

36 Overall, the exterior stone appeared to be stable with little evidence of movement
37 having occurred during the 2-year performance period prior to this field inspection (2010
38 to 2012). In the eastern end where the smaller rock exists, the field survey team noted
39 that individual rock pieces had been separated from the wall and were lying on the
40 beach in front (seaward side) of the wall (Illustration 3.1-5). In these local cases, the
