1 **3.6 SCENIC RESOURCES**

2 This section of the Revised Analysis of Impacts to Public Trust Resources and Values
3 (APTR) describes the visual environments and public aesthetic resources that would be
4 affected by the proposed Broad Beach Restoration Project (Project), identifies criteria to
5 assess the severity of impacts to these resources, and recommends avoidance and
6 minimization measures (AMMs) where applicable to reduce impacts. The information
7 presented in this section is intended to inform the California State Lands Commission
8 (CSLC) as it considers whether to issue a lease for those portions of the Project within
9 the CSLC's jurisdiction. As noted in Section 1, *Introduction*, because implementation of
10 the Project by the Broad Beach Geologic Hazard Abatement District (BBGHAD or
11 Applicant) is statutorily exempt from the California Environmental Quality Act (CEQA)
12 (pursuant to Pub. Resources Code, §§ 26601 and 21080, subd. (b)(4)), the scope of

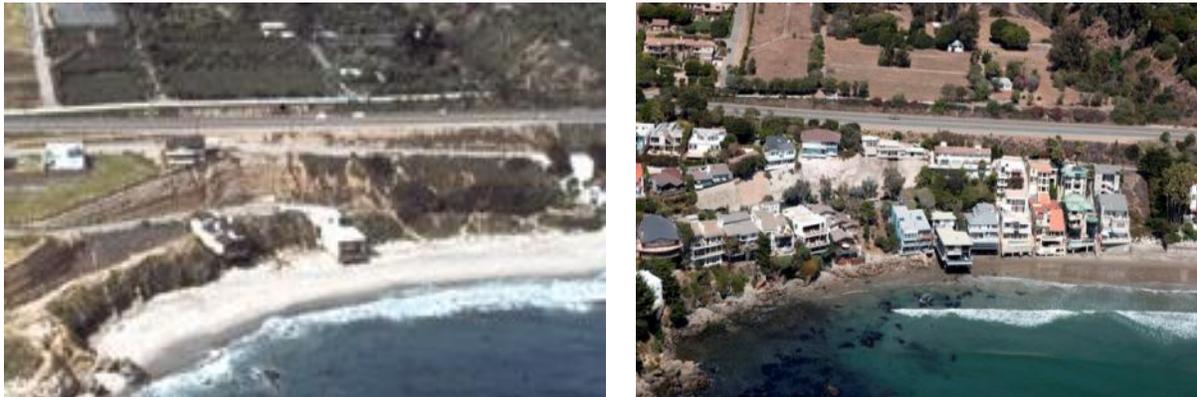
Illustration 3.6-1. Views of Broad Beach public trust intertidal lands have changed substantially over the last 40 years, as can be seen in these aerial photographs from 1972 (left) and 2010 (right). Views of a wide sandy beach backed by dunes have been replaced by those of a low tide beach backed by closely-spaced, sometimes multiple-story houses fronted by large coastal protection structures, including tall seawalls, timber bulkheads, and the recently installed emergency revetment (2010).

10 Broad Beach remained a relatively wide beach through the 1970s, considerably wider
 11 than it is today. The width of Broad Beach reached a peak in 1970 at an annual average
 12 of 60 feet landward of the mean high tide line (MHTL). However, coastal erosion
 13 accelerated in the 1980s and 90s, with much of the sand was lost from Broad Beach
 14 during this period. This directly changed the visual character of the beach, with much or
 15 all of the dry sand beach berm eliminated, and larger areas of rocky intertidal habitat
 16 seasonally exposed near the west end of Broad Beach. In response to this change,
 17 homeowners began to install extensive coastal protection structures, often immediately
 18 adjacent to public land. These included rock and sand bag revetments and concrete
 19 and timber bulkheads. Further, some properties raised houses up on pilings and
 20 elevated foundations near the west end of the beach.

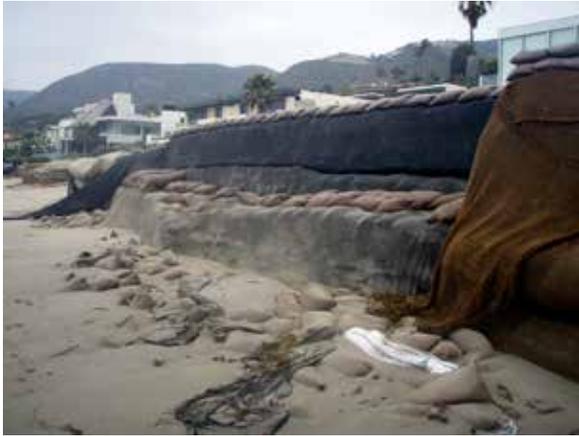
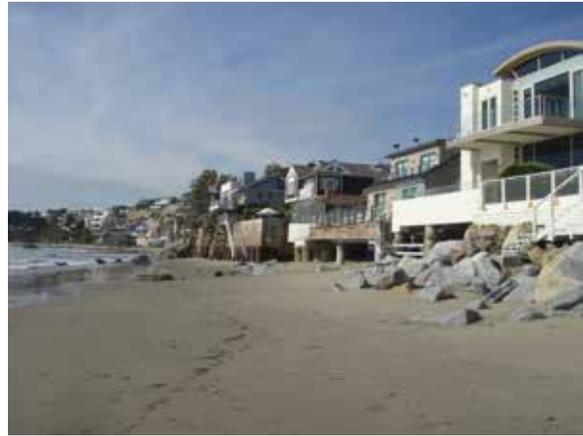
Illustration 3.6-2. Prior to installation of the rock revetment in 2010, individual homeowners protected their properties with a variety of rock, timber, geotextile, and Sakrete revetments.

21 The variety of coastal protection structures present on Broad Beach prior to the 2010
 22 revetment contributed to a relatively incoherent visual character (Illustration 3.6-2). The
 23 natural elements of Broad Beach (rocky intertidal habitat, bluff features, etc.) were
 24 similar to present conditions; however, the different colors, textures, and shapes of the
 25 various rock, timber, geotextile, and Sakrete revetments contributed to an exaggerated

1 aesthetic contrast between individual properties backing the beach and a discontinuous
2 overall character. In addition, certain types of revetments, especially those involving
3 plastic or cloth, were prone to disassemble as a result of wave action and become litter
4 on the beach. Since the individual revetments extended outward onto the beach for
5 different lengths, it is unclear whether any of them covered public trust lands, or to what
6 extent. Similar to the 2010 rock revetment, many of the individual revetments were also
7 tall enough to limit public views landward of the beach.

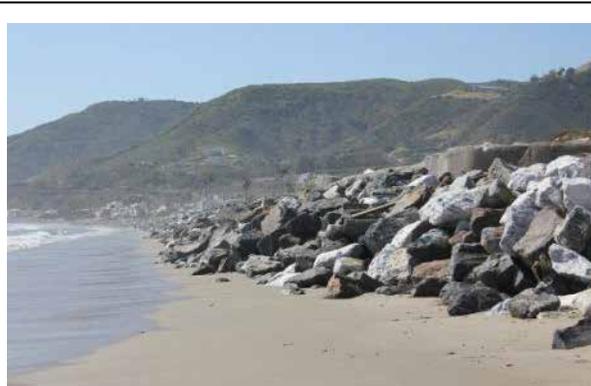
Illustration 3.6-3. The existing revetment rises up 12 to 15 feet in height above the low tide intertidal lands along Broad Beach, limiting public views landward from these public trust lands.

8 The existing emergency revetment was constructed along 4,100 feet of Broad Beach in
9 2010 in response to high erosion rates during the 2009 to 2010 winter season and
10 widespread failure of temporary emergency sand bag revetments. The revetment is
11 constructed of a combination of boulders and smaller rock fill, as well as portions of
12 sand bag reinforcements. The two existing public beach access ways were
13 reconstructed at that time to include stairways with guide rails to traverse the
14 approximately 12- to 15-foot- high revetments (Illustration 3.6-3). The property owner at
15 30822 Broad Beach Road opted not to
16 participate in the emergency revetment
17 project, leaving a 100-foot-long break in
18 the revetment in front of this property
19 near the east end of the Project area.

20 The existing revetment covers 3.02 acres
21 of public and private beach area. Of this
22 coverage, approximately 0.86 acre of
23 public trust lands are currently covered
24 by the revetment, which is highly visible
25 within Broad Beach and limits landward
26 views and public access to the beach.

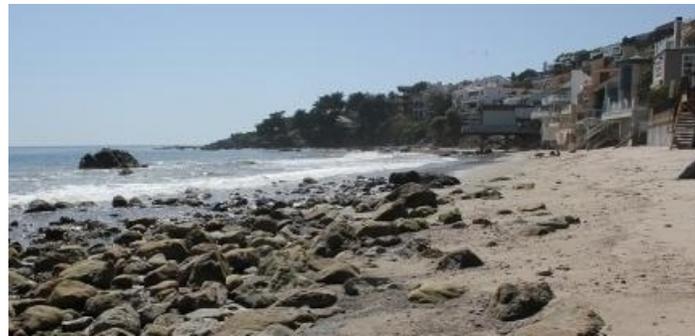
Illustration 3.6-4. Public trust intertidal lands along Broad Beach afford users views of the ocean, beach, emergency revetment, and residential properties along the beach.

2 The natural environment at Broad Beach consists of a narrow sandy beach on the west
 3 end, which widens towards the east end, backed by an emergency revetment along a
 4 majority of the beach, with
 5 residential development landward
 6 (Illustration 3.6-4). Significant
 7 visual resources available from
 8 public trust lands along Broad
 9 Beach include views of open
 10 water, the beach, and the bluffs.
 11 PCH, which is eligible for State
 12 scenic highway designation, runs
 13 parallel to Broad Beach Road and
 14 has limited views of the beach due
 15 to vegetation and residential
 16 development.

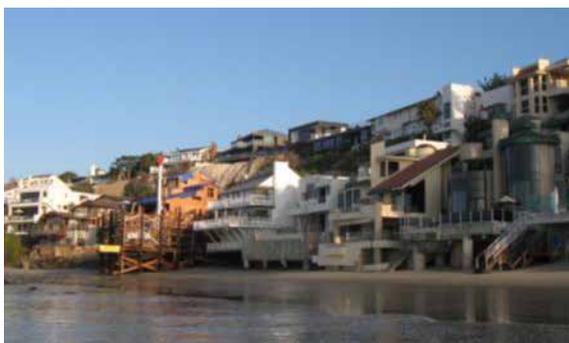
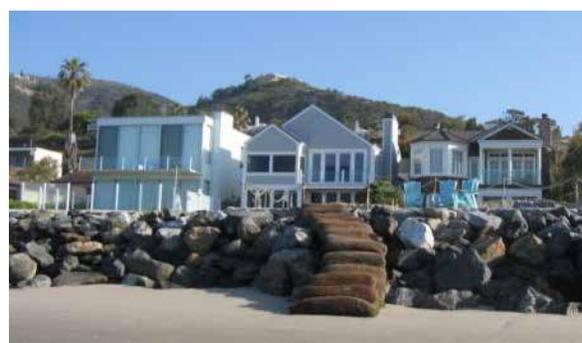
Illustration 3.6-5. Existing developments, including protective structures and the emergency revetment, dominate views from intertidal lands and offshore waters of Broad Beach.

17 At moderate tides, Broad Beach is currently a narrow ribbon of primarily wet-sand
 18 beach. The revetment dominates landward views from central and eastern Broad
 19 Beach, with portions of homes visible over the top of the 12- to 15-foot-tall rock
 20 stack (Illustration 3.6-5). At lower tides, up to 200 feet of intertidal beach is
 21 exposed, with these low-tide sand flats providing public views of intertidal and
 22 offshore areas, Zuma Beach, and Point Dume to the east, Lechuza Point to the
 23 west, and steep chaparral-covered slopes of the Santa Monica Mountains to the
 24 north. At these lower tides, although well set back, homes along the eastern
 25 portion of Broad Beach become more visible from the waterline as the
 26 revetment does not impede landward views. At the eastern-most end of
 27 Broad Beach in areas without the revetment, relatively intact coastal dunes
 28 remain fronting 5 existing homes, four undeveloped lots, and the Malibu

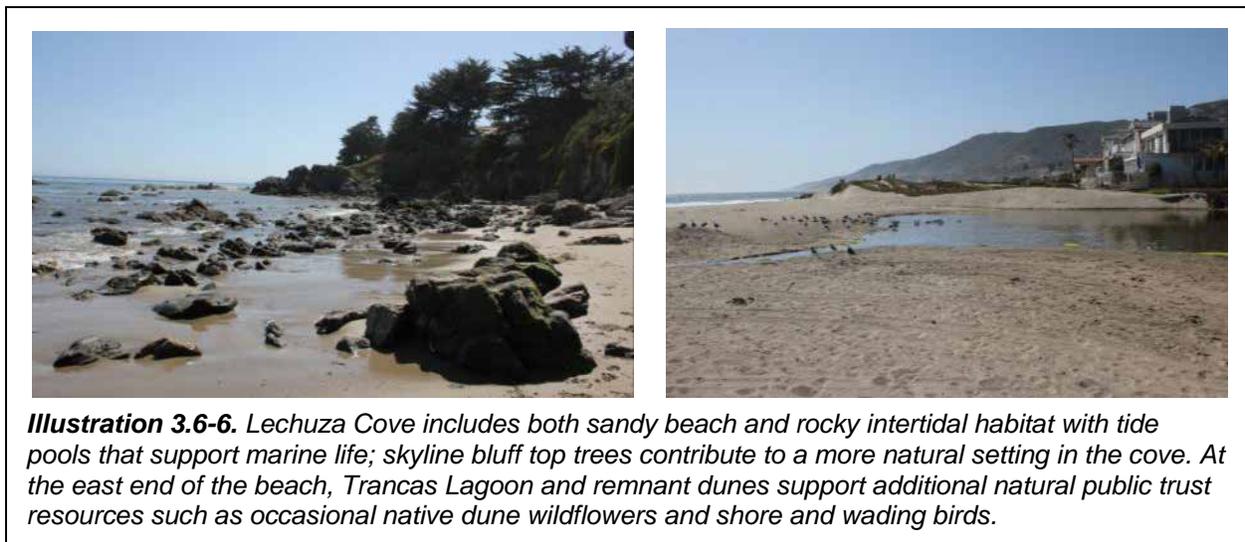
1 The beach becomes increasingly rocky in the west, in the sheltered cove inside of
2 Lechuza Point, where rocky intertidal habitat intermingles with intermittent sandy beach
3 (Illustration 3.6-6). At lower tides in this area, beachgoers can view tide pools and
4 marine life, including sea anemones, mussels, starfish, and beds of bright green
5 surfgrass. Landward views are dominated by homes built along taller dunes and the
6 bluff face and top, with scattered trees and other vegetation, breaking up and softening
7 views of residential development. Landward views from public trust lands at the west
8 end of the beach are dominated by two- and three-story homes, foundations, seawalls,
9 and pilings supporting these homes; however, the relatively natural bluff face within
10 Lechuza Cove, and skyline Monterey cypress trees and other vegetation contribute to a
11 more natural setting in the cove itself.

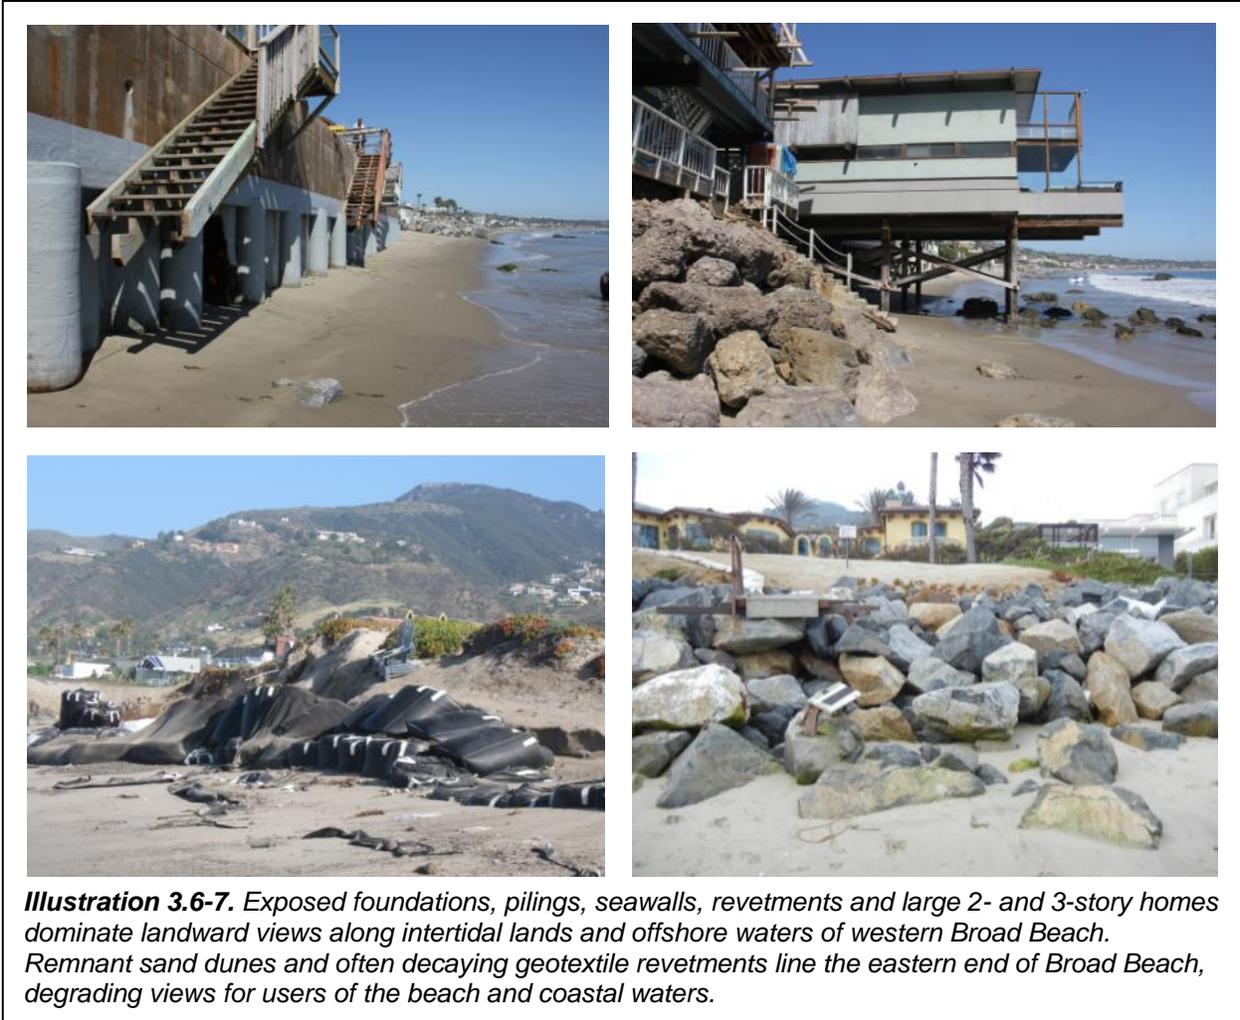
12 Residential homes along the beach are a primary visual feature along Broad Beach
13 (Illustration 3.6-7). Development in the area includes 109 homes along Broad Beach
14 and the Malibu West Beach Club. Approximately 79 residences are located landward of
15 the existing emergency revetment, while 35, located at the east and west ends of the
16 Broad Beach, lie outside the revetment's boundaries. Residences toward the west end
17 of the beach often have individual seawalls or rock revetments while those at the far
18 east end lie behind dunes and geotextile sand bag revetments reminiscent of those
19 present along the entire beach prior to the 2010 rock revetment (Illustration 3.6-7).

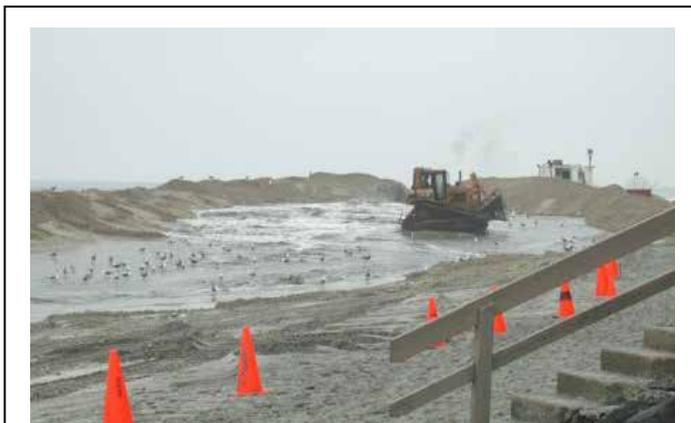
Illustration 3.6-8. Visual impacts from proposed beach nourishment activities would include operation of heavy construction equipment on the beach for up to an 8-month period.

20 Construction activities associated
21 with Project implementation would
22 have short-term impacts to the visual
23 quality of the Project area (Illustration
24 3.6-8). The visual environment would
25 be temporarily disrupted by the
26 presence and activities of
27 construction equipment. Views in the
28 Project area would be substantially
29 degraded on a daily basis for the
30 duration of construction activities,
31 impacting visual quality of Broad
32 Beach and vicinity.
