July 1, 2013  
(20252)

Russell Boudreau, P.E.  
Moffatt and Nichol Engineers  
3780 Kilroy Airport Way, Suite 600  
Long Beach, CA 90806

**SUBJECT: SUMMER MAPPING OF EELGRASS OFF BROAD BEACH IN MALIBU FOR THE BROAD BEACH RESTORATION PROJECT**

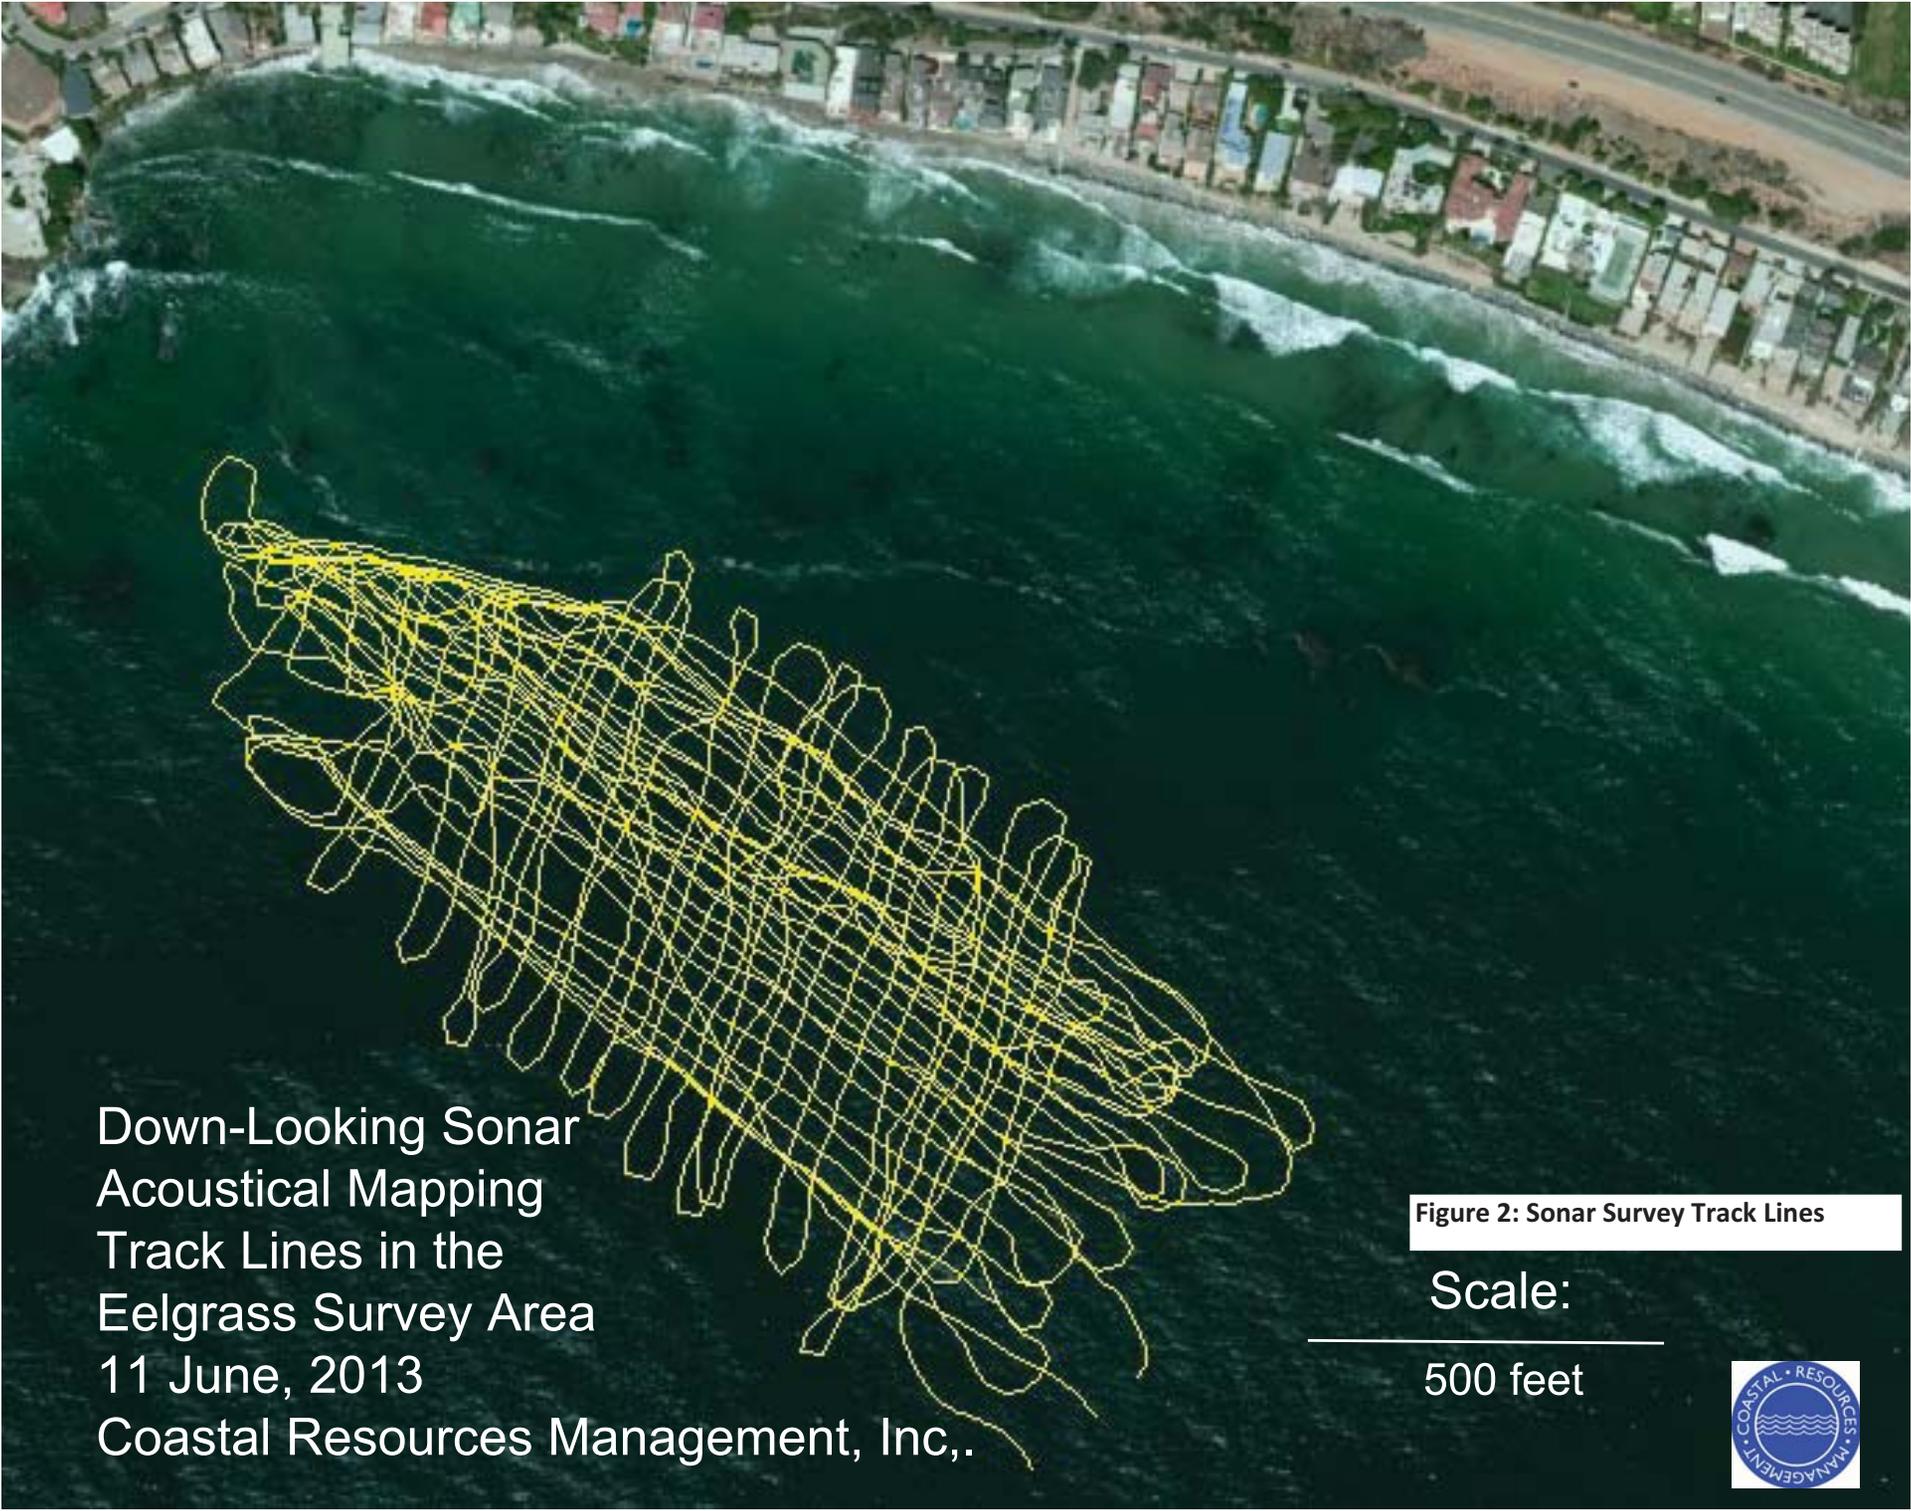
Figure 2: Sonar Survey Track Lines

The survey was conducted within a 1,355 foot-long by 590-foot-wide (18.6-acre) rectangular zone centered on the eelgrass meadow mapped by biologists in September 2012 (Chambers Group 2012b). Within this zone, data were collected along 67 shore-parallel and shore-perpendicular transects spaced between 10 and 50 feet apart (Figure 2). Transect lengths were longer and extended farther inshore and offshore than the known eelgrass bed to insure full coverage. The CRM vessel was operated at speeds between 3 and 6 knots.

Down-Looking Sonar  
Acoustical Mapping  
Track Lines in the  
Eelgrass Survey Area  
11 June, 2013  
Coastal Resources Management, Inc.,

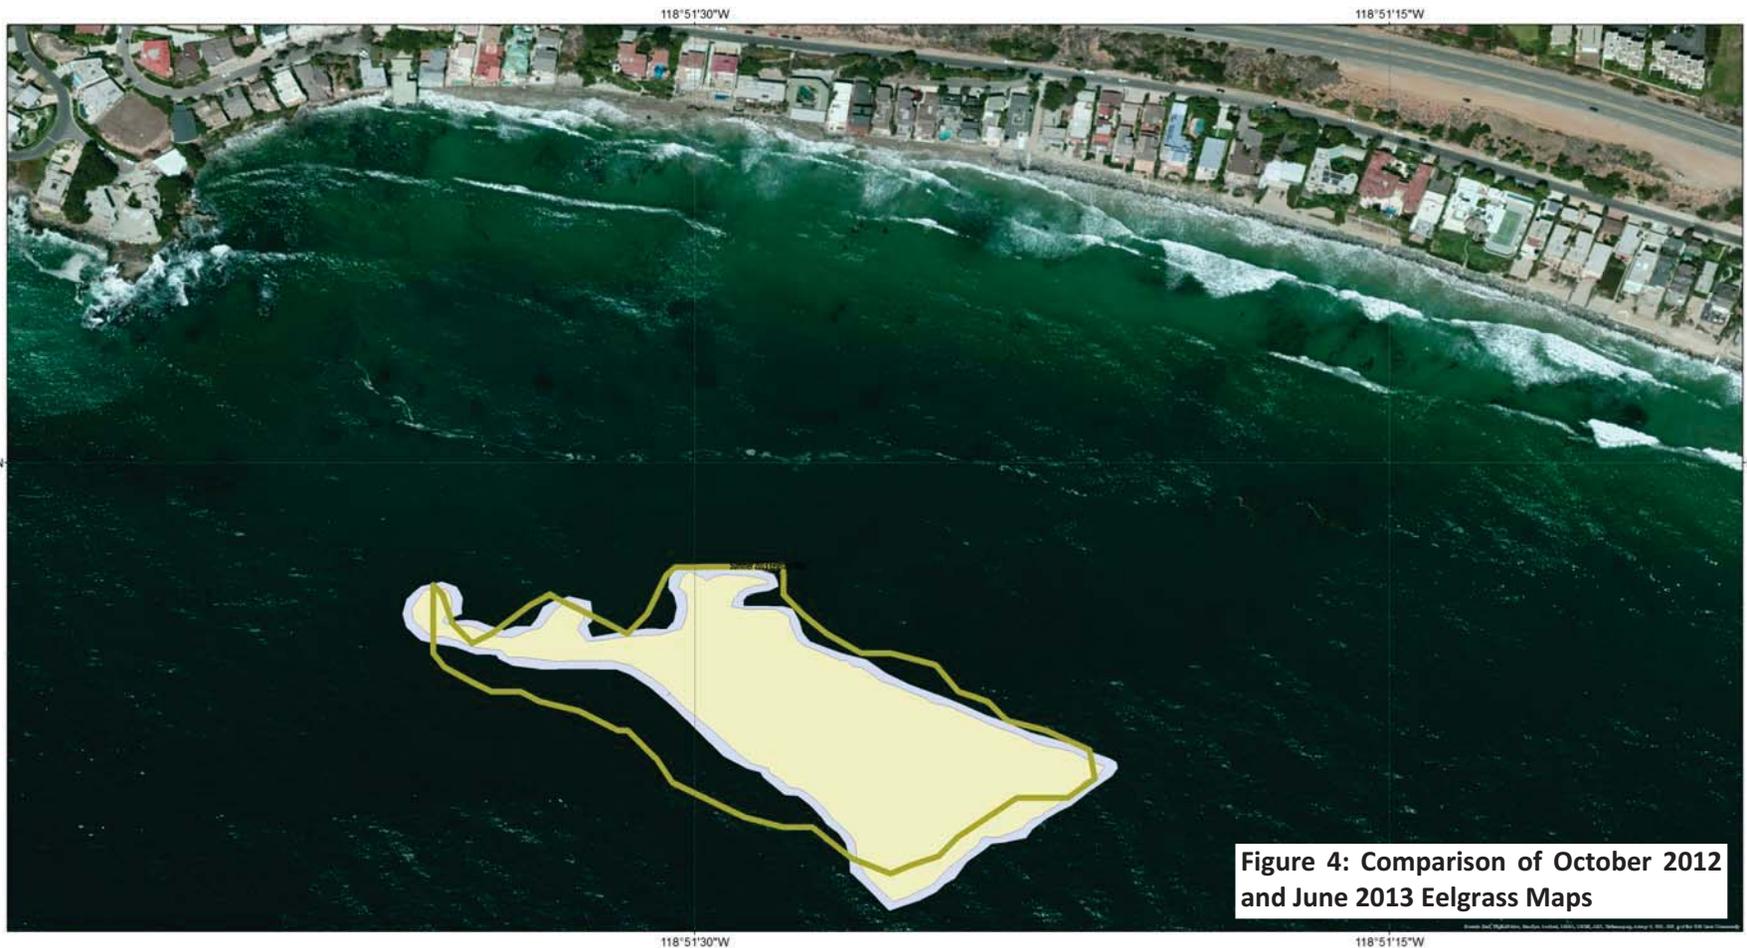
**Attachment 4 – Figure 4: Comparison of October 2012 and June 2013 Eelgrass Maps**

Figure 4 compares the outline of the bed mapped in November 2012 by divers with the outline of the bed mapped by sonar in June 2013. The November survey estimated the size of the bed as 6.9 acres compared to the June estimate of 8.75 acres. The footprints are similar, but the June survey shows greater width throughout the bed, particularly on the offshore edge. Some of the difference may be due to the fact that the sonar detected eelgrass patches, while the divers in November did not attempt to map all the patches. However, it is likely that the bed did expand during the spring growing season following a calm, dry winter. The divers observed new growth of eelgrass in June. The bed depths mapped in June of 21 feet to 40 feet were slightly different than the November estimate of the bed as occurring between 24 feet and 42 feet. The depth difference may be a result of the greater accuracy of the depth measurement using sonar compared to diver depth gauges.

# Broad Beach Eelgrass Surveys, October 2012 and June 2013
