## **Prevention First 2004 Symposium:**

## "Bow Mariner" Tanker Casualty

Douglas Martin, Smit Salvage

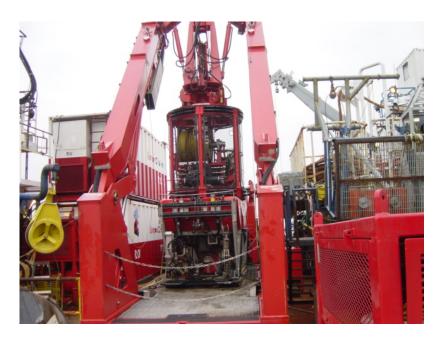
## .14 ROV – Triton XLS
