An Oily Summerland Century Story

Ira Leifer and Ken Wilson

**University of California, Santa Barbara
Office of Spill Prevention and Response**

Prevention First
Long Beach, California
Sept 12, 2006

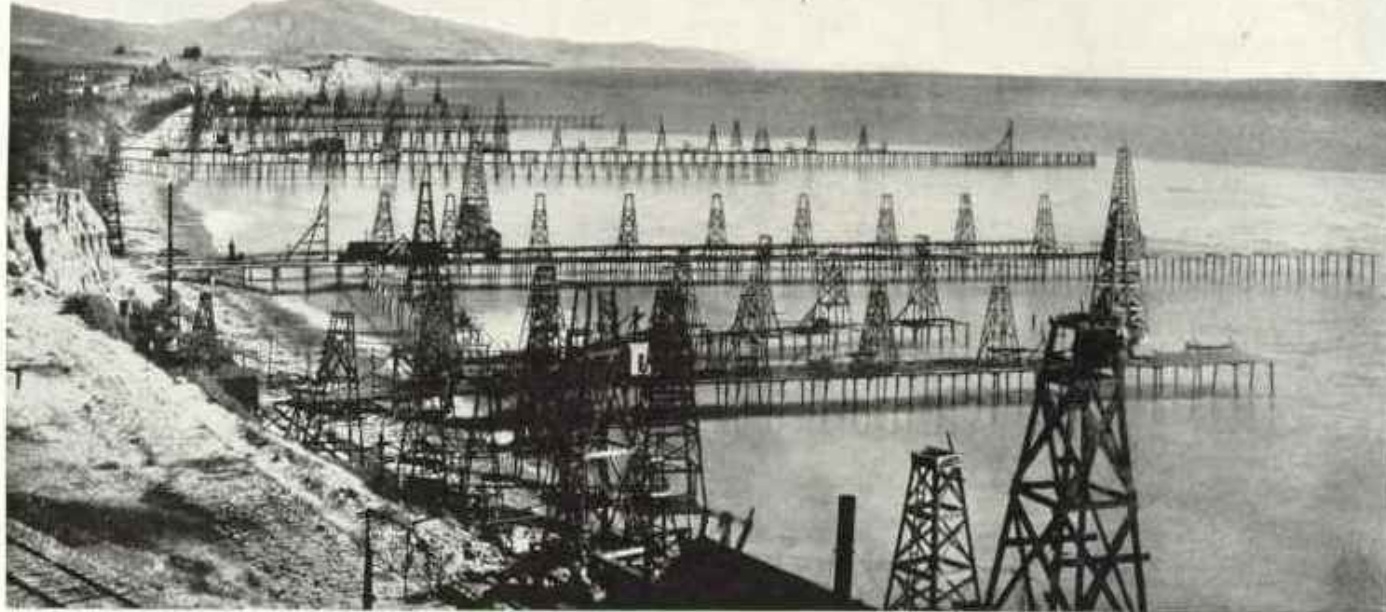
THE SUMMERLAND FIELD IN SANTA BARBARA COUNTY, CALIFORNIA

416 wells drilled 1895-1906

220 wells drilled nearshore and offshore

Where man's conquest of the subterranean treasure extends beyond the shore-line. These wells were drilled 300 feet below sea-level to reach the oil.

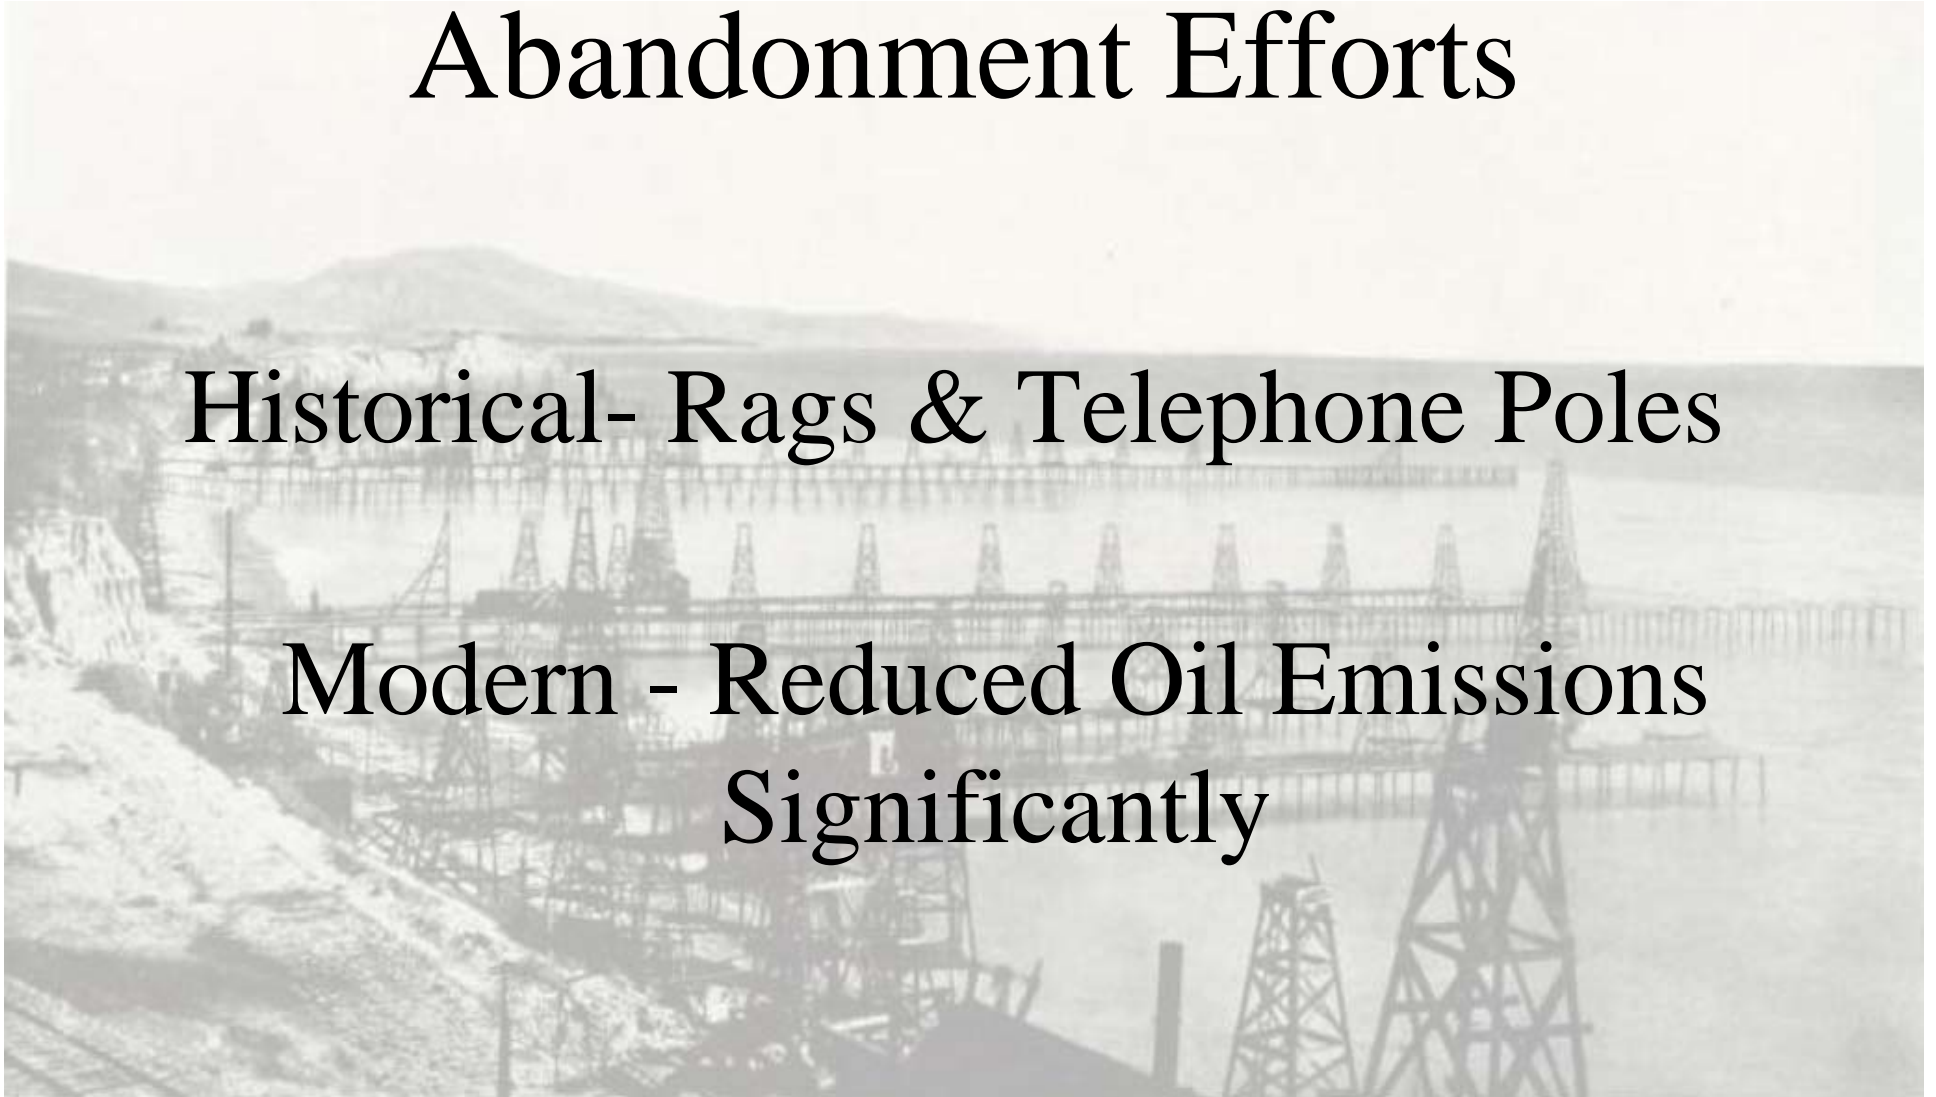
Abandonment Efforts

Historical- Rags & Telephone Poles

Modern - Reduced Oil Emissions
Significantly

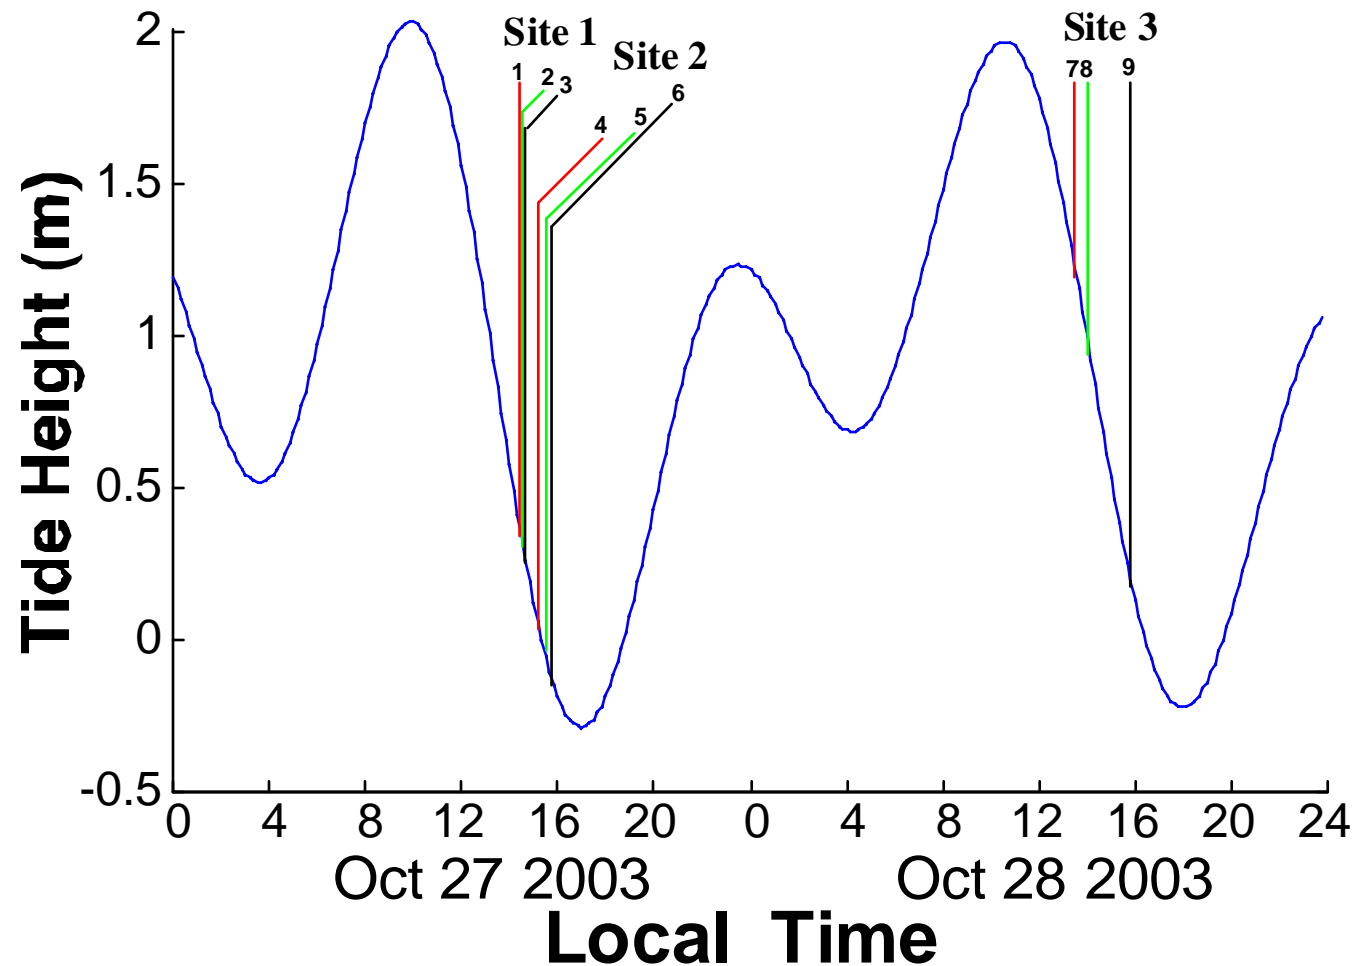
Oct 27-28, 2003 Seabed Deployment

Oct 27-28, 2003 Sites 1-3 Emissions

Site 1 10/27/2003 34° 25.0549'N, 119° 35.8777'W (NAD83)

Site 2 10/27/2003 34° 25.0687'N, 119° 35.9224'W (NAD83)

Site 3 10/28/2003 34° 25.0832'N, 119° 35.9640'W (NAD83)

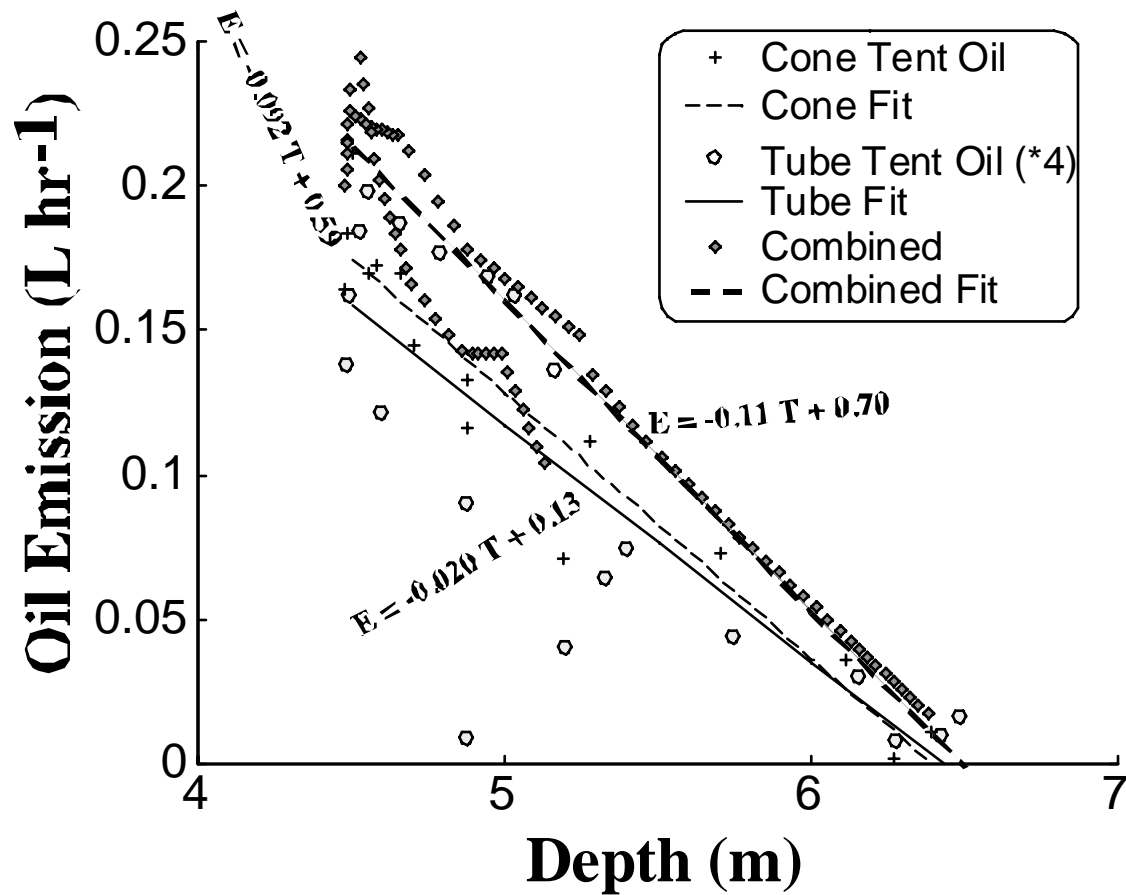
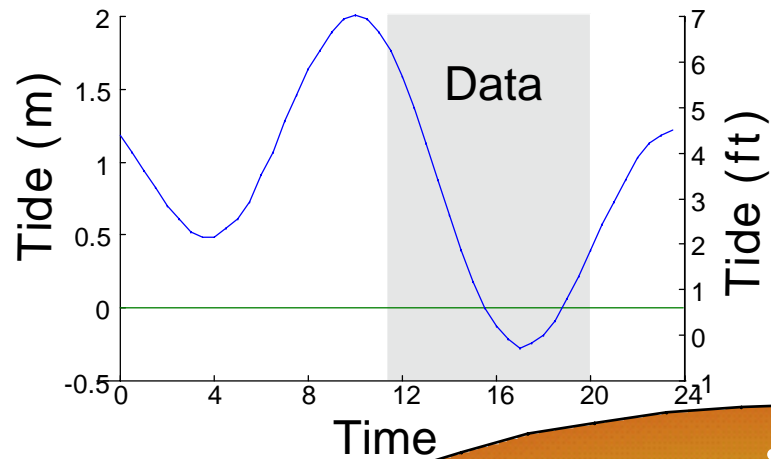
Curve Fit to Data

Bottom Line:
2.62 liters oil day⁻¹
from T-10 Well

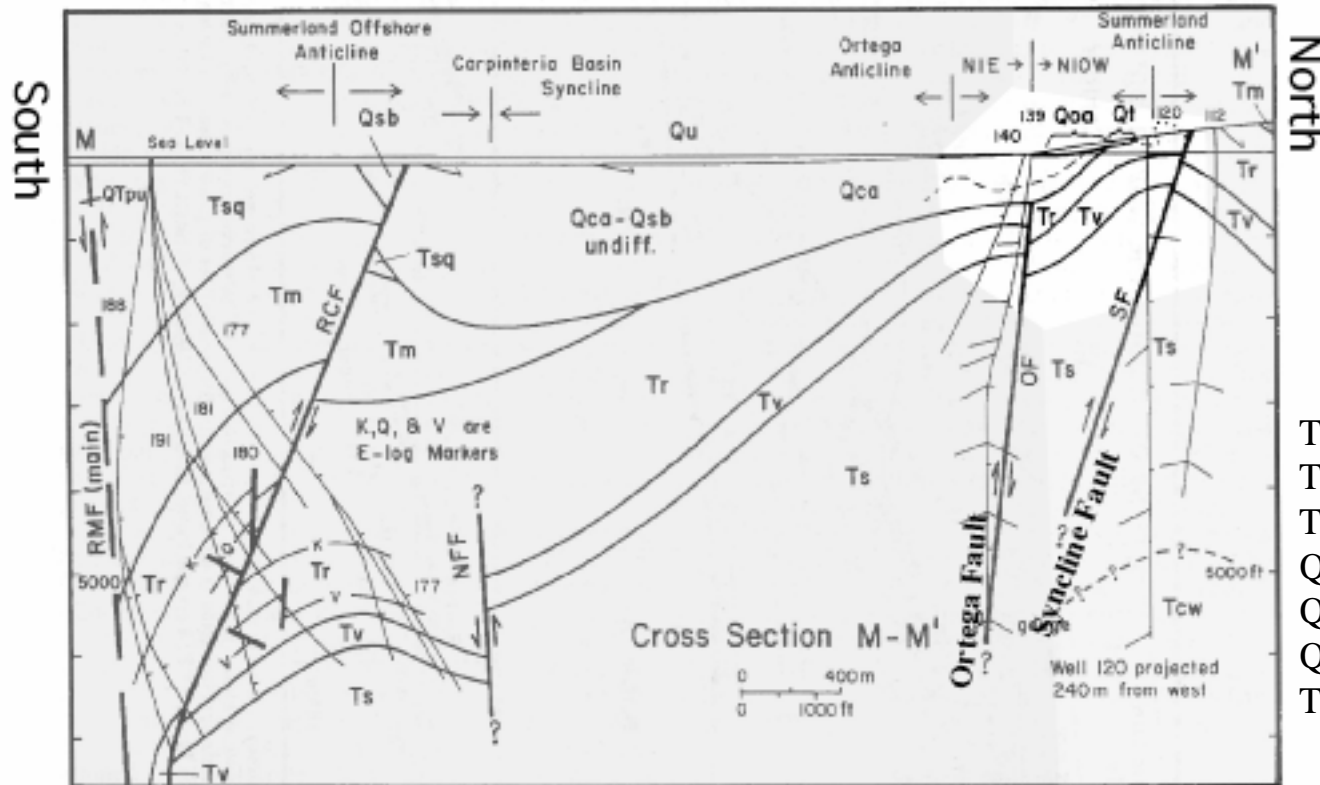
North-South Summerland Cross-section MM'

- Tv - Vaqueros Formation
- Tr - Rincon Formation
- Ts - Sespe Formation
- Qca - Casitas Formation
- Qoa- Alluvium
- Qt - Terrace
- Tm - Monterey Formation

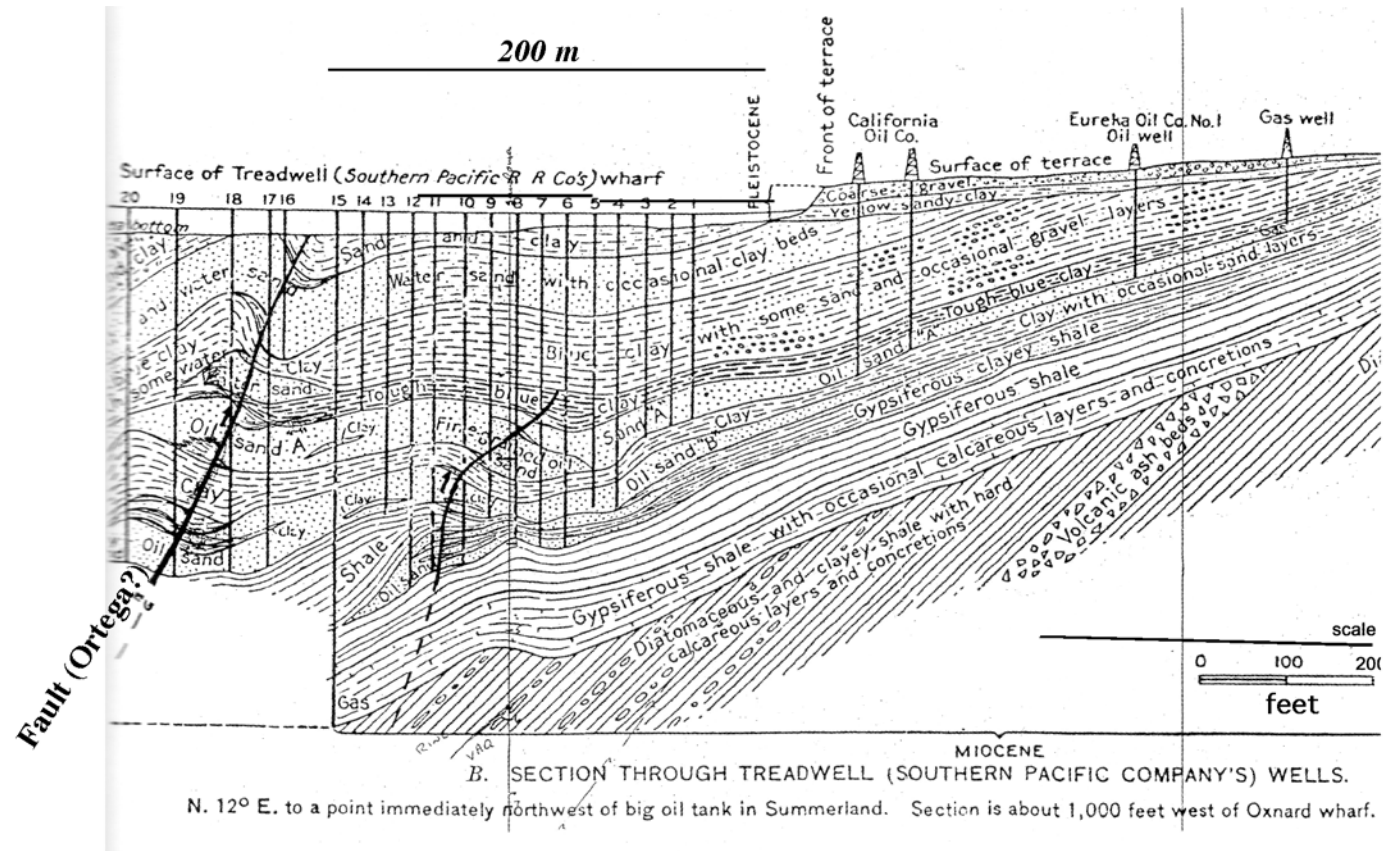
Treadwell Pier Cross-section

from Grosbard (2002)

**Trends show Treadwell T-10 was drilled
into a fault**

- Geologic data indicates a fault passes through the Treadwell Pier
- Seep trend indicates a fault offshore Summerland - Proposed as the Ortega Fault
- The Proposed Ortega Fault passes through T-10 and likely other wells on the Treadwell Pier
