# **Integrity Management of Thums Cement Lined Pipelines**

## Thums Subsea Pipelines

#### Original Pipelines installed in 1966 Oil , Gas and Water (J-lines) Pipelines

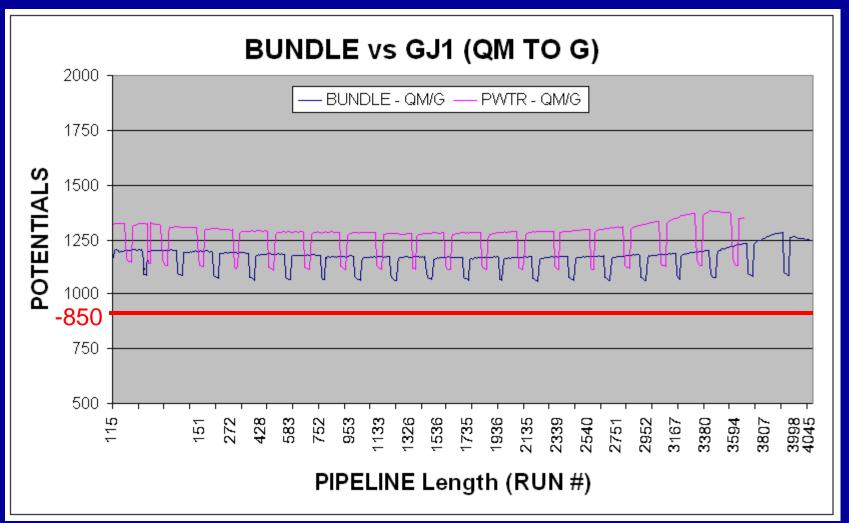
#### J-Line: CP Over-the-line Survey

- Generate a potential profile along the entire Pipeline Length
  - Test connection to the pipeline is onshore
  - A silver/silver chloride reference electrode is towed above the pipeline
  - Test connection is Maintained to the pipe by spooling out a light gauge insulated wire

- The pipe-to-electrolyte potential is measured
  - The polarized potential of the pipeline is measured by cycling rectifiers "ON" and "OFF"

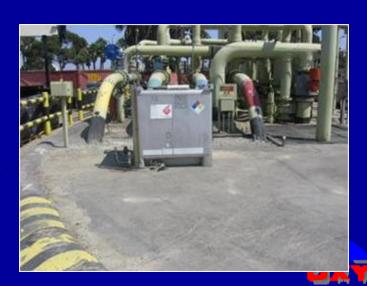
Heavy residual inhibitor concentrations from Islands

Pipelines also Treated Continuously with small dosage of Corrosion Inhibitor

Corrosion coupons analyzed to track deposit build-up that may affect Water Quality

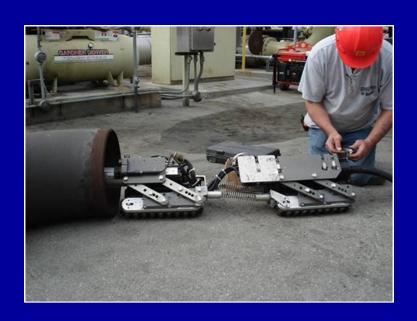
## **J-Line: Video Inspection Survey**

Pipeline is Internally Cement Coated

Pipelines not able to use UT Smart Pig or MFL Technology

Video Camera Technology will allow documented visual internal inspections

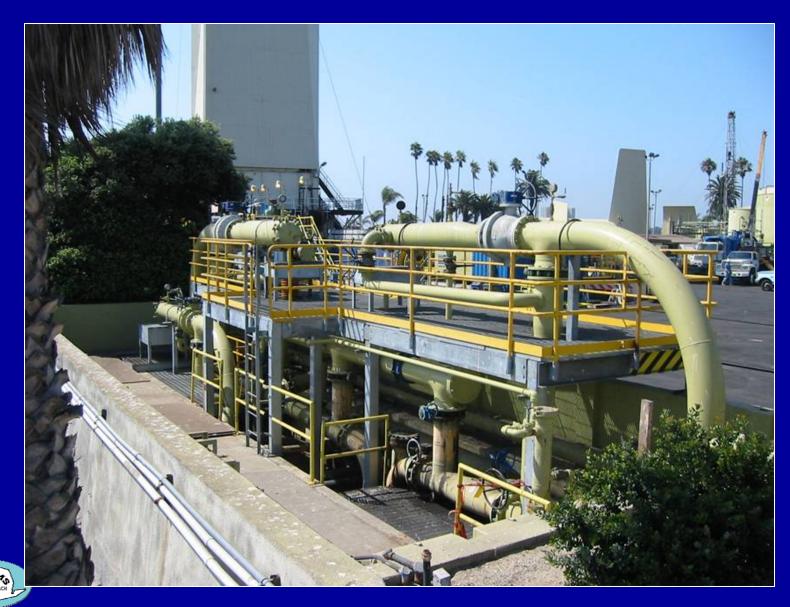
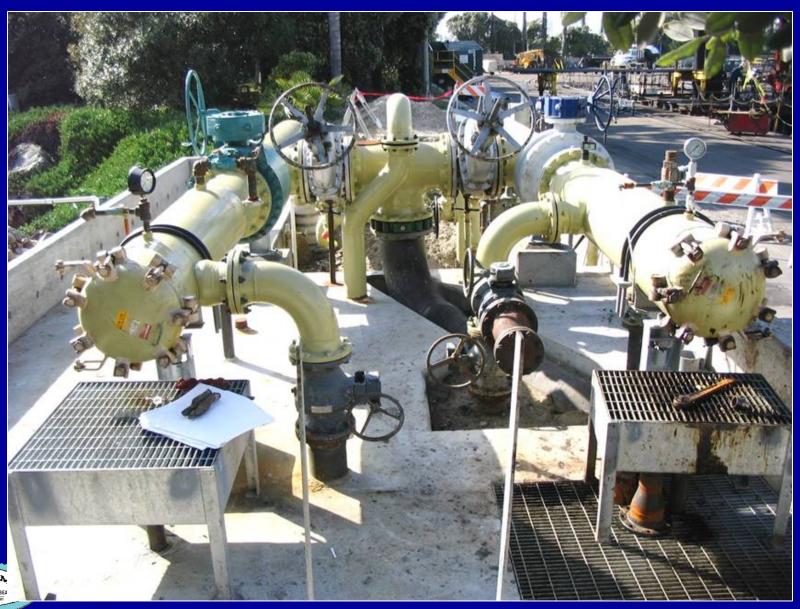
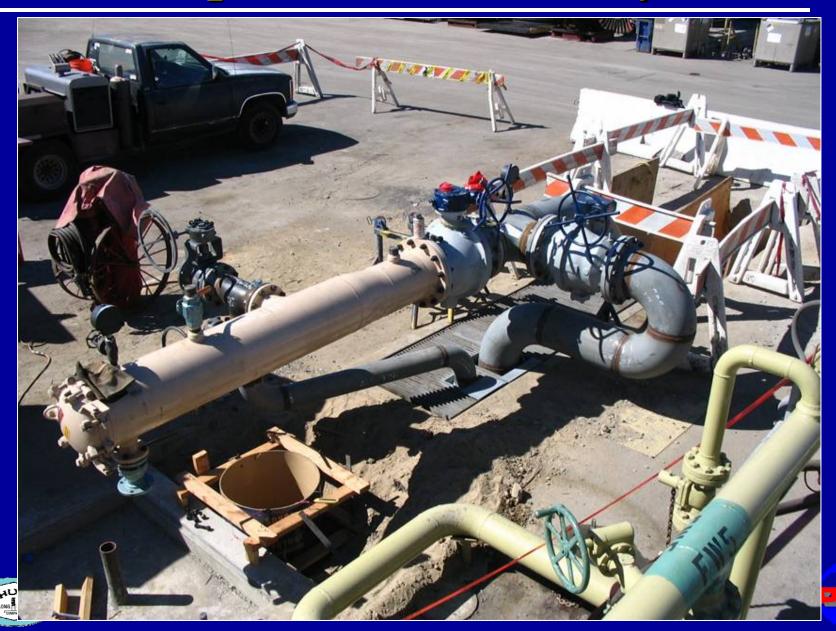
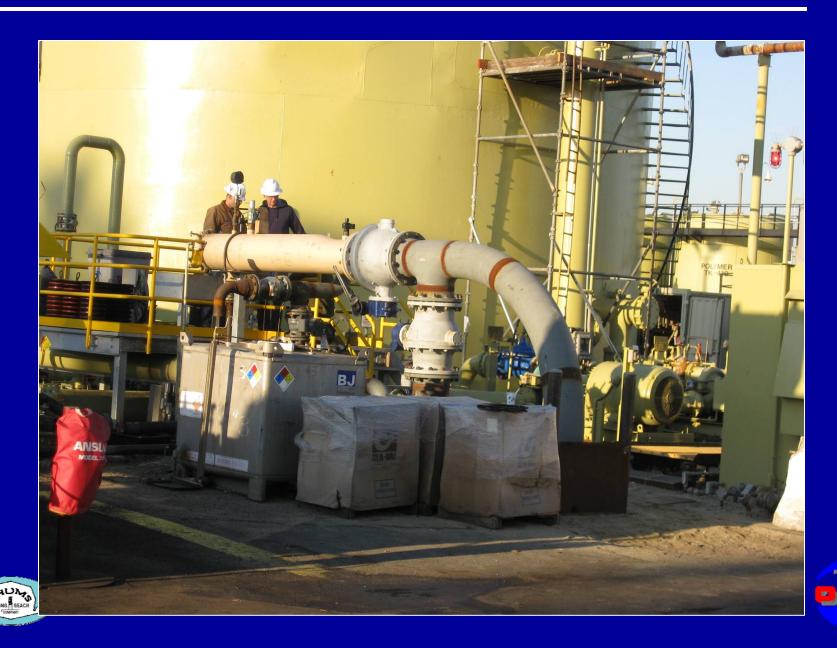
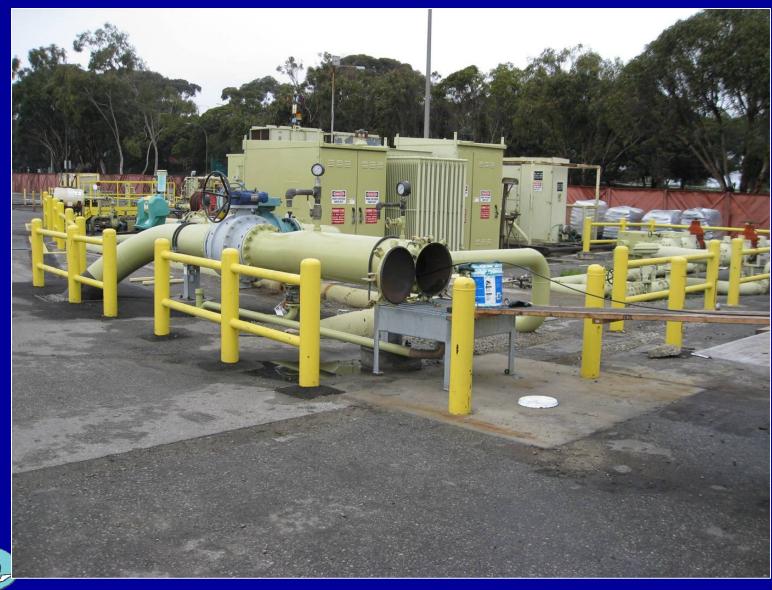
• Use of Crawler required installation of Pig Launchers / Receivers

- 2007/2008 Installed Launchers / Receivers
  - Allow for Cleaning of the Pipelines
  - Access for the Inspection Tool
- Project Cost was approx \$2.1MM

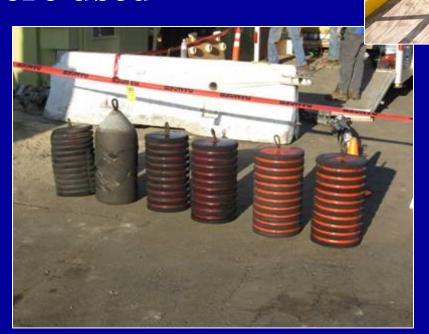
• Lines were Pigged to remove solids

• 5 & 8 lb Foam pigs were used

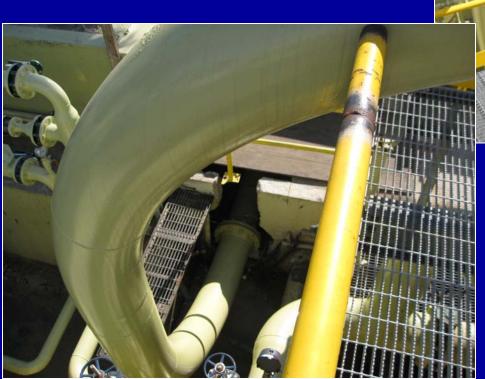
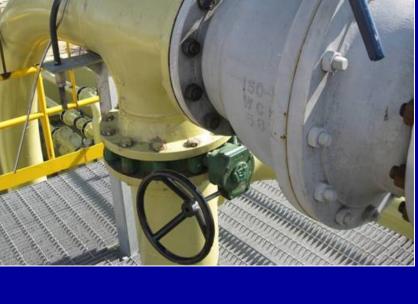
## Launcher / Receiver Piping Bends

- Initial Survey was in Water
- Lines then pigged to Nitrogen for Better Clarity
- Crawler Survey distance inhibited by
  - Condensation in Pipelines
  - Friction from the Tether line
- Problems with Crawler Orientation due to Piping Bends

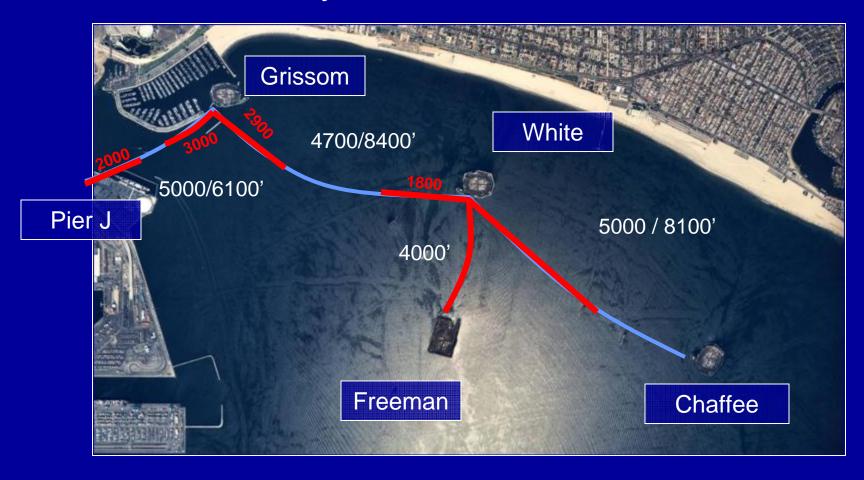
#### J-Line: Video Survey

#### Surveyed 70% of the J-lines

- Good Visual of the Pipeline Condition
- Internal Cement coating appears to be in good condition
- Good Weld Integrity
- Successful Hydrotest
