DEVELOPMENT AND EVALUATION OF A STEEL-COMPOSITE HYBRID COMPOSITE REPAIR SYSTEM

Chris Alexander
Stress Engineering Services, Inc.
Houston, Texas
chris.alexander@stress.com

Carl Brooks
Western Specialties
Avon, New York
cbrooks@westernspecialtiesllc.com

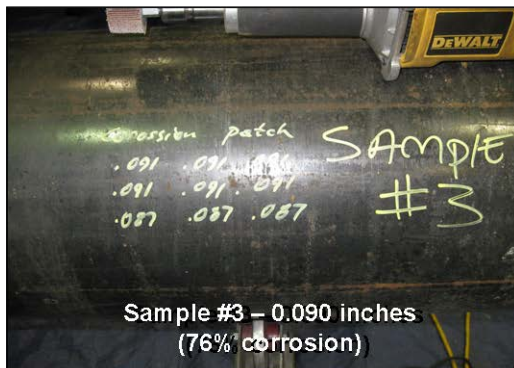
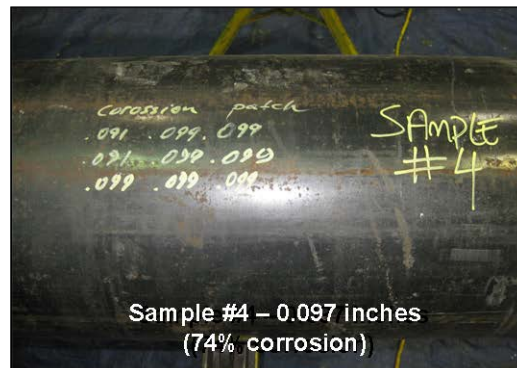
Figure 6– Photographs showing machined corrosion depths

Figures 6 through 10 provides a series of photographs showing actual measurements made after the machining was completed. The target machining depth was 75%, although as can be seen from these photographs, the machining depth averages ranged from 74% to 78% of the pipe's nominal wall thickness. After machining, end caps were welded to each sample. The samples were sandblasted to a near white metal finish (NACE 2) prior to installation of the repair system.

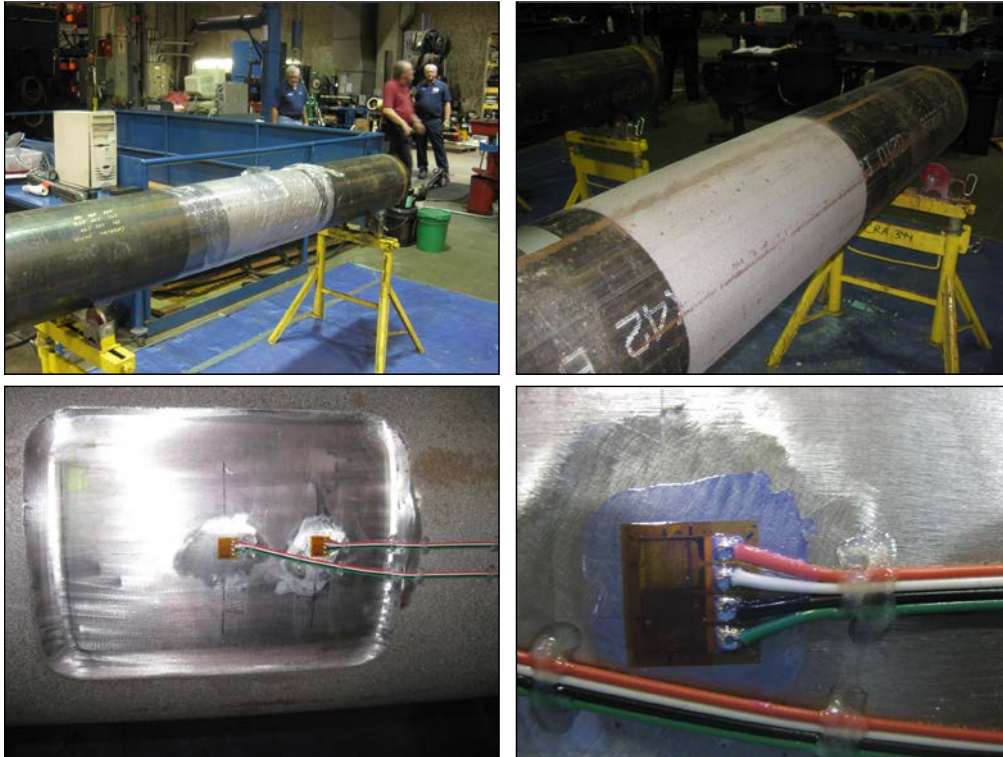
Figure 7 – Photographs of test sample preparation efforts (Set #1)

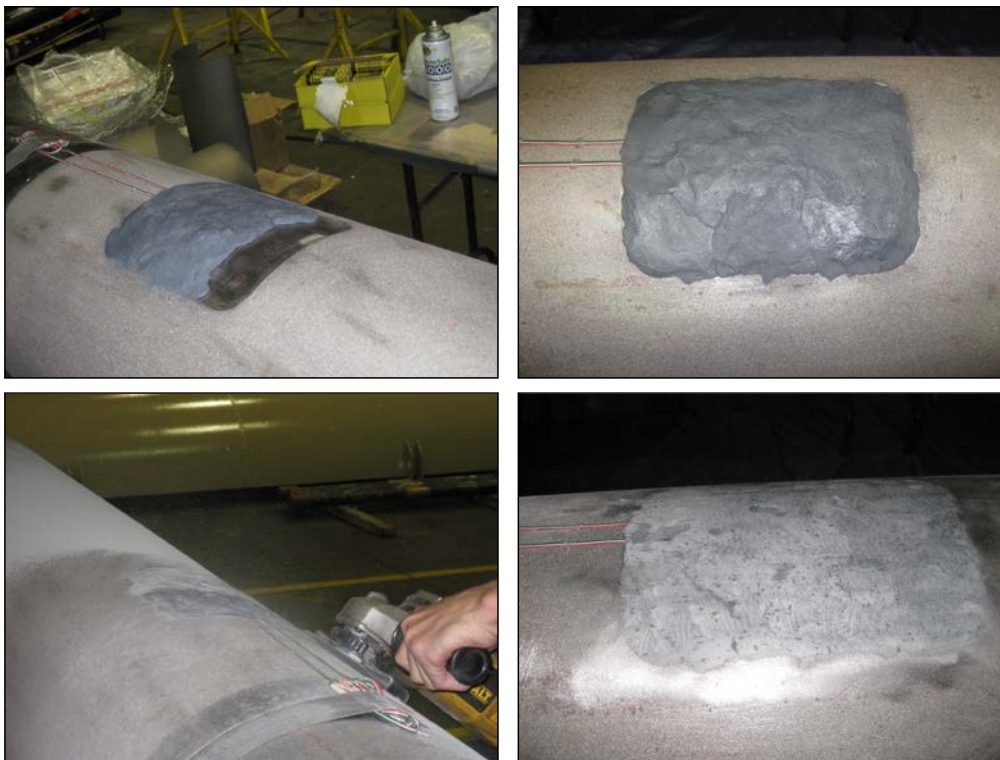
Figure 8 – Photographs of test sample preparation efforts (Set #2)

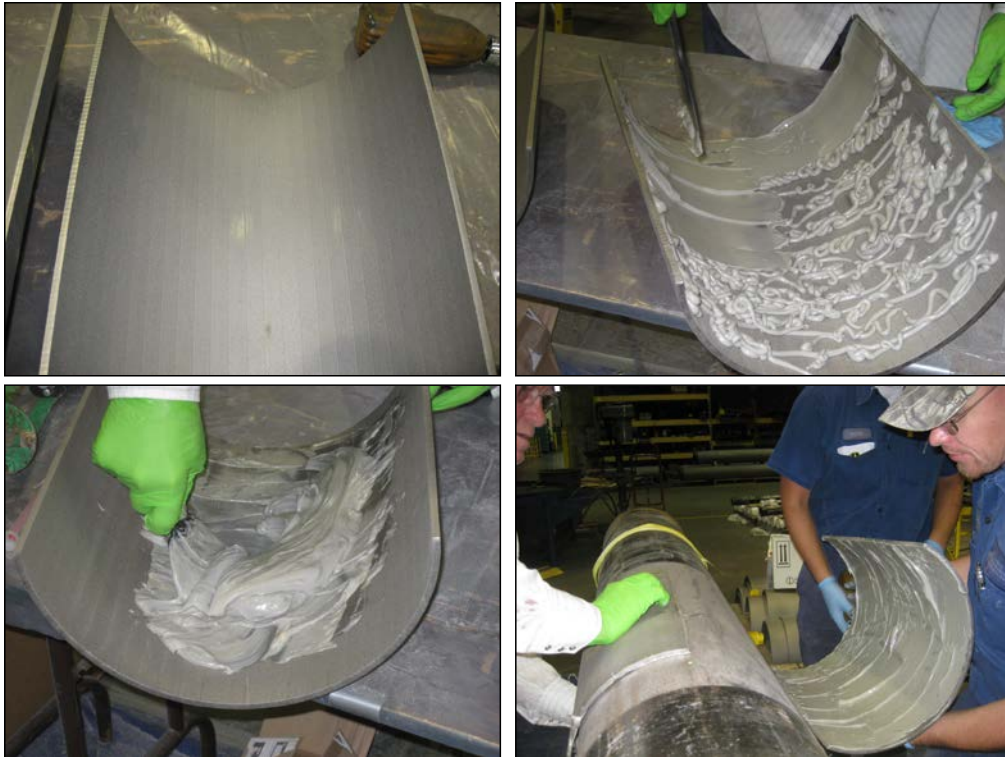
Figure 9 – Photographs of test sample preparation efforts (Set #3)

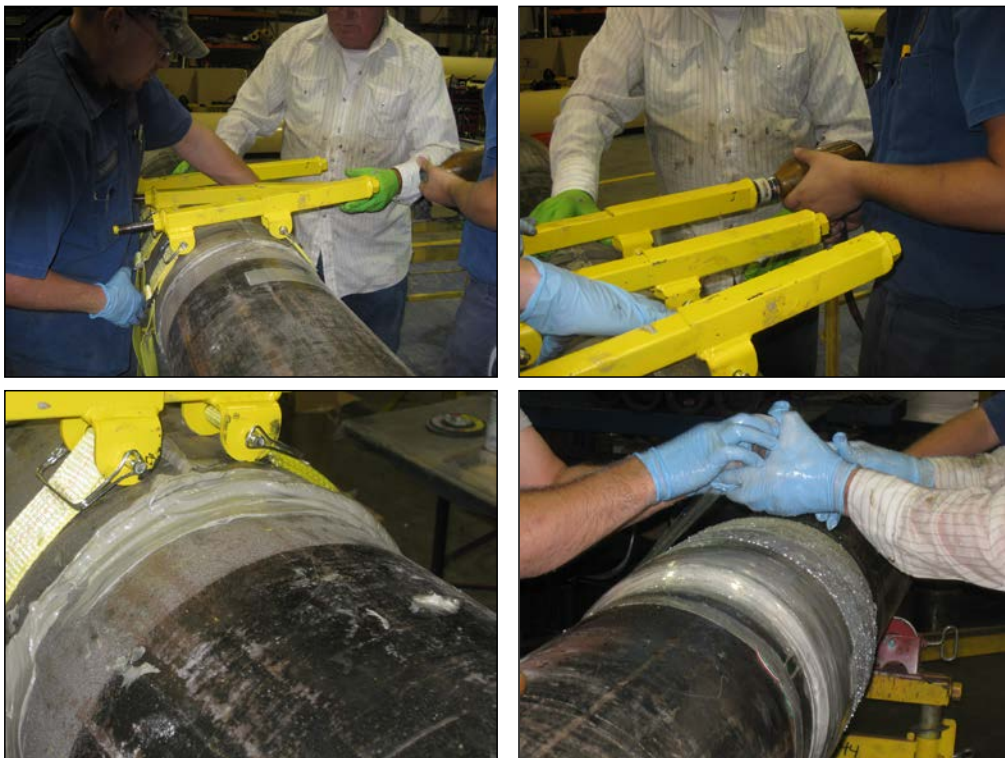
Figure 10 – Photographs of test sample preparation efforts (Set #4)

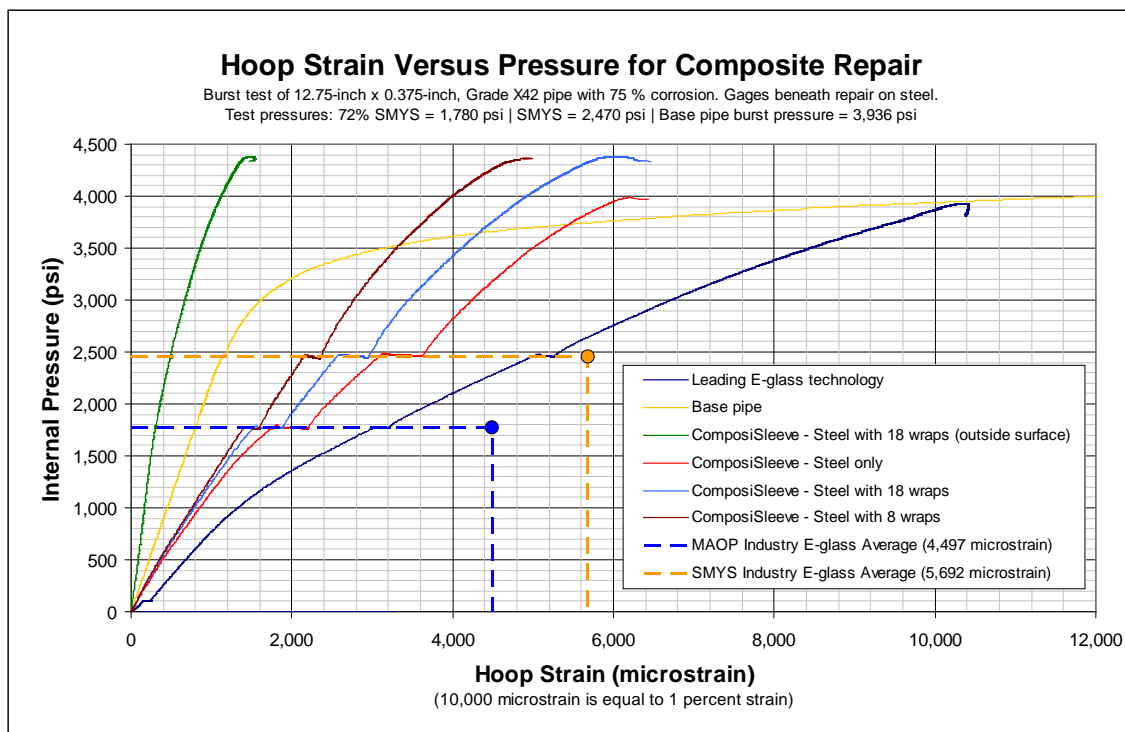
Figure 12 – Hoop strain measured as a function of internal pressure

SMYS (1,780 psi and 2,470 psi, respectively). Figure 12 plots hoop strain as a function of internal pressure. Results are included for the following data sets:

- Leading E-glass technology
- Base pipe (non-corroded section)
- Sample #1: Steel only
- Sample #2: Steel plus 18 wraps
- Sample #2: Steel plus 18 wraps (outside surface of repair)
- Sample #3: Steel plus 8 wraps
- Data point at 72% SMYS for Industry average for other competing E-glass systems¹
- Data point at 100% SMYS for Industry average for other competing E-glass systems¹

There are several observations made in viewing this plot; however, the most noteworthy point is the significant reduction in strain provided by the ComposiSleeve™ system when compared to other E-glass technologies. The large number of fatigue cycles acquired during the pressure cycle test is testimony to the appreciable level of performance (i.e. strain reduction) provided by the ComposiSleeve™ system.

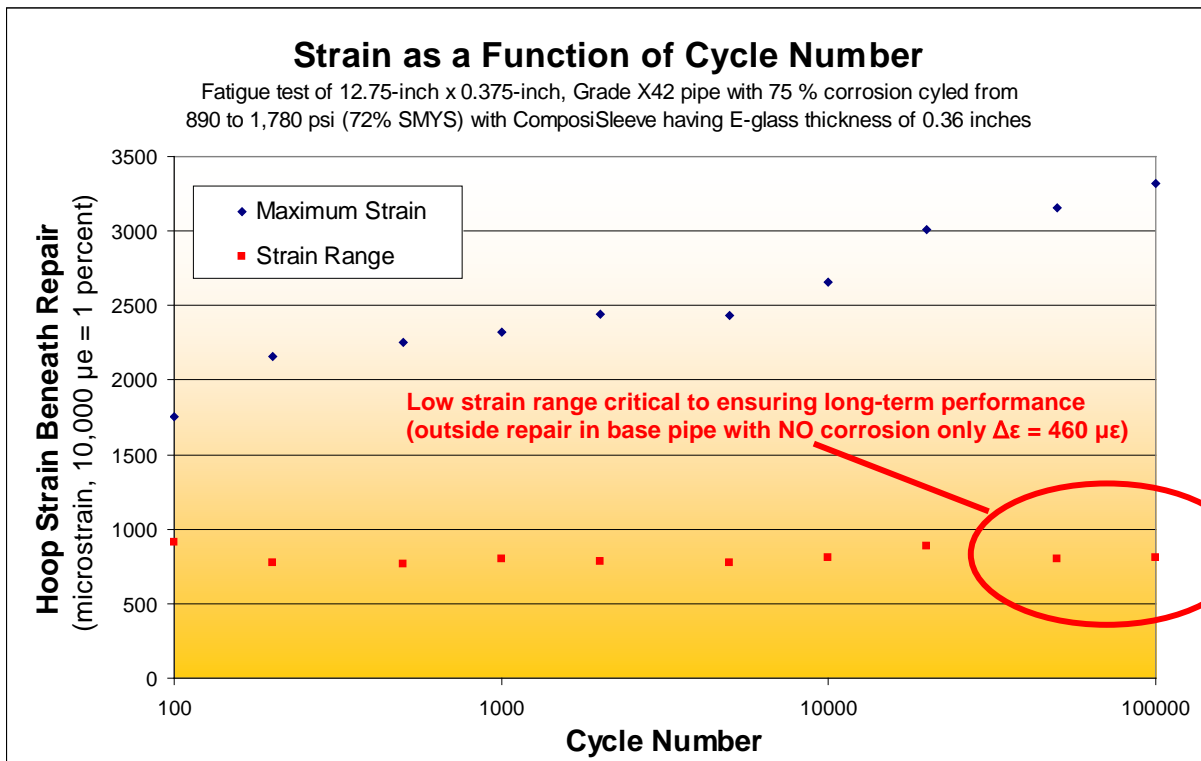
Figure 14 – Strain as a function of cycle number for 75% corroded sample

fatigue tested integrated strain gages installed in the corroded region beneath the repair. The strain gages measured hoop and axial strains at designated cycle periods during testing. Figure 14 plots the maximum hoop strain and hoop strain range for Gage #1 located beneath the repair up to 100,000 cycles, while Figure 15 lists hoop and axial strains at designated cycle periods. The strain range is the difference between the maximum and minimum strains.

In viewing the strain data from Figure 14 and Figure 15 there are several important observations. Note that the data plotted in Figure 14 is for Gage #1 located beneath the repair.

- The maximum measured strain beneath the repair (i.e. Gage #1) increased from 1,756 $\mu\epsilon$ at start-up to 3,318 $\mu\epsilon$ at 100,000 cycles. This is approximately a 90% increase over the designated cycle period.

- Over the 100,000 cycle recording period there was actually a decrease in the Gage #1 hoop strain range from 914 $\mu\epsilon$ at start-up to 810 $\mu\epsilon$ at 100,000 cycles. This represents a strain reduction on the order of 12%.

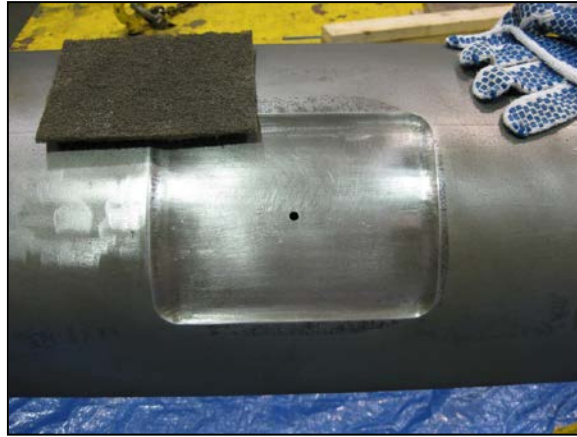
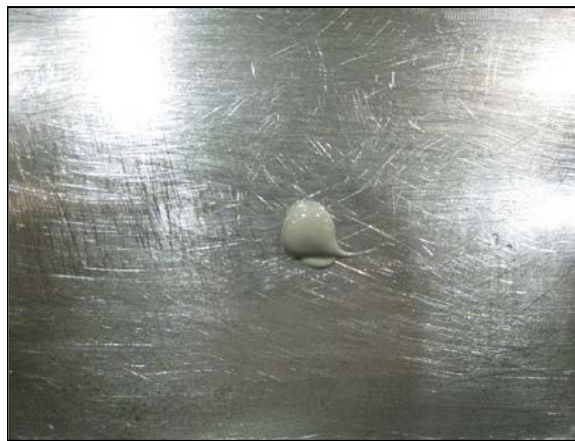
Figure 17 – Photographs of test sample having a thru-wall defect

In addition to the burst and pressure cycle tests, repairs were made on two (2) test samples, using 12.75-inch x 0.375-inch, Grade X42 pipe material, with each having a 60% deep corrosion defect. One of these test samples had a thru-wall hole (Sample #1). Prior to burst testing, each test sample was subjected to 22,503 pressure cycles from 890 psi to 1,780 psi, or from 50% to 100% of the maximum operating pressure (MAOP). After the pressure cycles, the samples were subjected to a static burst test. Sample #1 developed a noticeable leak at approximately 4,000 psi of internal pressure. The maximum pressure reached was 4,163 psi. Sample #1 did not burst due to a leak that developed at the high pressure condition. The leak occurred in the repaired region. Sample #2 burst in the base pipe away from the repair where the maximum pressure applied to the sample was 4,033 psi. Figure 17 provides two photographs of the thru-wall defect test sample prior to repair.
