Update of Pacific OCS Region Pipelines

Theresa Bell, Petroleum Engineer
Prevention First
Long Beach, Calif., October 2014

Bureau of Safety and Environmental Enforcement (BSEE)

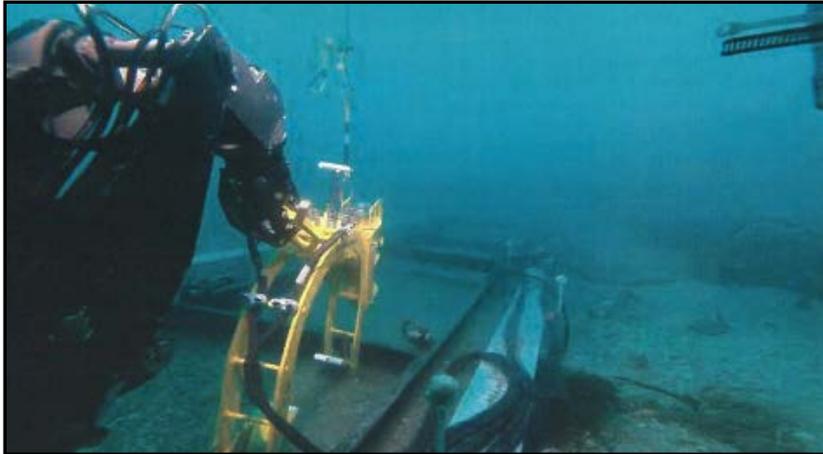
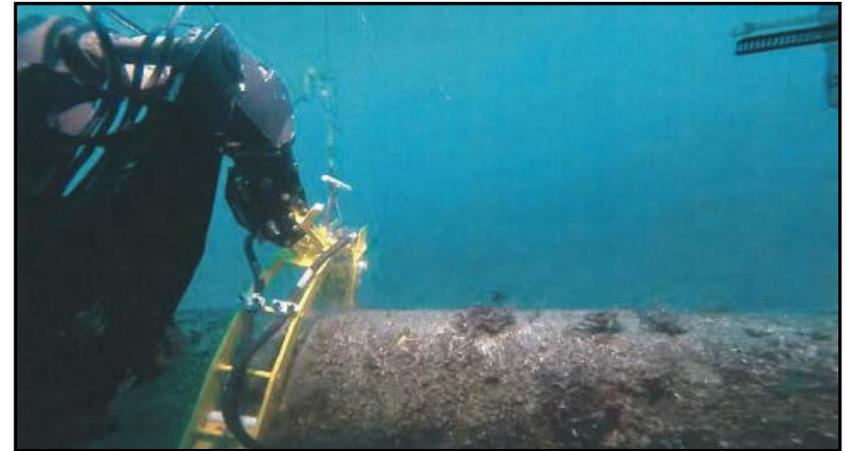
Beta – Cathodic Protection

- Inspection type: ROV and cathodic protection survey
- Problem identified: Platform Elly to shore oil pipeline historically has low cathodic protection readings; less negative than required

- Install 5 test points for future readings,
2 anode sleds, and 4 articulated mats

- All installed except for the 5th test point (in
Long Beach Harbor), due to depth of cover

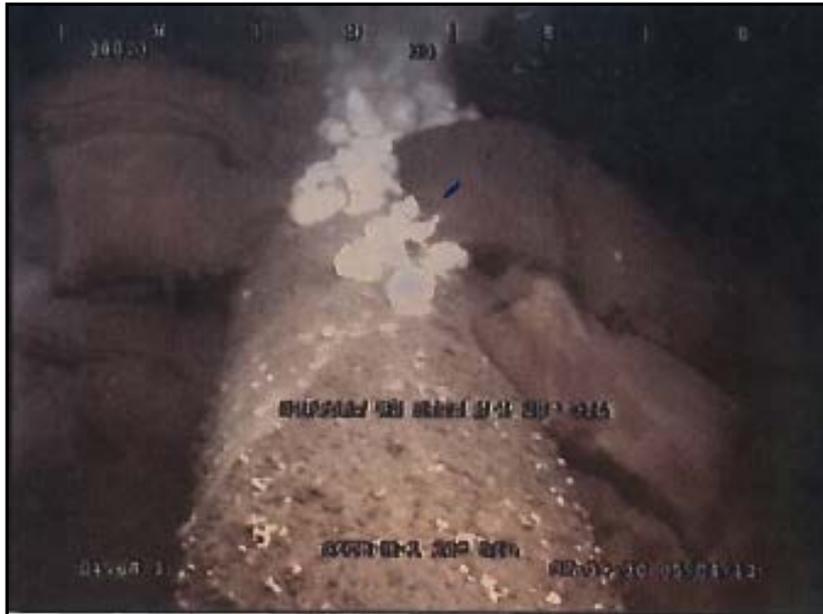
Santa Ynez Unit – Span Remediation

- Inspection type: ROV survey
- Problem identified: Multiple pipelines with excessive span lengths

Site ID	Pipeline	Reported Span Length (Feet)	Surveyed Span Length (Feet)
M-1	20" Oil	173	169
M-2	12" Water	163	195 *
M-3	12" Water	192	147
M-4	20" Oil	113	114
M-5	12" Gas	149	96 **
M-6	12" Gas	193	94

- Solution:
Setting concrete in burlap bags at predetermined locations under and along the pipelines

Site ID	Pipeline	Remediation
M-1	20" Oil	3 span supports (up to 10" of water under pipeline)
M-2	12" Water	3 span supports (up to 8" of water under pipeline)
M-3	12" Water	4 span supports (up to 12" of water under pipeline)
M-4	20" Oil	3 span supports (up to 10" of water under pipeline)
M-5	12" Gas	4 span supports (up to 18" of water under pipeline)
M-6	12" Gas	3 span supports (up to 12" of water under pipeline)

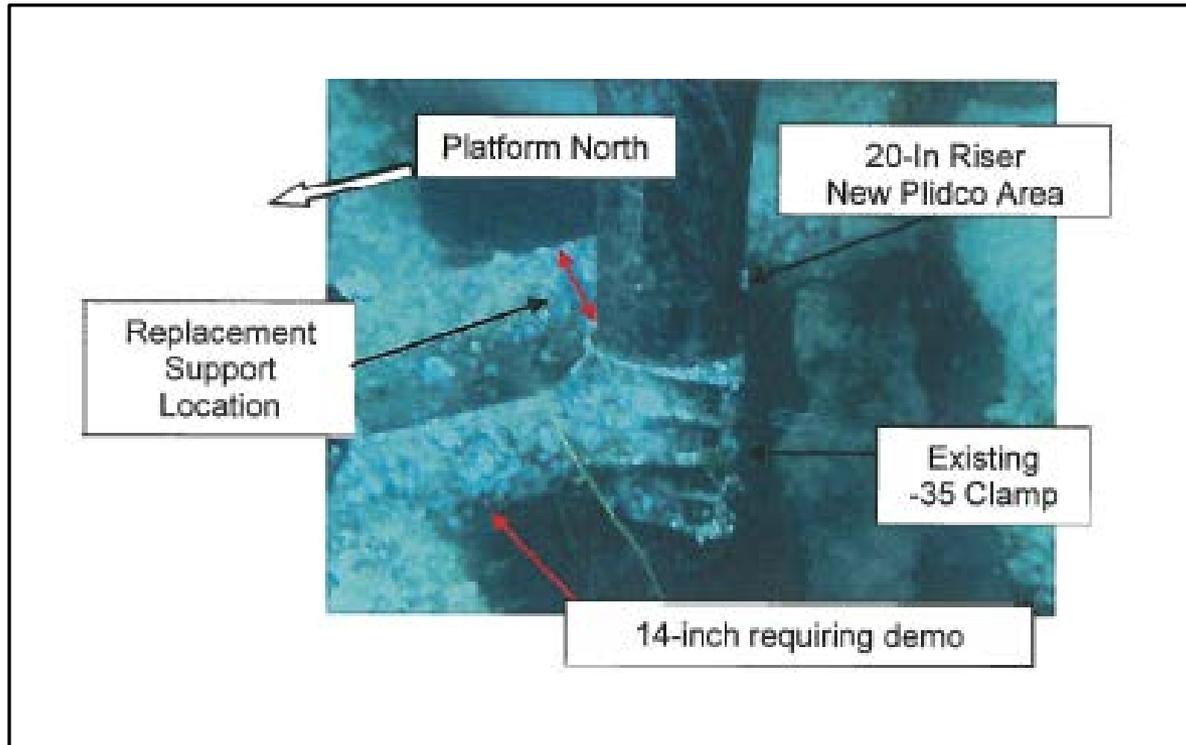
Irene – Pipeline Repair

- Inspection type: Internal inspection (smart pig)
- Problem identified: Wall loss on Irene oil pipeline riser at -35 feet

Results of Irene Riser Oil Emulsion Pipeline Inspections		
Year	Type of Inspection	Wall Loss
2004	Smart Pig	45%
2004	UT/ Pit Gauge	40%
2005	Smart Pig	40%
2006	Smart Pig	40%
2007	Smart Pig	32%
2008	Smart Pig	41%
2009	Smart Pig	49%
2010	UT/ Pit Gauge	41%
2010	Smart Pig	47%
2011	Smart Pig	36%
2012	Smart Pig	54%

- Solution:
Relocate riser support clamp and install full encirclement clamp over wall loss
