## **Appendix B**

### **Underwater Inspection Report**

**Port Costa Underwater Inspection**

**March 19-21, 2013**

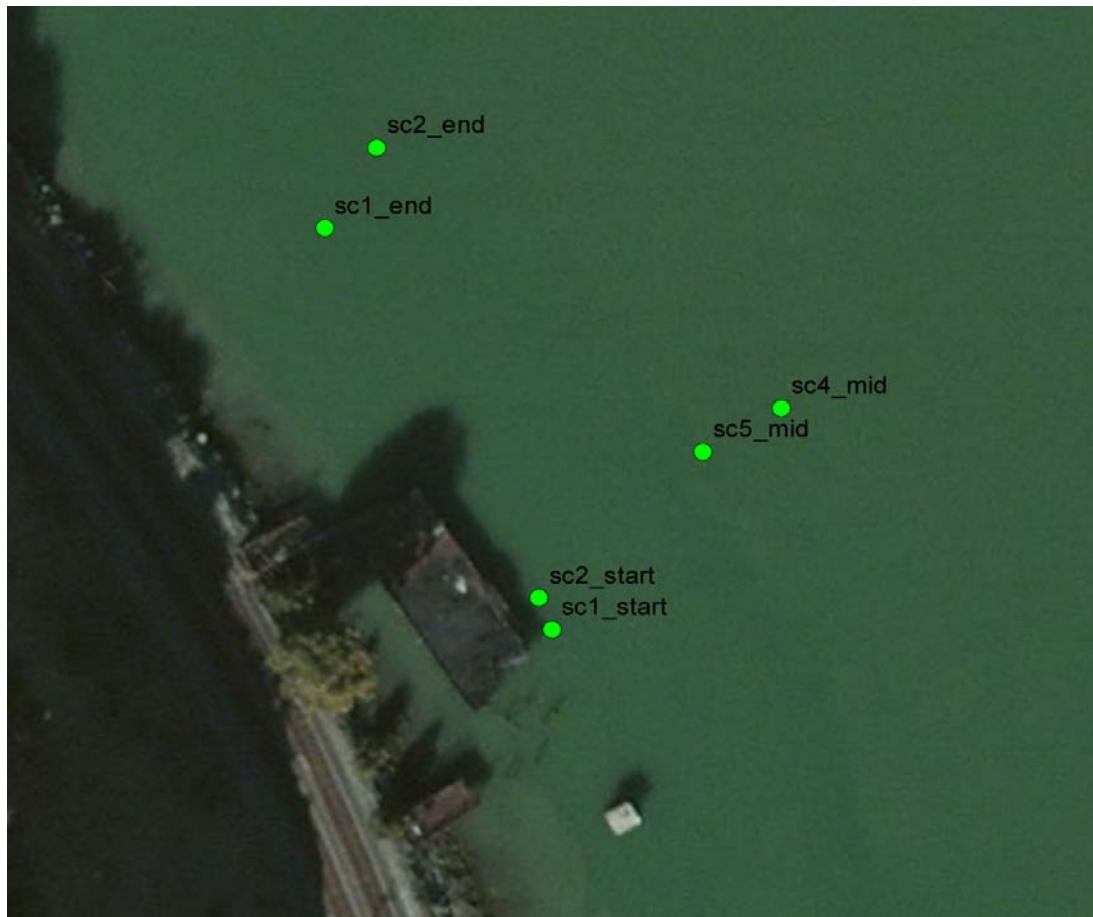
North Coast Divers was contracted to provide a support vessel and dive crew to determine the exact nature of four sonar contacts, and obtain information that would be useful for future removal of the objects. The objects were designated SC-1, SC-2, SC-3 and SC-4, with locations that ranged from near the face of the main wharf, to about 175 feet offshore. Water depth at the offshore contact was approximately 95 feet. The image below shows the submerged object locations per the 2012 sonar survey.

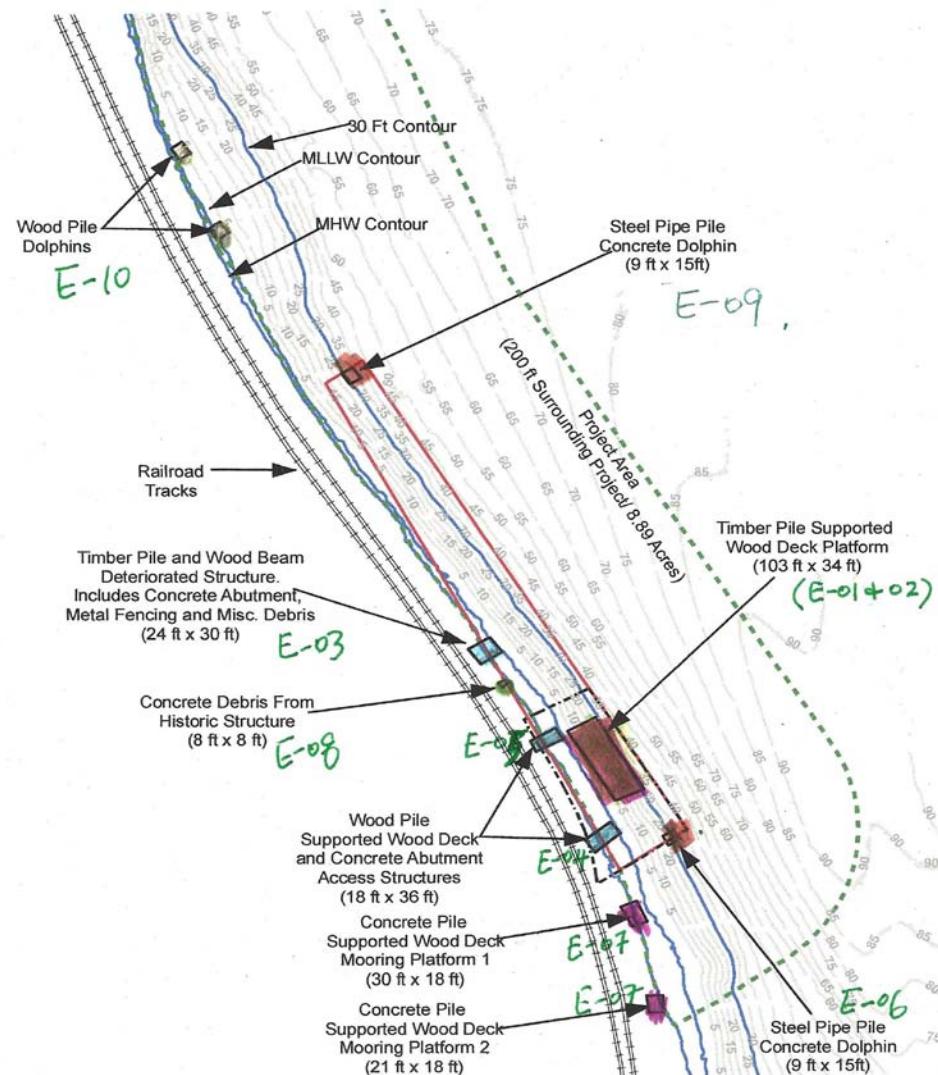
The annotated drawing below (provided by AECOM) shows the structure designations for each location. The intent of the inspection was not a detailed report of each piling, for which access was not permitted in any case, but focused instead on information that may be useful when planning future demolition and disposal. The findings are in general conformity throughout the survey area in terms of typical pile and bottom conditions. These are described below for each location, beginning at the northern end of the project area.
