Huntington Beach Platform Emmy Structural Analysis

Michael Williams P.E. | Mechanical Integrity Engineering Lead

Platform Emmy History

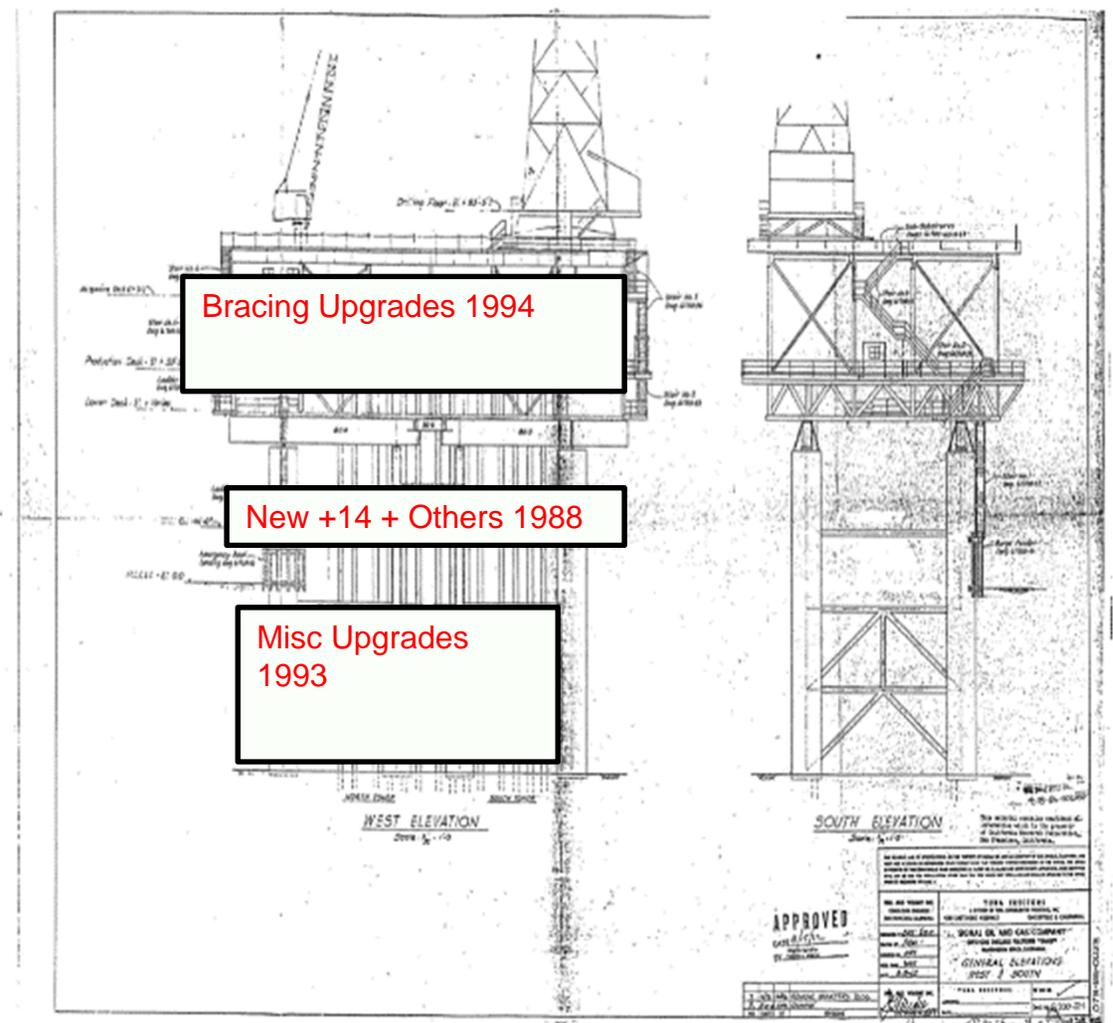
Original 1961 Construction Drawing

Platform Emmy was built in 1961 by Signal Oil and Gas.

1988 added additional cross member level

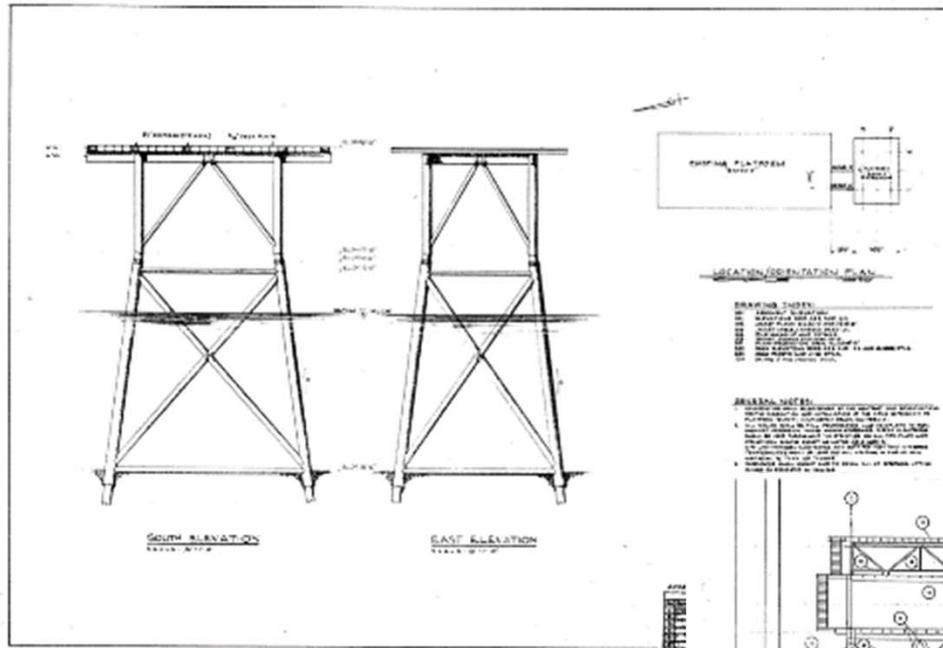
PLATFORM EMMY SATELLITE PLATFORM

1980

1989

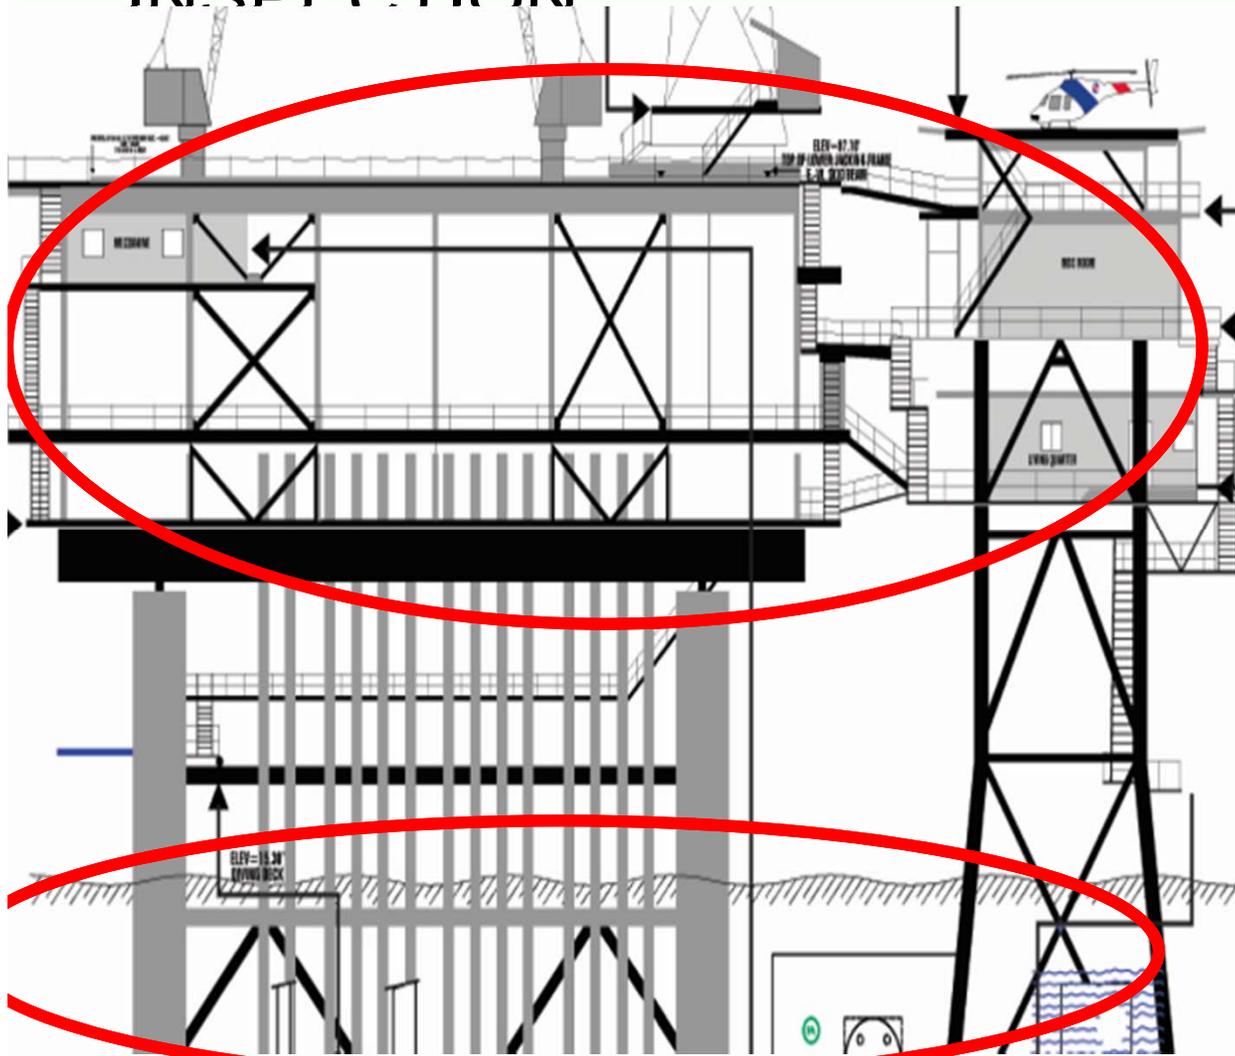
- Level I: Topsides survey

- Level II: General underwater visual inspection
- Level III: Underwater Visual inspection of pre-selected areas
- Level IV: Underwater non-destructive examination of pre-selected areas

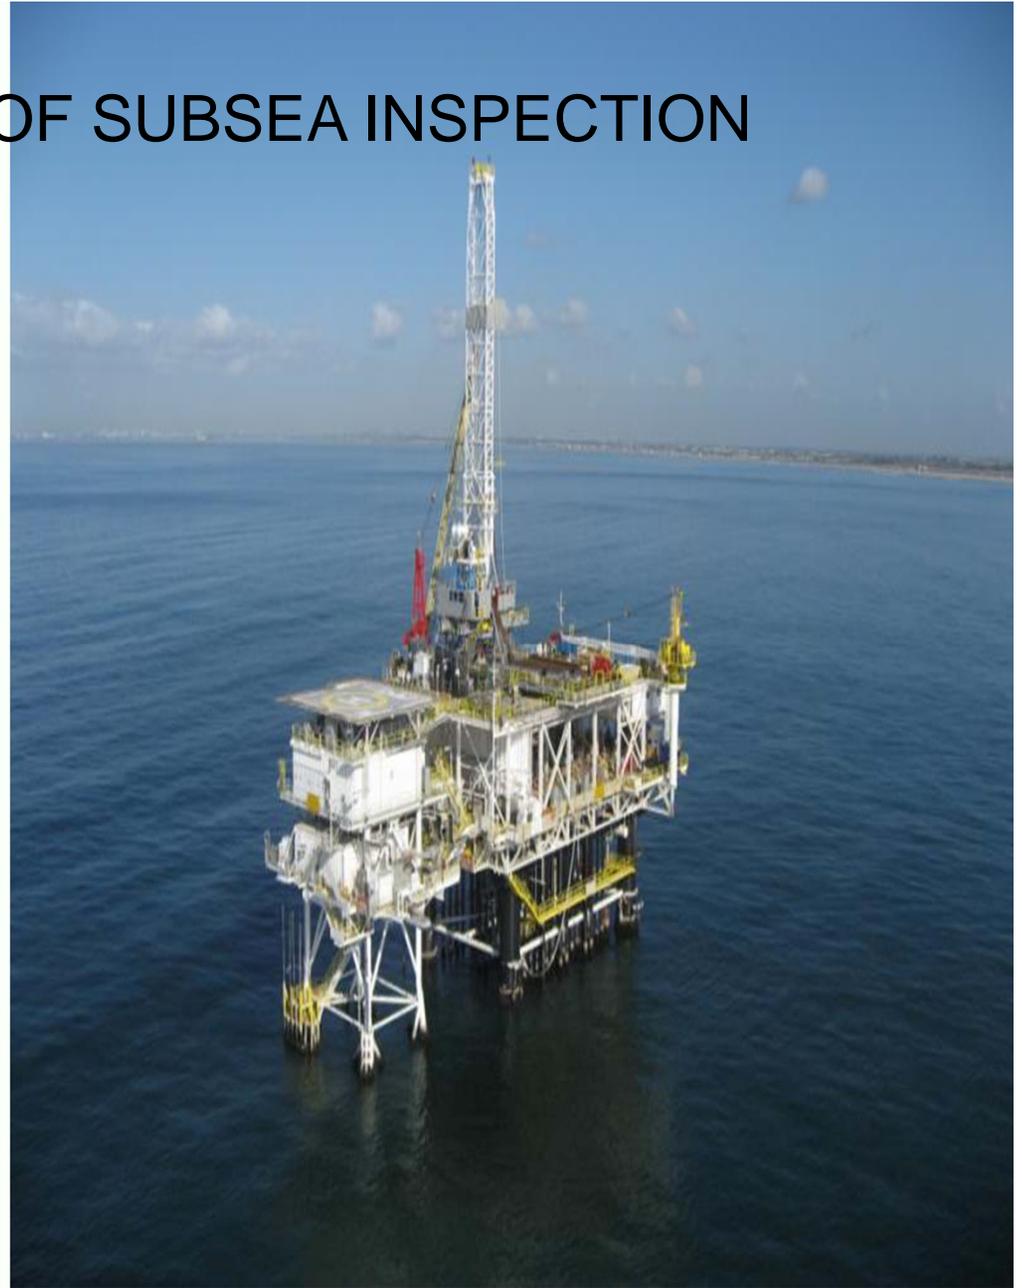
AQUEOS EXCELLENCE IN OILFIELD SOLUTIONS		Weld Mag Particle Survey #4				Job Number: 13-013	
Structure Name		Area		Block		Date: 05/28/13	
Pit Emmy		PRC		425		Inspection Level: API Level IV	
Name		Operator		Inspector (1)		Inspector (2)	
Huntington Beach		Oxy		MT Performed?		DVD Number	
Location		B3 -23 HD TO		C3.5		-23	
B3 NODE		Barr		YES		MAG 01	
Member Diameter		Weld Geometry		Overall Condition		Estimated Loss of Definition	
12"		Flat		Fair		0-25%	
General Corrosion		MUC					
W,N or M Clock Comment: (Defect, L x W x D, additional details)							
W,N & M		12:00		Slight Loss of weld definition. MUC throughout.			
M		12:30		Hole like indication in toe of weld 1/8" diameter			
W,N & M		1:00		Slight Loss of weld definition. MUC throughout.			
W		2:00		Flat weld			
N & M		3:30		LUC to MUC throughout.			
W,N & M		6:00		Slight Loss of weld definition, 3 Stringer Cap pass, Flat weld.			
W,N & M		6:30		Slight Loss of weld definition, 3 Stringer Cap pass, Flat weld.

W,N & M		7:00		Slight Loss of weld definition, 3 Stringer Cap pass, Flat weld.			
W,N & M		9:30		Slight Loss of weld definition. MUC throughout.			
W,N & M		10:00		Slight Loss of weld definition. MUC throughout.			
W,N & M		11:00		Slight Loss of weld definition. MUC throughout.			
Photo/Sketch:							
<div style="display: flex; justify-content: space-between;"> 12:00 3:00 6:00 9:00 12:00 </div> <p>LEG</p> <p>MEMBER</p>							
Comments							
<ol style="list-style-type: none"> 1. No previous inspection report 2. Hole type indication in toe of weld 1/8" diameter

- Platform Emmy is required to have the Level II, III & IV inspections on a 5 year cycle.
- Engineering evaluation requires detailed understanding of the past findings, inspection history, and structural analyses in order to choose the correct joints and inspection techniques
- Platform Emmy has 5000+ pages of historical analysis documentation mostly in narrative form.
