**INITIAL STUDY/MITIGATED NEGATIVE DECLARATION  
SANTA BARBARA CHANNEL  
COASTAL HAZARDS REMOVAL PROJECT  
SANTA BARBARA COUNTY AND VENTURA COUNTY  
CALIFORNIA**

**California State Lands Commission**  
100 Howe Avenue, Suite 100 South  
Sacramento, CA 95825-8202  
Contact: Mr. Eric Gillies  
(916) 574-1897

**Padre Associates, Inc.**  
5951 Encina Road, Suite 209  
Goleta, CA 93117  
Contact: Simon A. Poulter  
805-683-1233

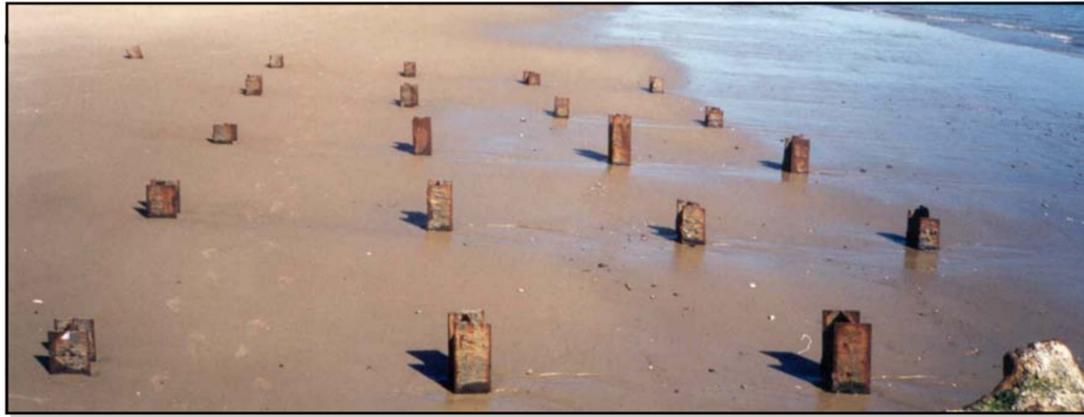
Steel H Piles and H Beams

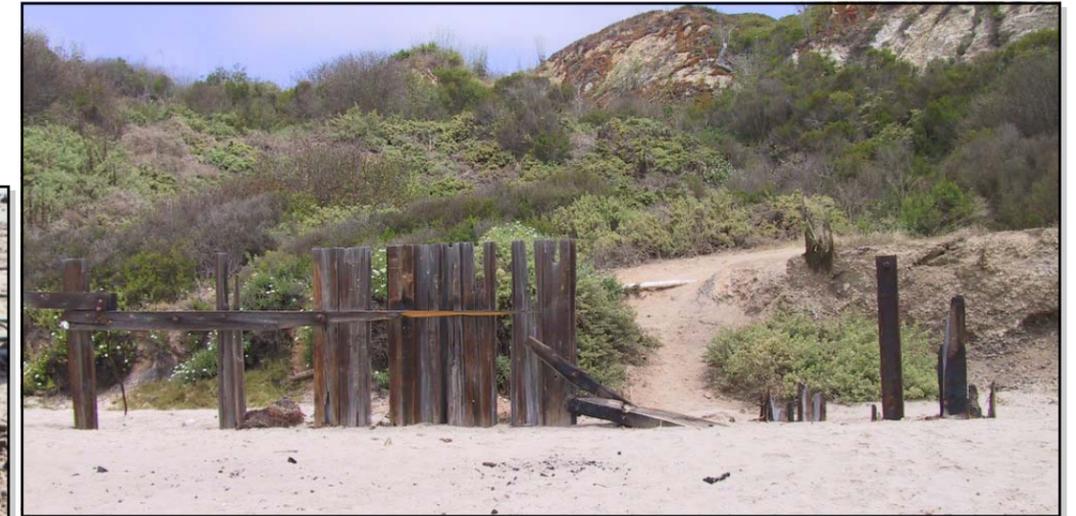
Sheet Pilings

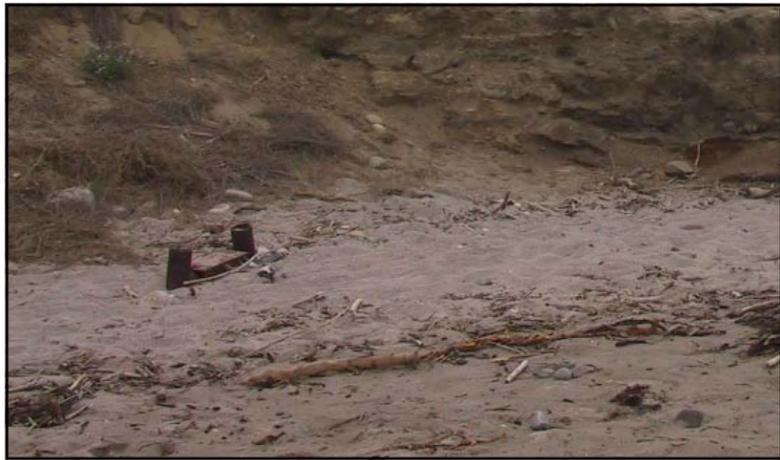
Steel Pile or Pipe Frames

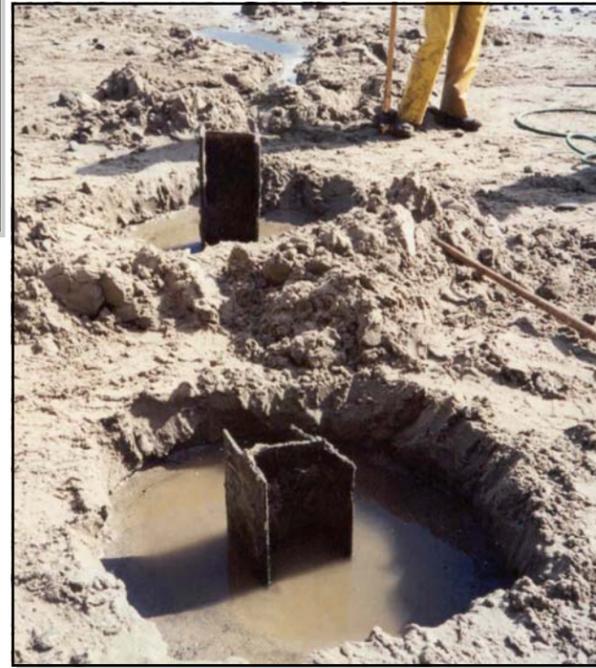
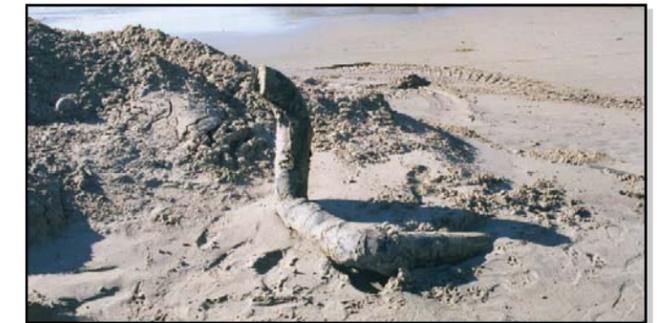
Pipeline Segment

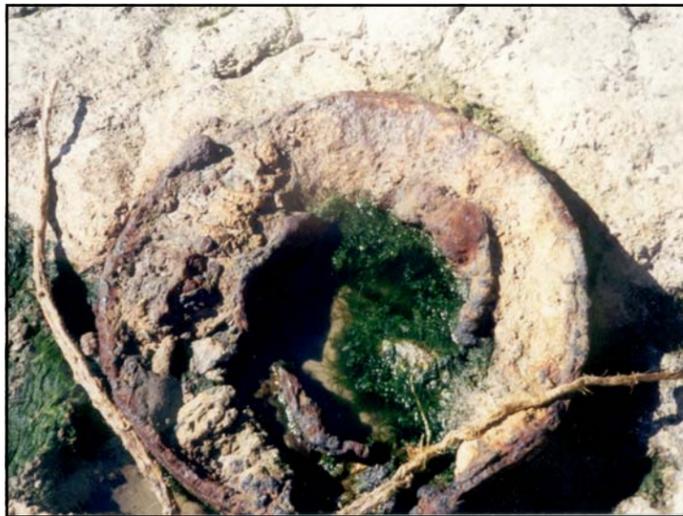
Well Casing

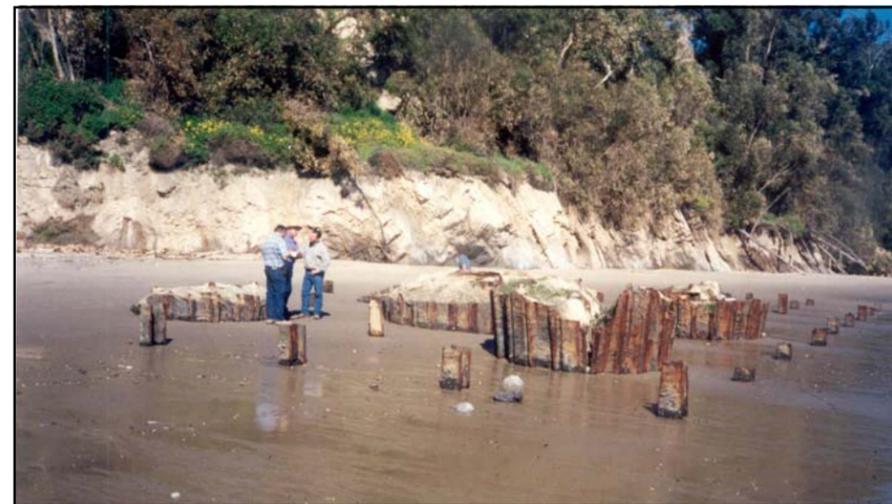
Well Caissons and H Beams

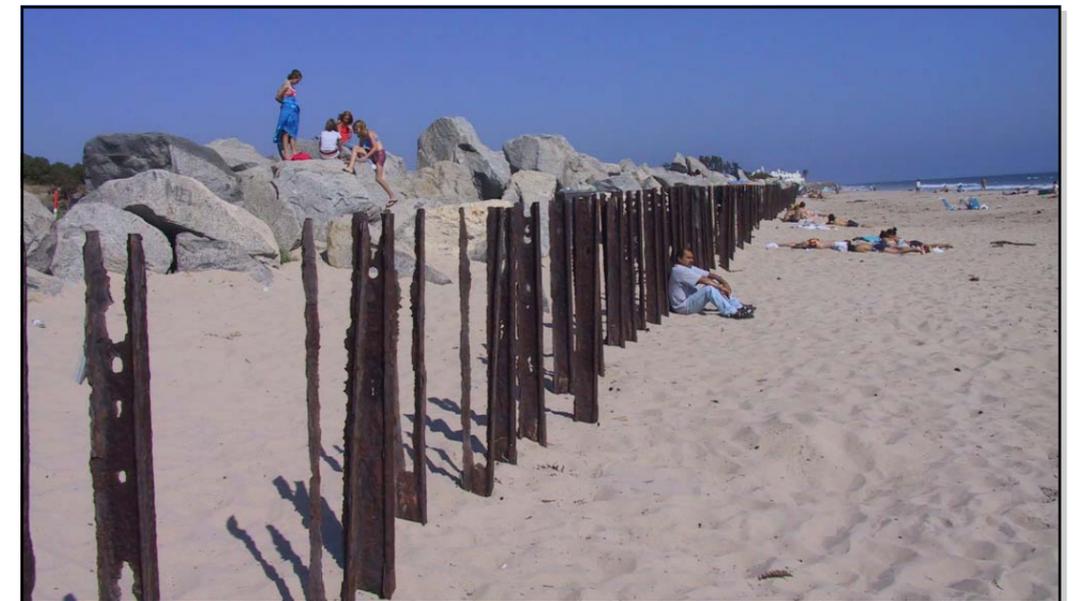
Railroad Irons

**Site No. 1 (Tajiguas Creek)** - Site No.1 is located in close proximity to the mouth of Tajiguas Creek, approximately 8-10 feet seaward of the sea wall. The hazards at the site consist of 30 railroad irons that stick out about 1-2 feet above ground, and are spaced approximately 10-15 feet apart. During removal activities, the staging area would be located on private property near the project site. The project site will be accessed through private property via Arroyo Cuemada. Some coordination with Union Pacific Railroad may be necessary prior to removal of this hazard.

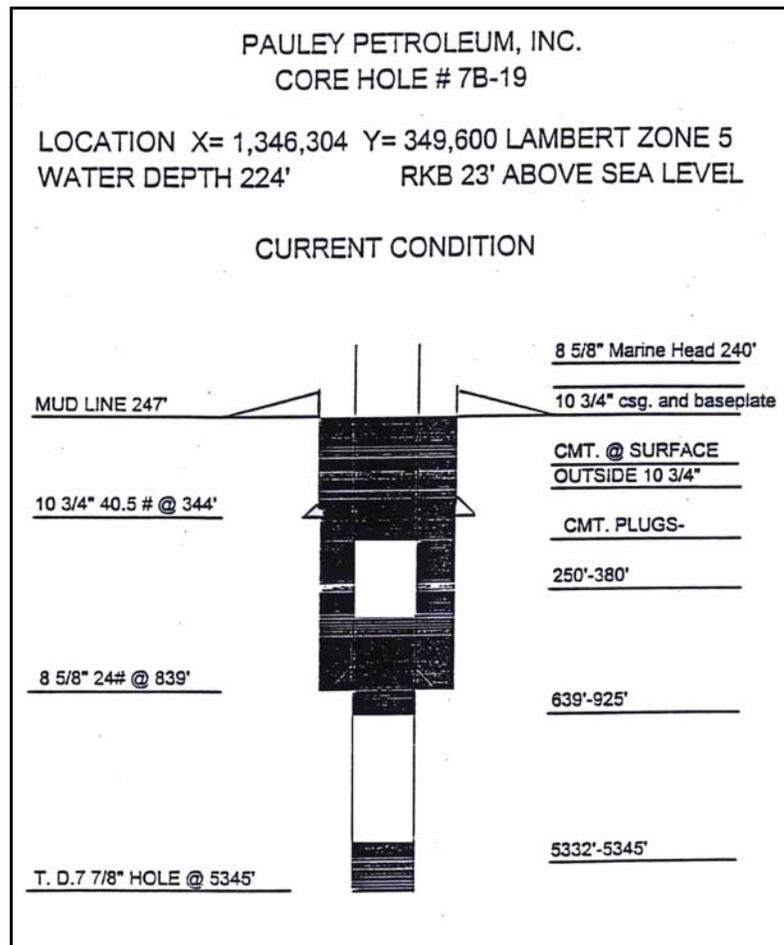
**Figure 1-3. Cross section of Pauley wellhead**

**Deep Offshore Wellhead.** A deep offshore wellhead would extend from the well to the surface, with the head being the top of the well. Hazard Site No.24 involves the removal of the abandoned Pauley wellhead, a deep offshore wellhead or marine riser; located 240 feet below mean sea level (see Figure 1-3).

**Site No. 24 (Pauley Well)** - Site No. 24 is located approximately 13,500 feet offshore from Gaviota on State Lease PRC-2920. The hazard to be removed is the abandoned offshore Pauley wellhead. Casing records for the well are: 10 ¾ " casing set at 344 feet, 8 5/8 " casing set at 839 feet and 7 7/8 " hole to a total depth of 5,345 feet. The well was abandoned by plugging it with cement from 5,332 feet to 5,345 feet, 639 feet to 925 feet, and 250 feet to 380 feet (all depths measured from RKB, which is 23 feet above sea level, with a water depth of 254 feet). The current conditions are depicted in Figure 1-3 (cross section of Pauley wellhead). There is no staging area necessary for this project site. The offshore hazard will be accessed via boat deployed from Port Hueneme or the Santa Barbara Harbor.

**Methodology.** The deep offshore beach hazards consist of those hazards that will require deep diving operations. Deep diving operations will be required for the removal of the Pauley wellhead at Site No.24. Please refer to Figure 1-3, below, or Section 1.6 (Site Descriptions) for specifications of the Pauley well. The deep offshore wellhead will be removed following the methodology described below.

The work will be completed as follows (refer to Figure 1-3 for well specifications):

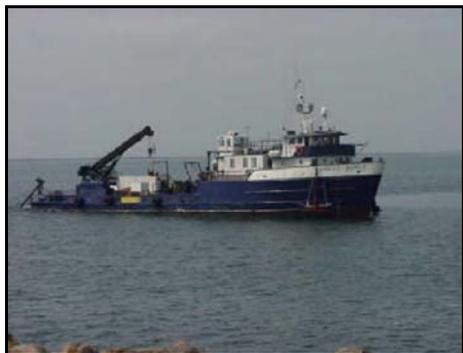
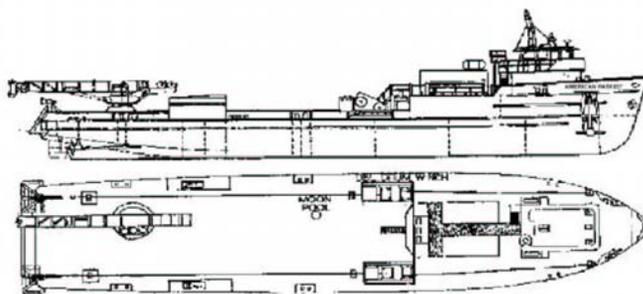
**M/V American Patriot:** 165' Construction Support Vessel

**Figure 1-4A. Work Vessel Diagrams and Specifications**

The hazard at Site No.24 will be removed using surface supplied mixed gas diving techniques from the 165' workboat the "*American Patriot*" or equivalent vessel (see Figure 1-4). The "*American Patriot*" is equipped with a 40-ton crane and four point mooring system. Survey and positioning services will be provided by Fugro West, Inc. Divecon will supply a deep surface supplied mixed gas diving system complete with wet bell, Hysub 10 or Phantom HD2+2 Remotely Operated Vehicle System (ROV), generators, jet pump, high pressure water blaster with zero-thrust gun, 400 amp welding machine, underwater burning lead, rigging, and offshore style debris dumpsters.

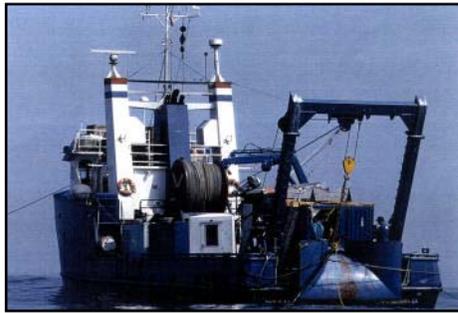
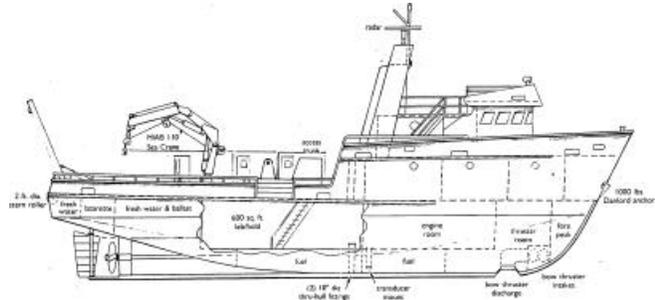
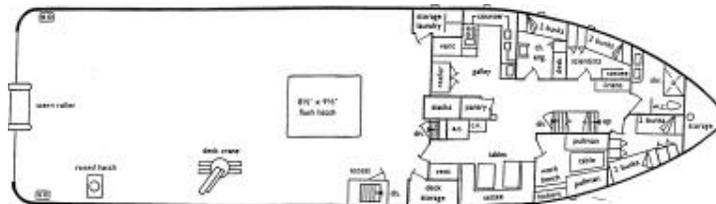
**R/V Wm. A. McGaw:** 106'3" Dive Support Vessel

Official No.: 678182  
 Call Sign: WSP 4965  
 Size & Class: 106 Single Screw  
 Home Port: Santa Barbara  
 ABS Classification: Load Line Certification  
 Hull Construction: Steel

**DIMENSIONS: MACHINERY:**  
 Tonnage: 243 Gross; 166 Net Main Engine: CAT D398TA; 850 HP @ 1225 RPM  
 Length: 106'3" Bow Thruster: White Fill 360 degree  
 Beam: 26' trainable, flush mounted  
 Depth: 13'4" Electrical Power: 2 CAT 3304 PCNA 40 KW  
 Draft: 12.5' max.; 10' average 208 VAC, 3 Phase generators  
 Work Deck: 25' x 50'  
 Equipment Hold: 600 sq. ft.; additional lab Hydraulic Power: 1-15 GPM @ 2000 PSI system with counter space 1-75GPM @ 2000 PSI system  
 Hatch: Oversized 8.5' x 9.5' Auxiliary Power: Detroit Diesel 12 V71, 325 HP  
 Through-Hull: Dual ten-inch through-hull  
 Fittings: Fittings

**Figure 1-4B. Work Vessel Diagrams and Specifications**

The 106' 3" dive support vessel "McGaw" or similar vessel will be employed for the shallow diving operations. The "McGaw" is equipped with mooring systems and a crane. Please refer to Figure 1-4 for specifications of the proposed work vessels.
