Hydrogen Sulfide and Pipeline Corrosion

Integrated Solution Set Addressing Unpiggable and Difficult Pipelines Through Modern Technology

Flexible Ultrasonic In-line Inspection

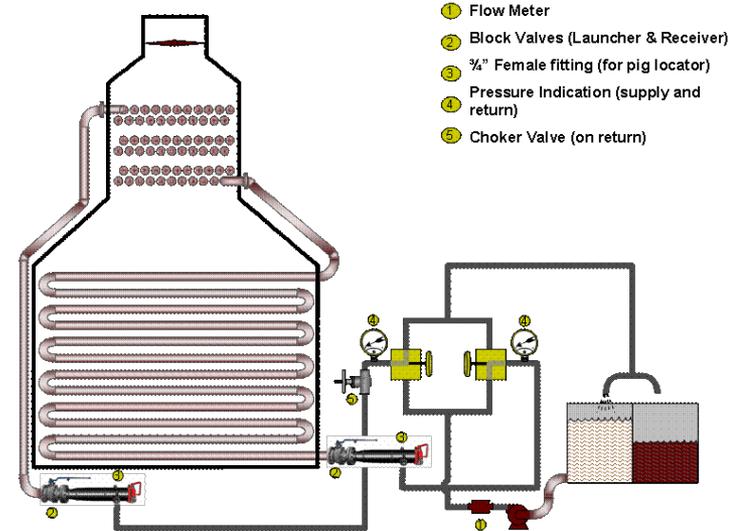
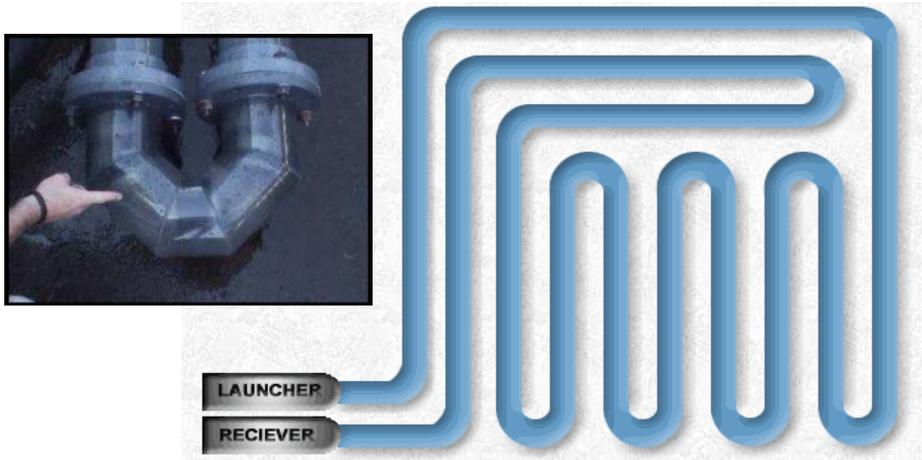
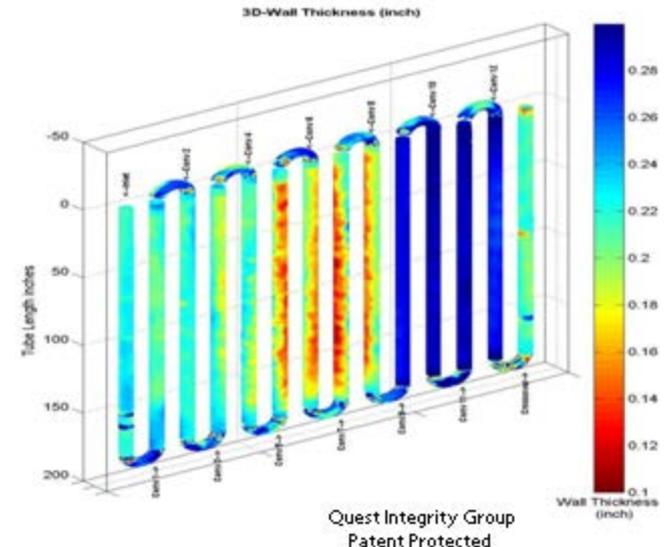
Free Swimming UT Furnace Tube Inspection System – designed to fully navigate short radius - 1D serpentine coils in both radiant and convection sections

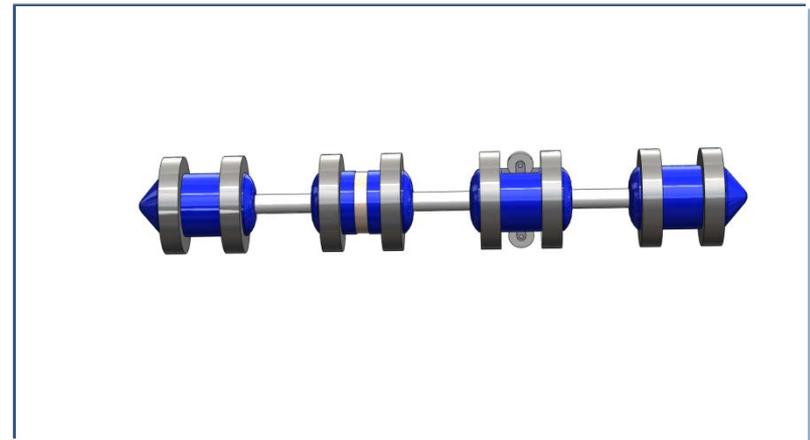
- Ultrasonic inline inspection of unpiggable and difficult pipelines 3" – 24" in diameter
- Combined absolute wall loss and full geometry dimensions in a single pass
- Circumferential, longitudinal and ID/OD location of defects with referencing
- High-density direct measurement ultrasonic technology provides accurate, repeatable results measured to 0.005" precision & 0.030" remaining wall

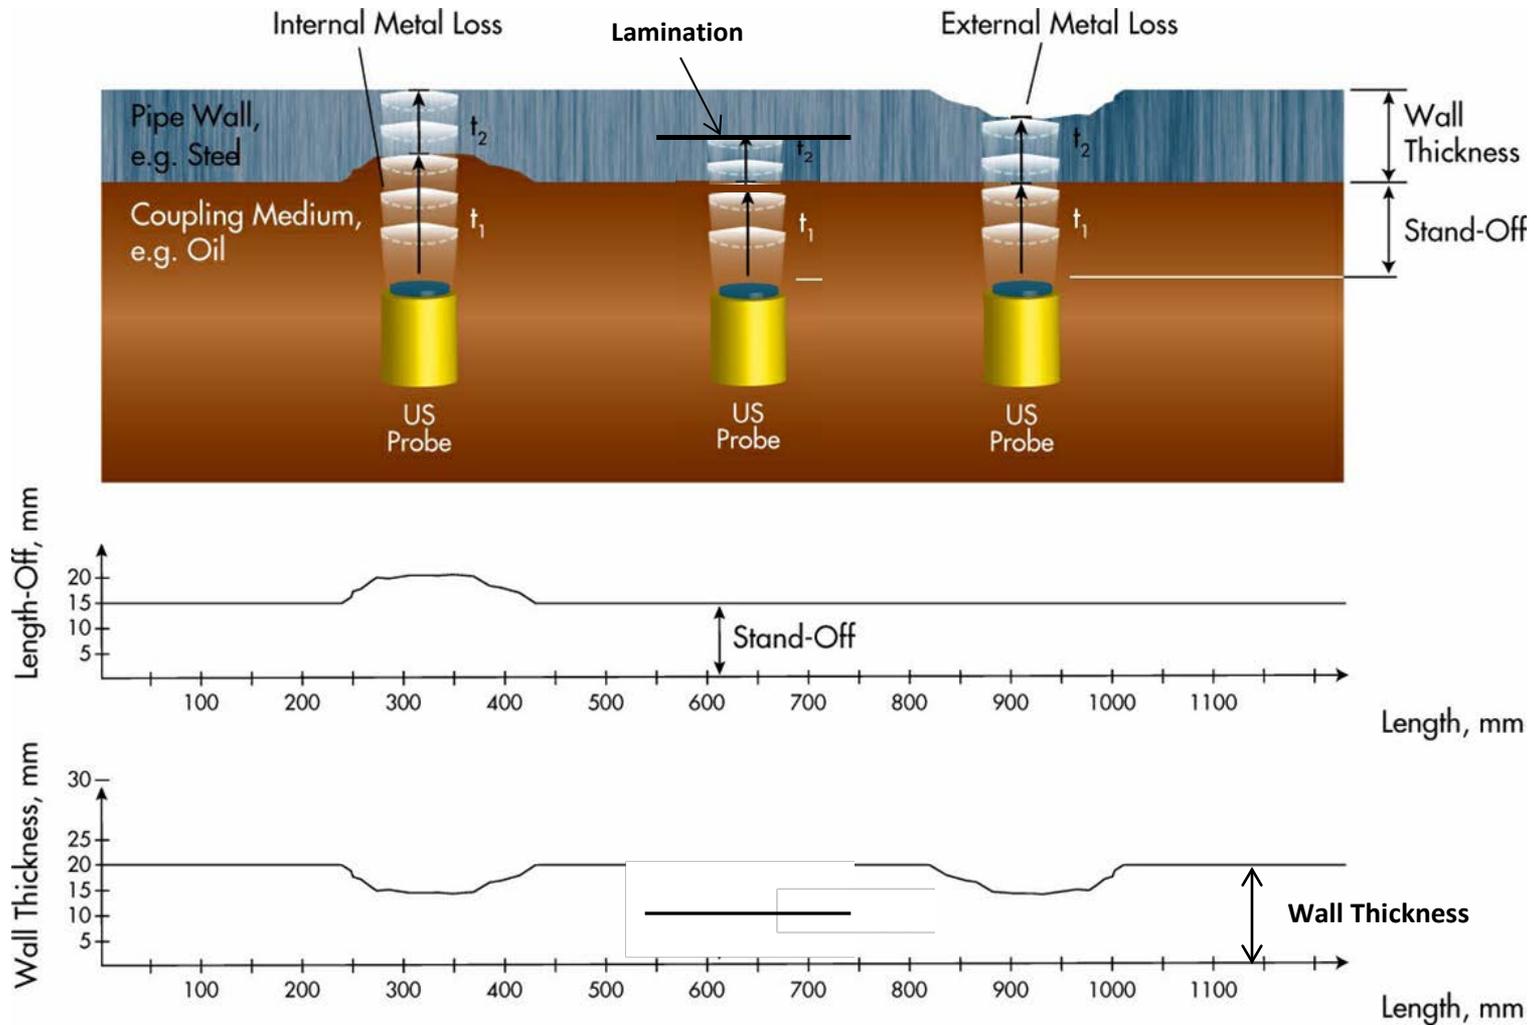
Immersion Ultrasonic Data Capability

Geometry, Metal Loss, and Lamination

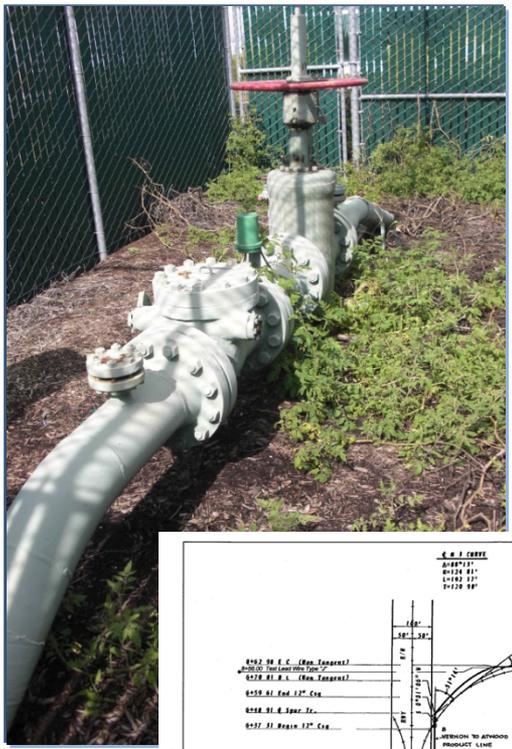
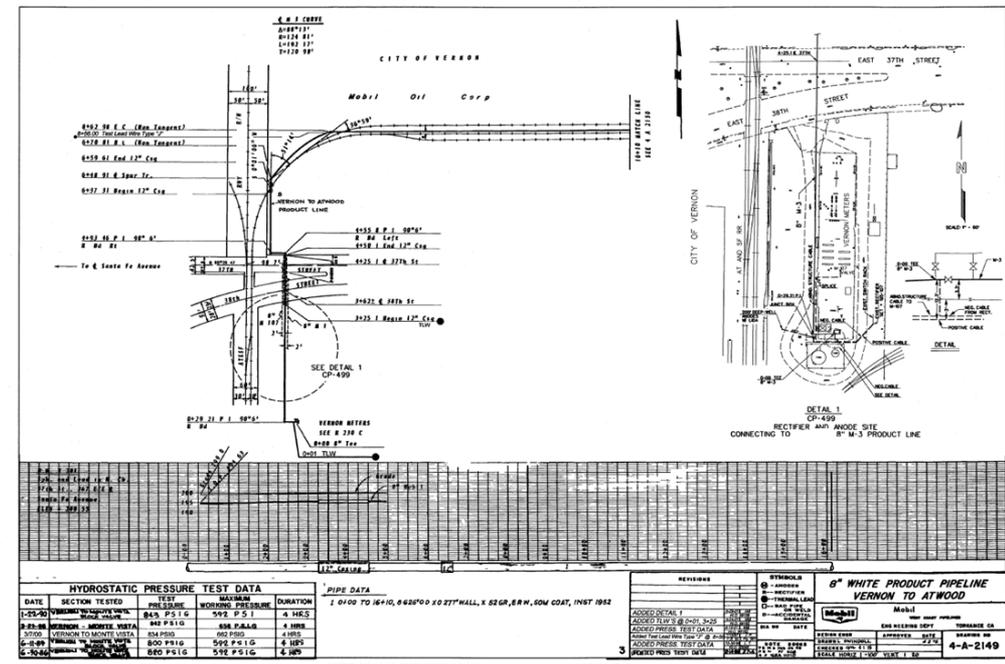
Case Study – Dual-Diameter Lines

Multiple dual diameter lines have been inspecting in the Los Angeles Greater Metropolitan Area. Ranges span 6”/8”, 8”/10”, 10”/12”

Previous attempts to run MFL failed to navigate all transitions either from SR bends or cup wear.

Low-drag dual-diameter UT tool was able to both navigate and collect complete data.

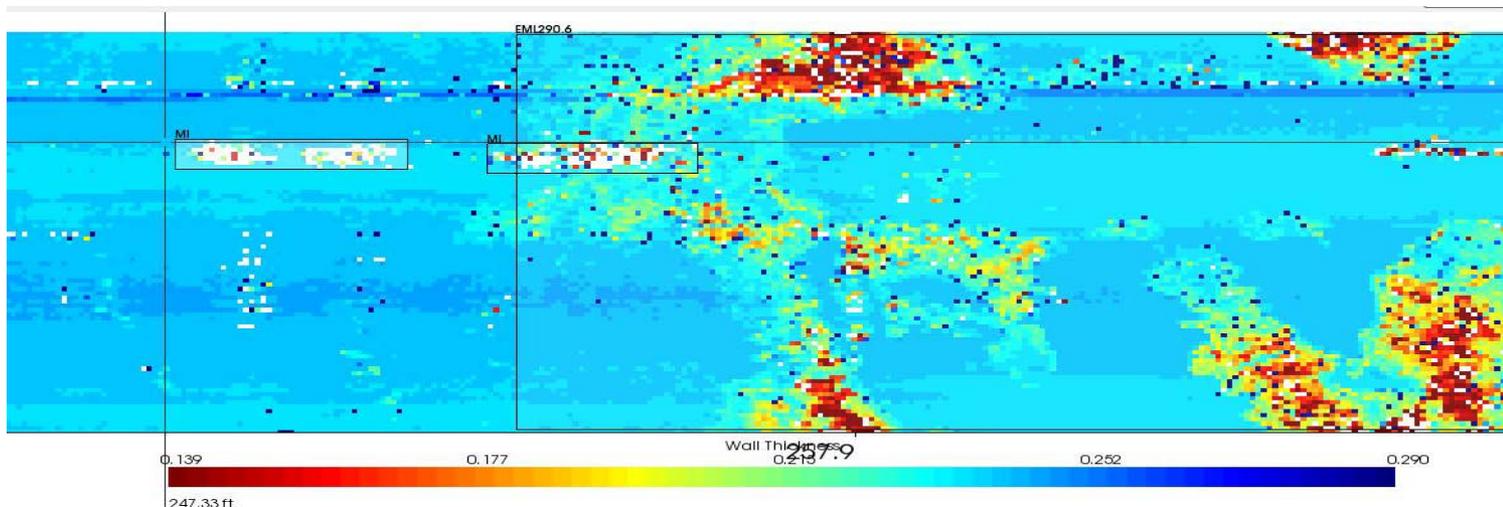
Localized Internal Corrosion

- Crude pipeline with multiple locations of internal metal loss in an 8"/10" dual diameter line
- Note the excellent data quality despite localized fouling remaining following the cleaning program.

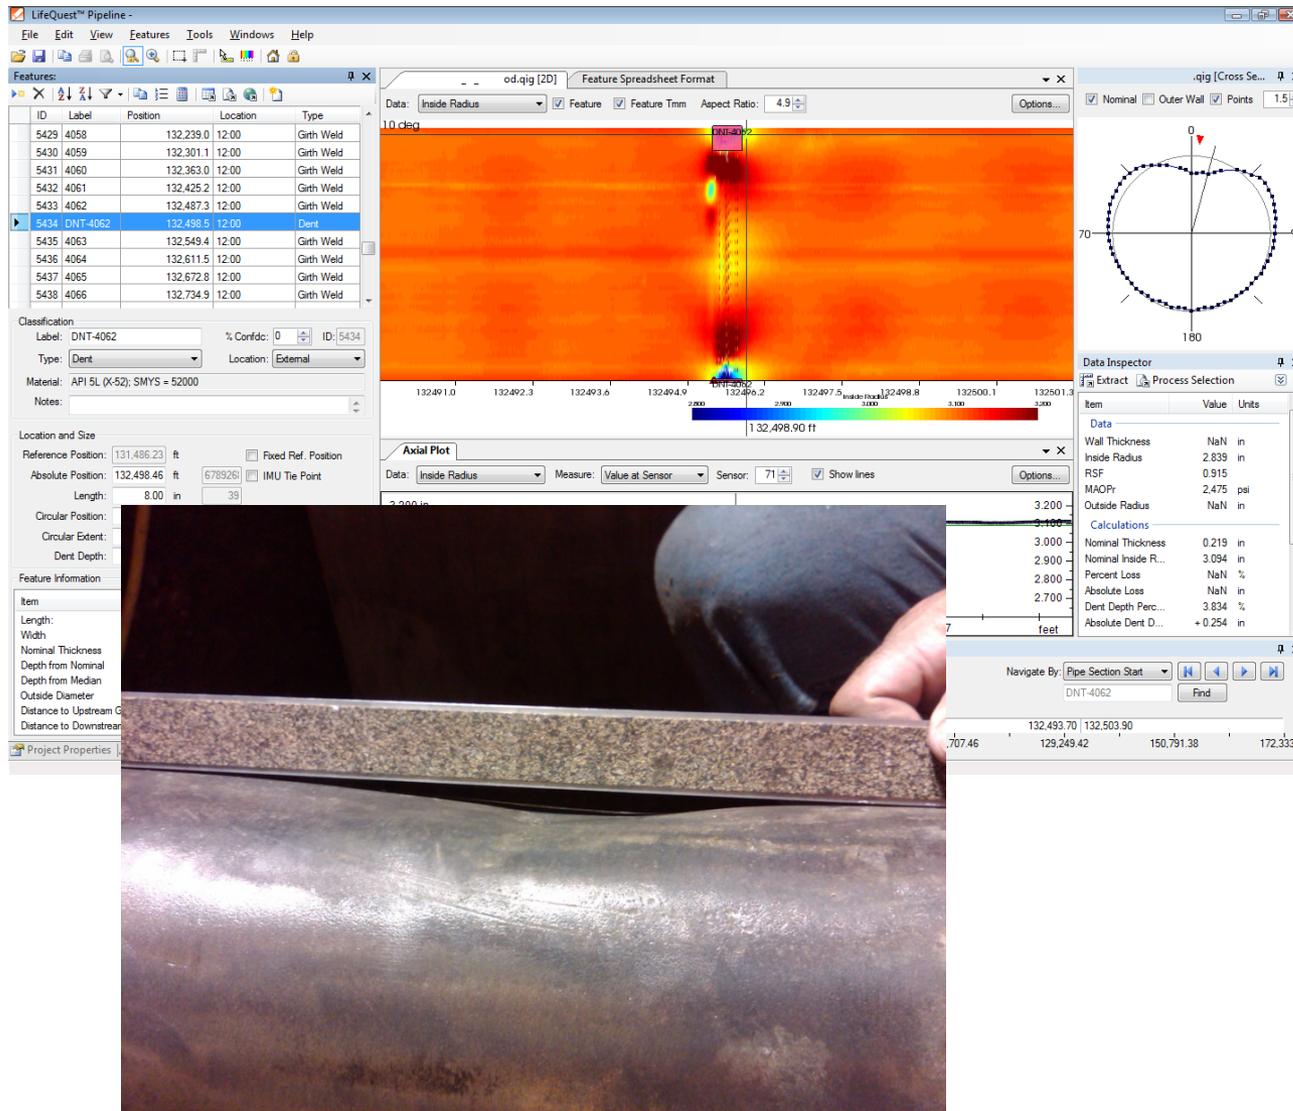
Dual-Diameter Case Study Greater than 6% Topside Dent

- Quest collected analyzed and performed a full Fitness-For-Service Assessment on nearly 9 GB of data
- Customized reporting to fit client requirements including piping station locations
- Critical defects such as this 6% topside dent were found that would not have been detectable by a hydrotest and could have led to a costly in-service failure

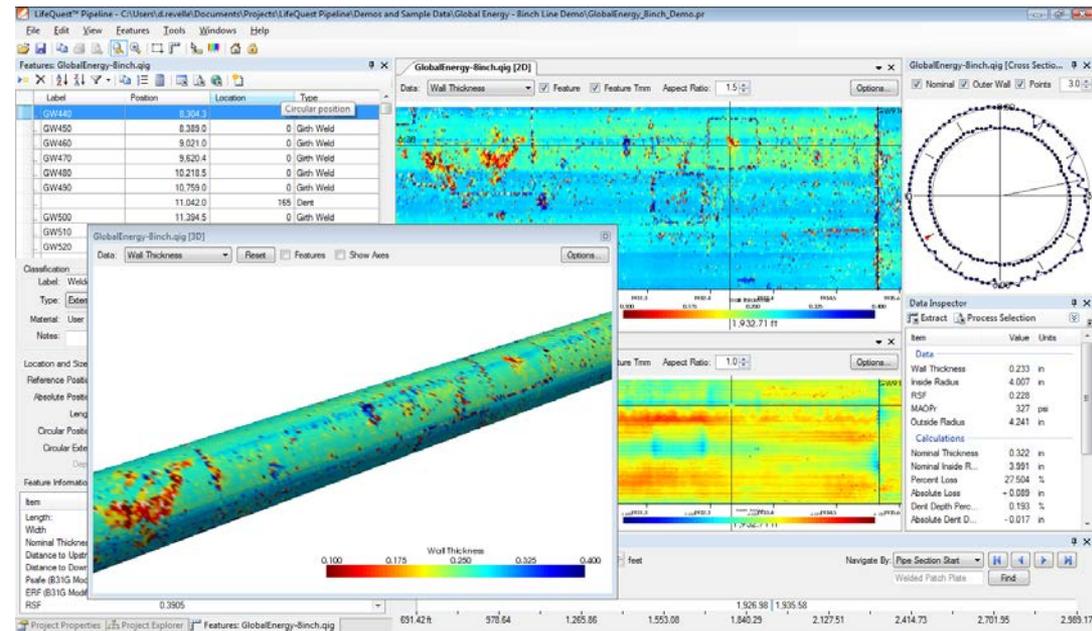
Dual-Diameter Case Study: Large Scale Wall Loss

- Extensive external corrosion found ($T_{mm} < 0.085$ inches Over 80% wall loss)
- Large scale wall loss at a location in the pipeline that was not readily accessible.
- High consequence area if there had been a leak.
- High resolution UT measurement provides a clear picture of previous repairs (patch plates).

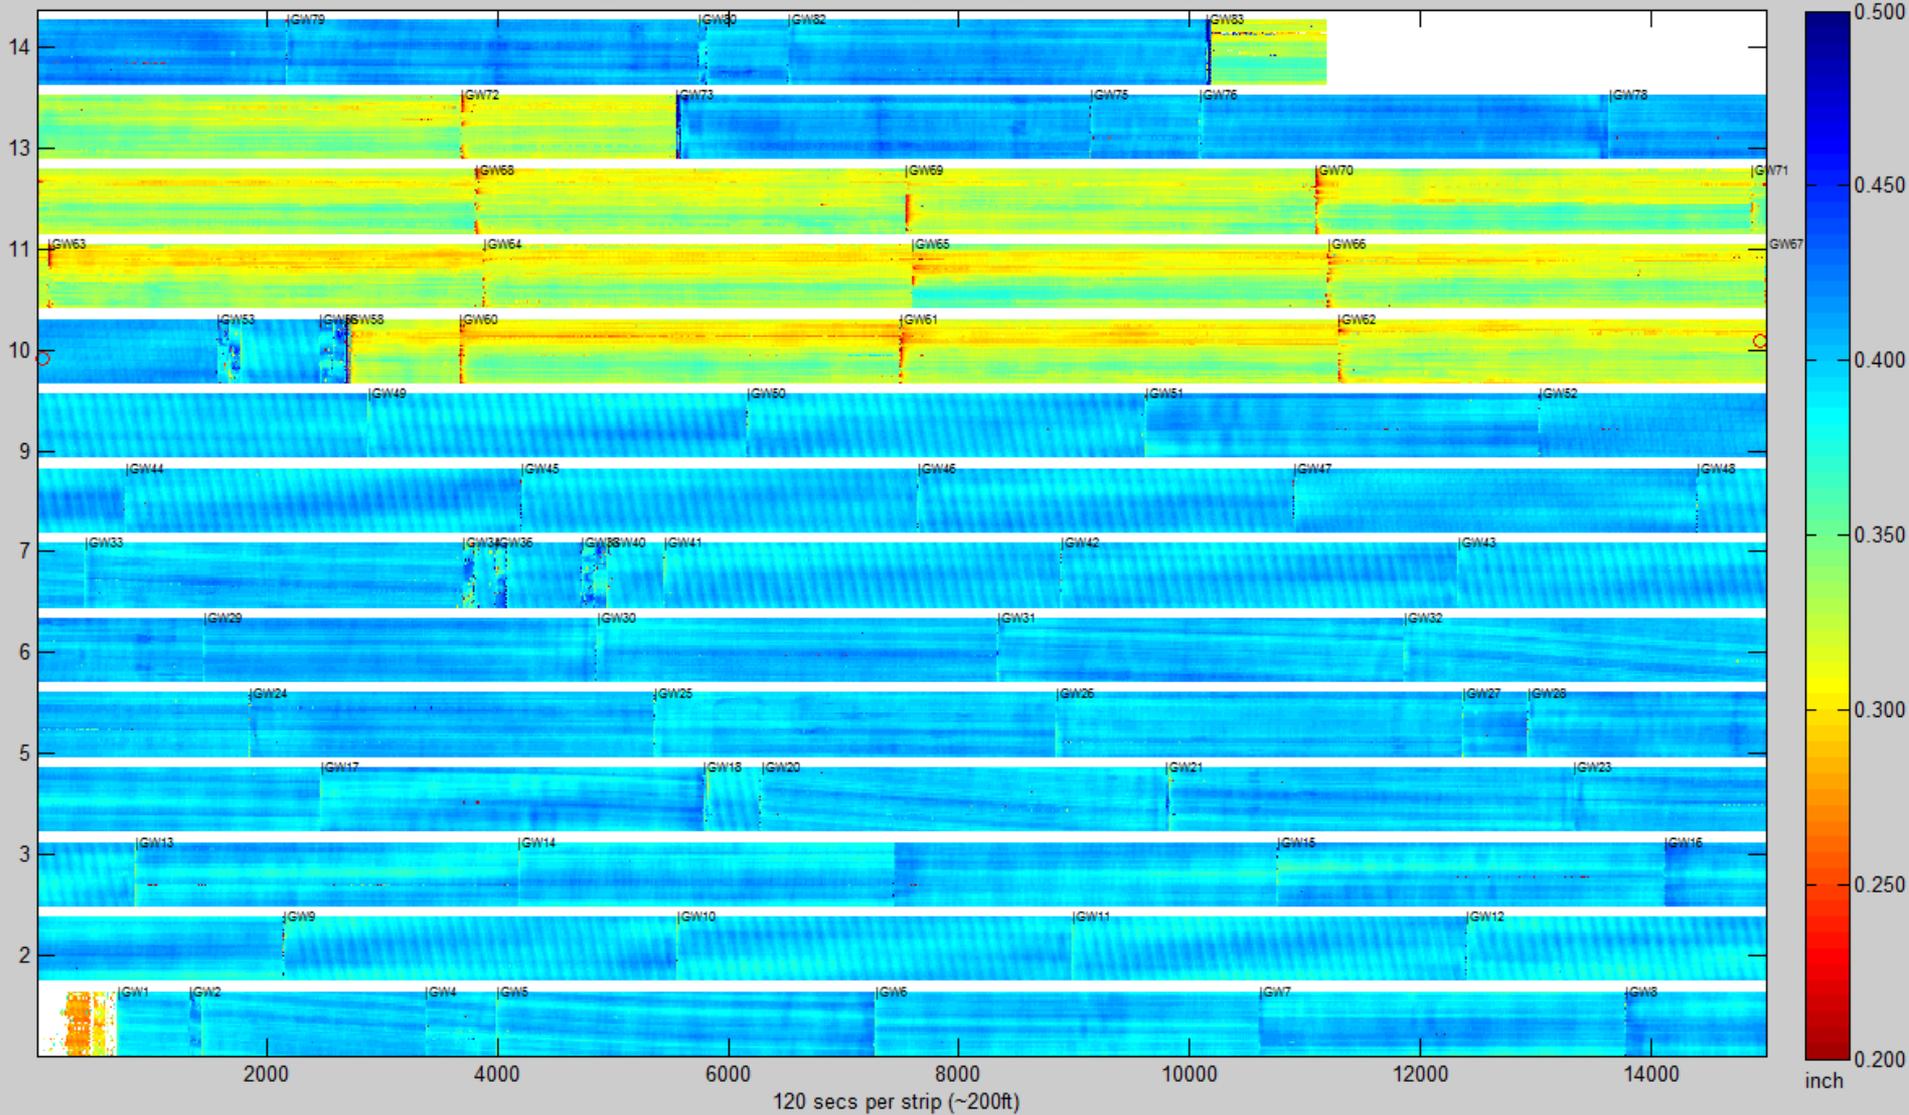
Case Study - Sulfuric Acid Pipeline

Wall Thickness Data
generated with QUEST proprietary technology (patents pending)

- Refiner operated a 6” Diameter Sulfuric Acid Pipeline which had failed.
- Plant hired Quest to see if the pipeline was salvageable.
- The pipeline contained multiple repairs which had occurred over its lifetime.
- InVista™ inspection detected and quantified severe areas of erosion damage on the downstream side of several circumferential welds.
- Inspection results provided justification for refiner to building a new replacement pipeline.
- Customer then hired Quest to inspect the new acid pipeline, both as a baseline to accurately monitor future damage and to ensure proper Q/C on root weld penetration

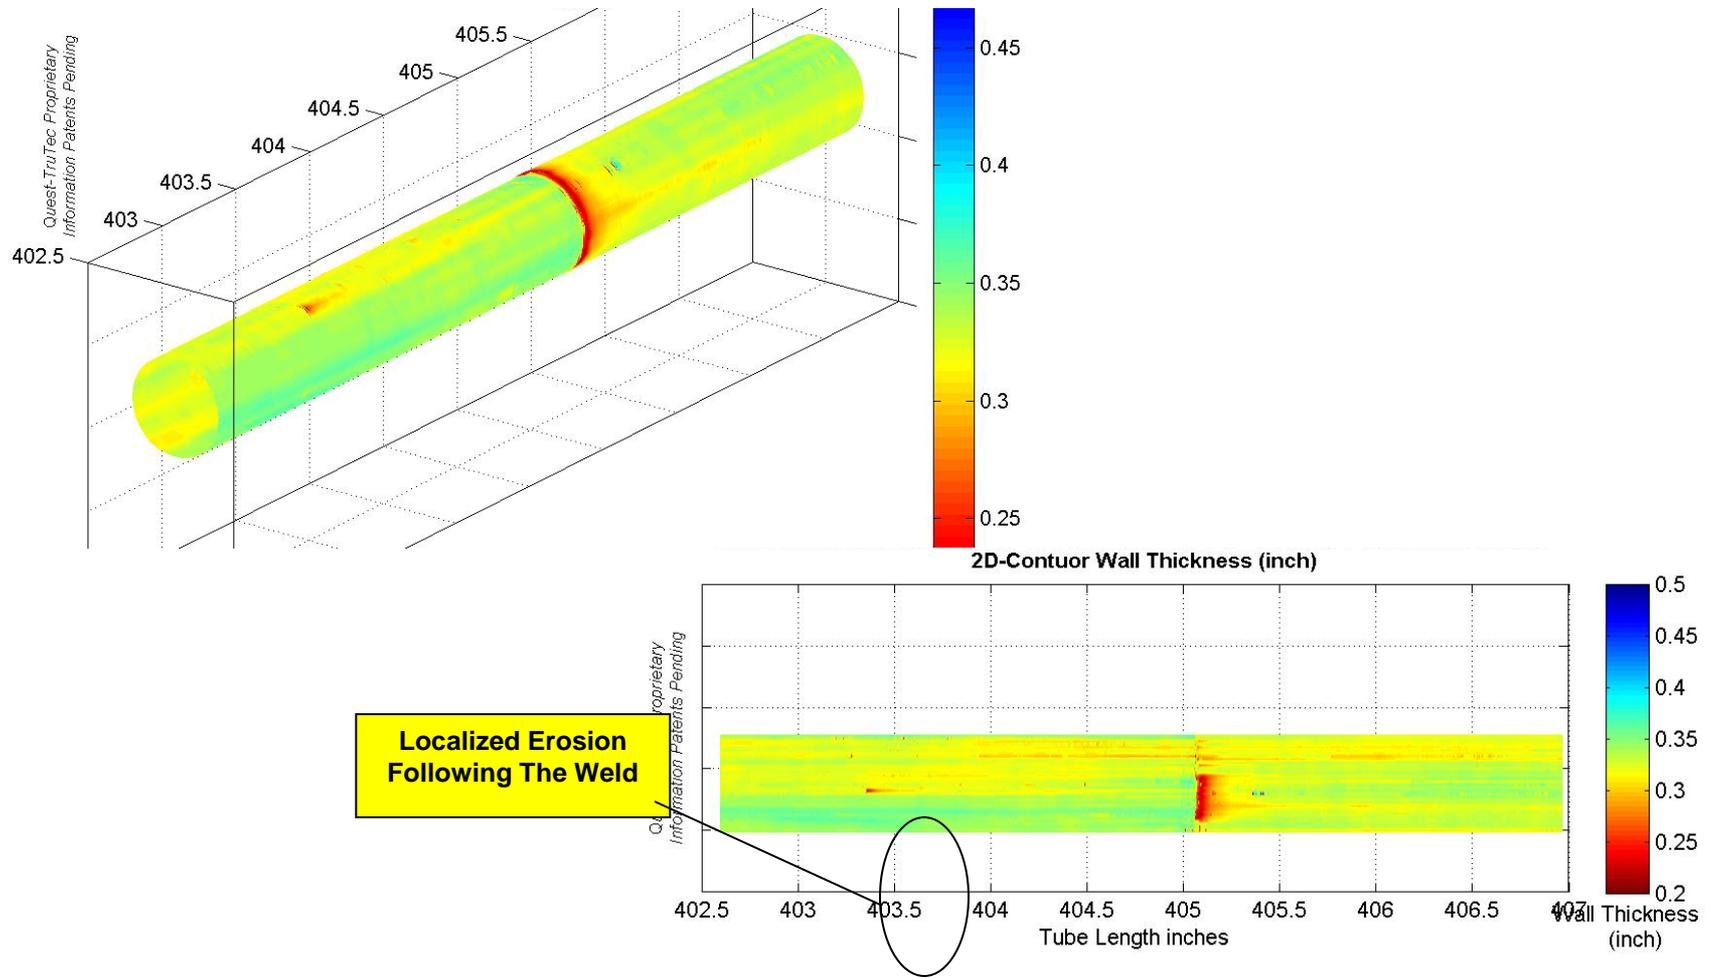
Erosion Damage after Excessive Weld Penetration

Damage was found downstream of the welds which was a big surprise to the client.

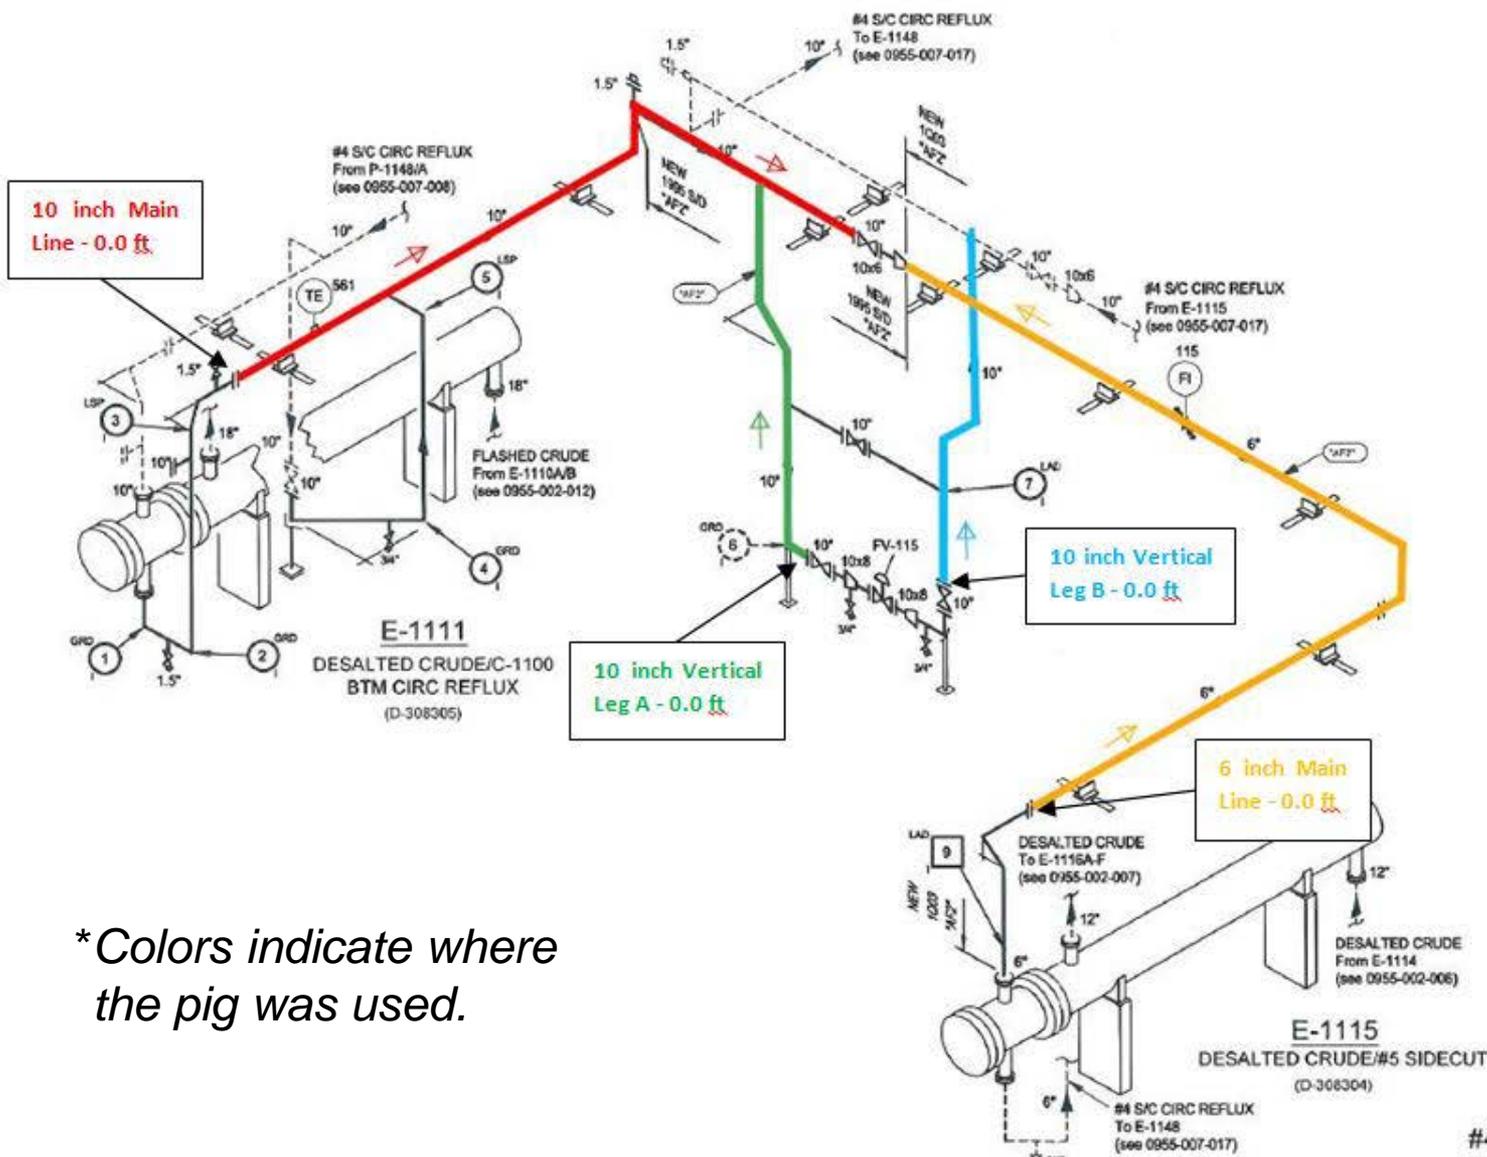
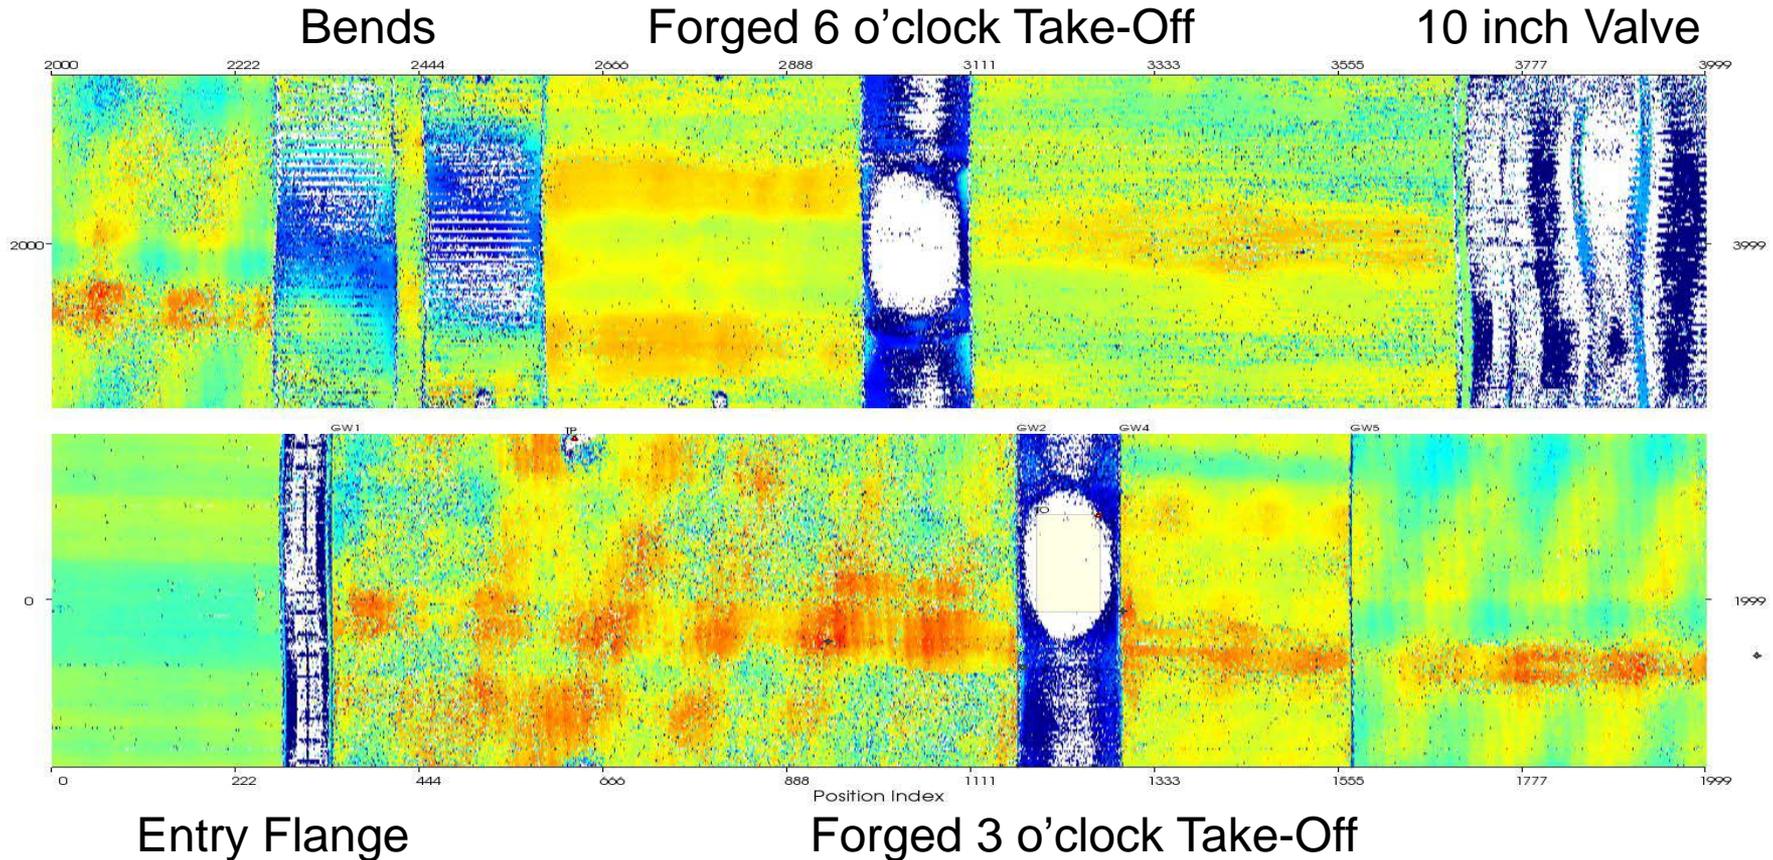
High Temperature Sulfidation

*Colors indicate where the pig was used.

The plots illustrate the pipe in a 2-Dimensional (2D) plot, as if the pipe is cut down the axial length and rolled out flat so that all 360-degrees of the pipe can be viewed from one (1) image. The pipe is presented in continuous rows in order to maximize the axial pipe length per page. The color coding corresponds to the associated thickness (red = thinnest pipe).

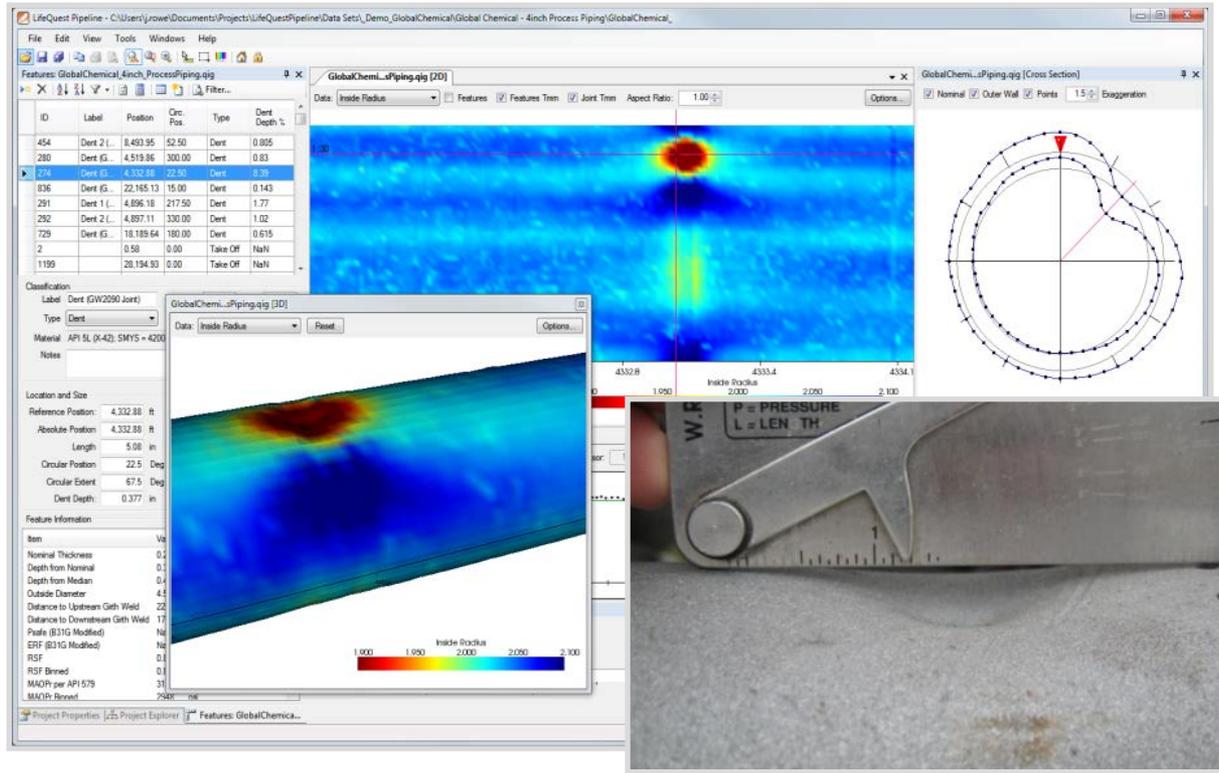
Dents

Dent Assessment.

New software tools allow for rapid engineering assessment of the severity of the dents. Have standing proposals with per dent pricing so engineers can get B31.8S strain assessments on any dent within 24 hours. Complete FEA models can be rapidly generated using geometry data directly imported from the InVista inspection

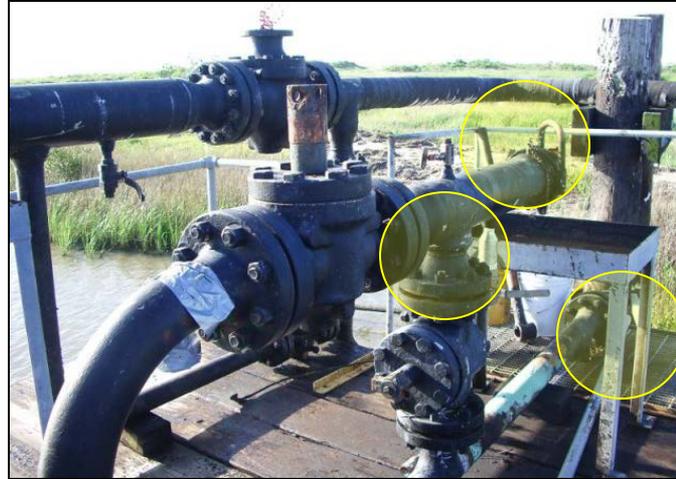
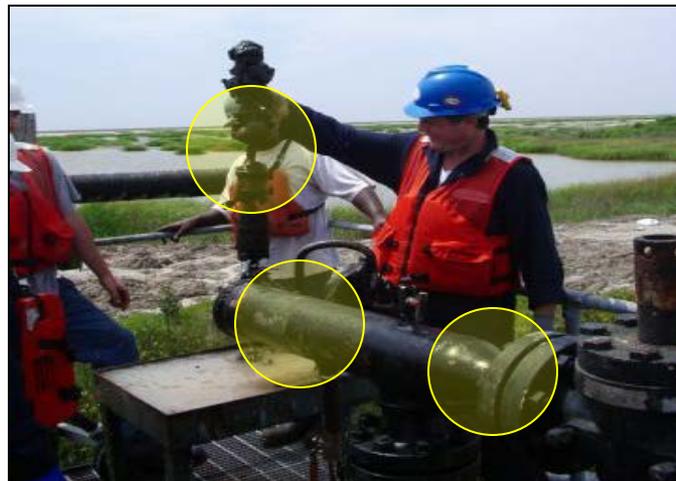
Launcher

- Minimal working area
- Minimal trap length
- Unbarred 6" x 6" (150mm) tee at 6 o'clock

Receiver

- Minimal nominal pipe after valve
- Minimal trap length
- Line was not properly cleaned prior to ILI

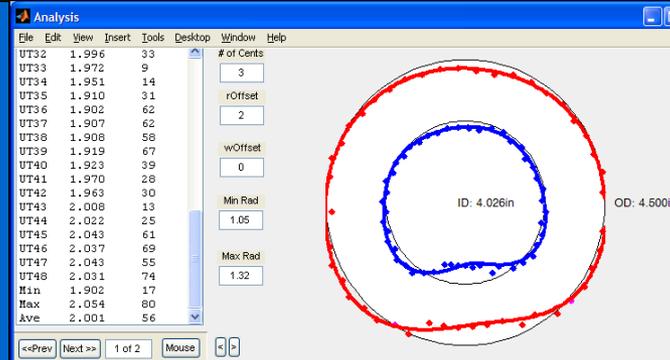
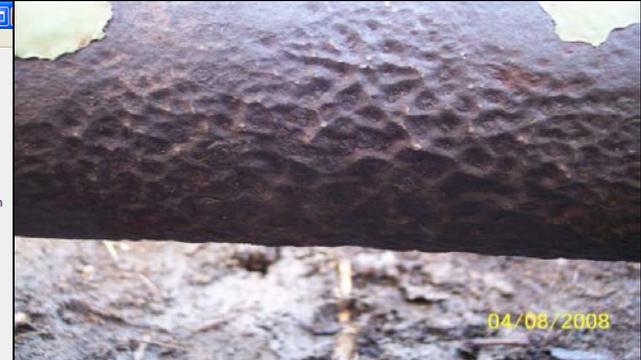
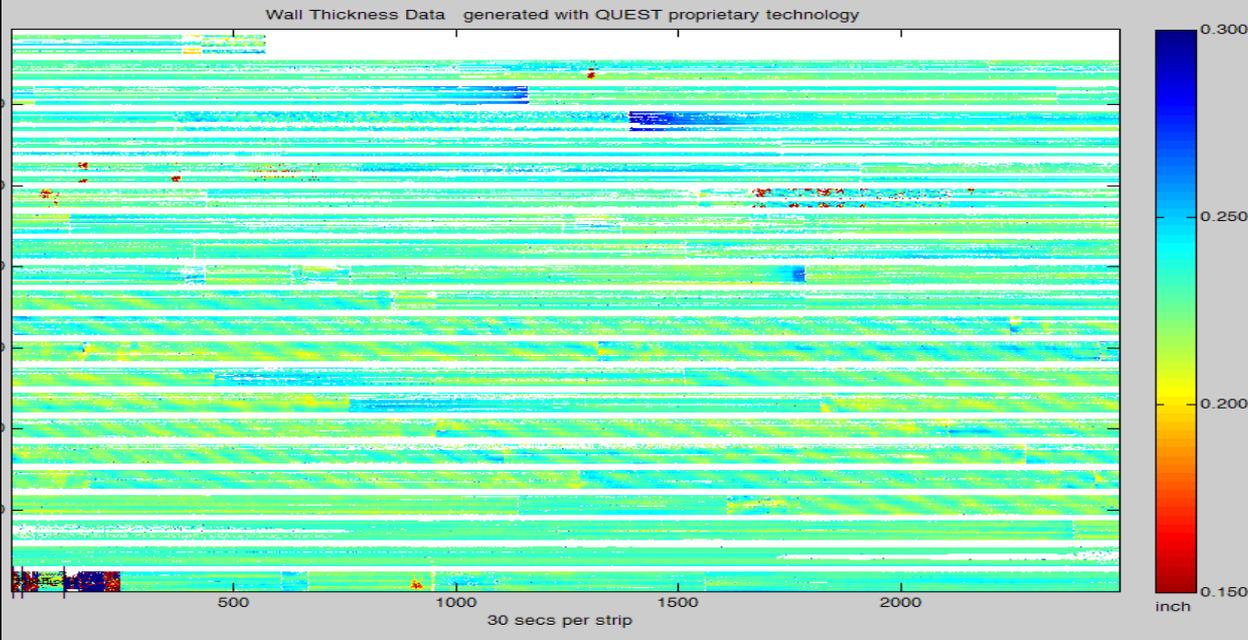
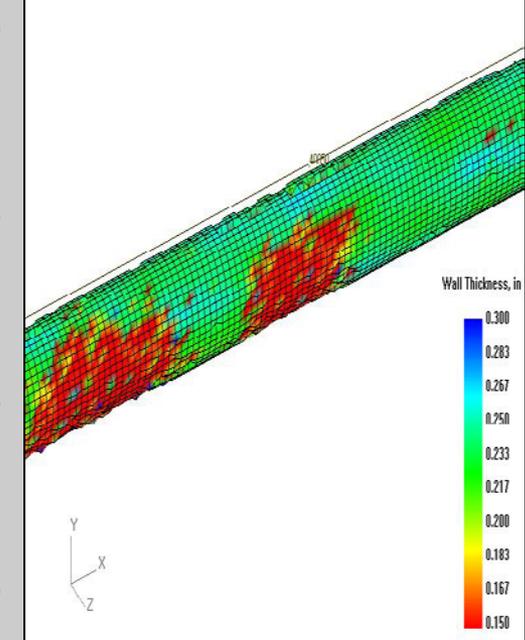
Case Study – Bi-Directional Results

- 7 major corrosion and pitting flaws detected
- Client verified each flaw with alternate manual NDT method (i.e. pit gauge and/or manual ultrasonic scope)
- Repairs were made to all areas based upon InVista™ inspection results

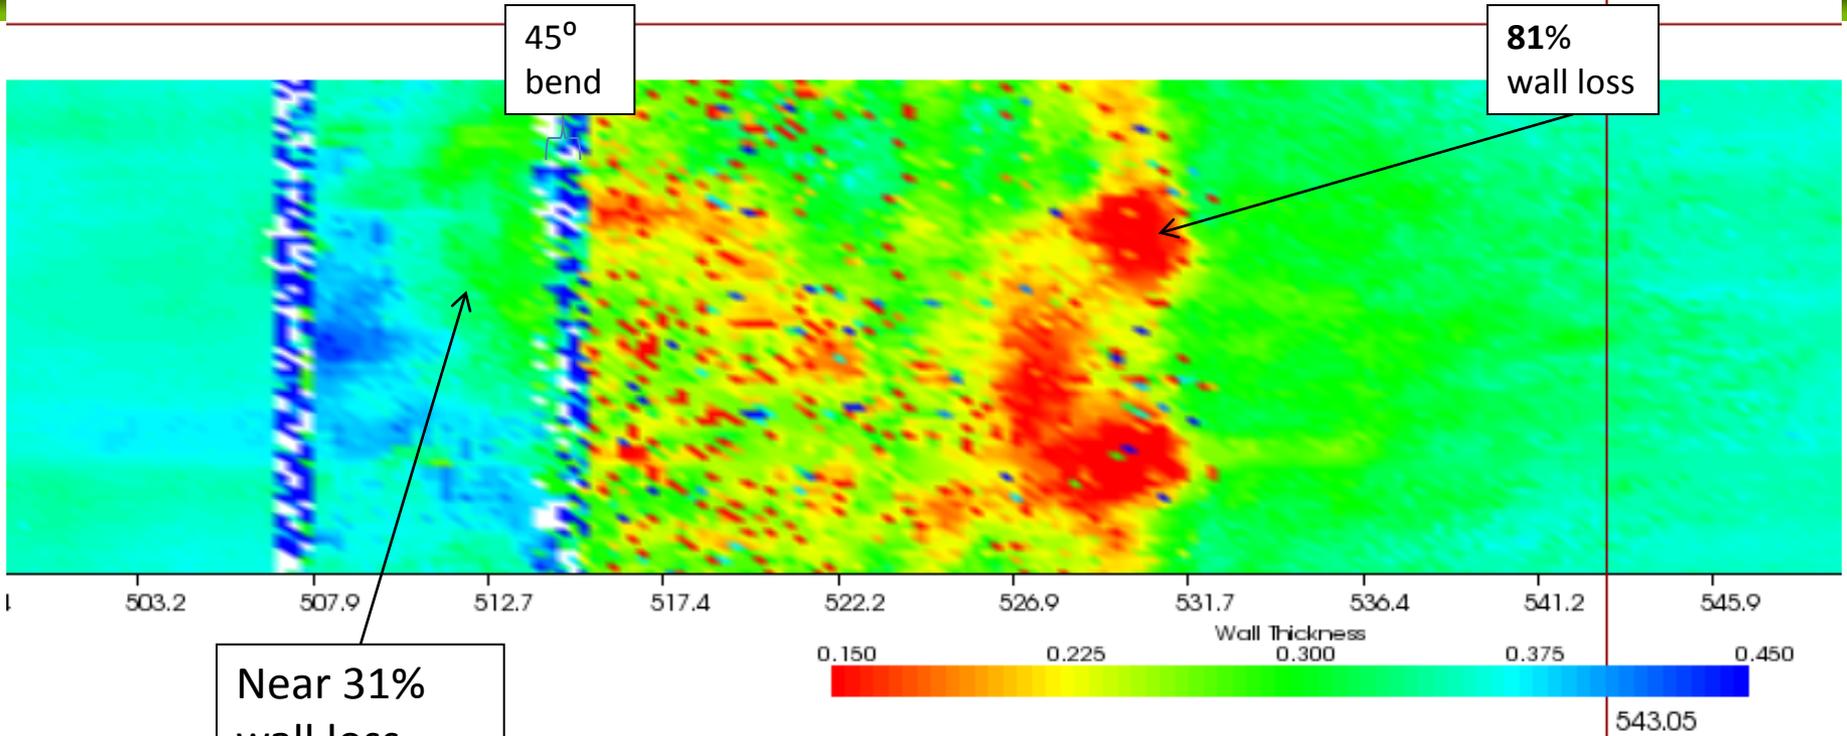
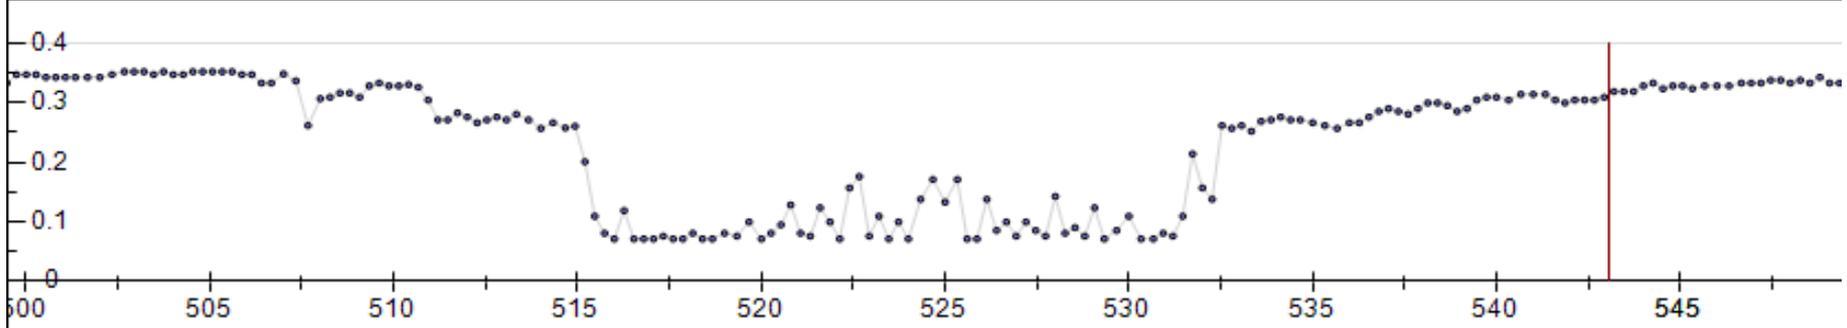
Case Study - Corrosion under insulation:

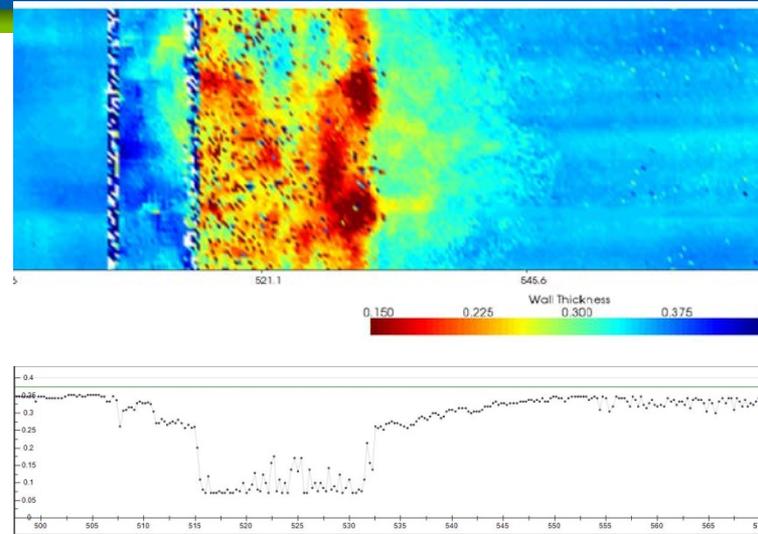
External Corrosion
Area

Case Study: External Wall Thinning

- 81.1% Wall Loss
- RSF = 0.278
- MAOPr = 986 psi
- Pipe section replaced following inspection.

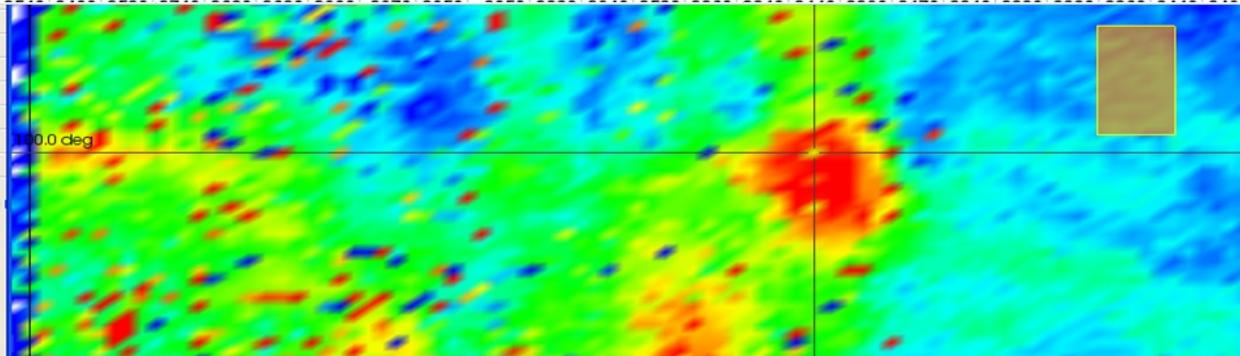
Manual UT Results

Case Study: Prove-Up Results

220	220	220	250	230	230	230	180	200	260	230	230	160	160	190	230	240	290	280	270	300	300	310	300
250	210	260	250	240	240	240	170	180	260	210	230	140	150	200	250	290	310	300	310	320	290	290	300

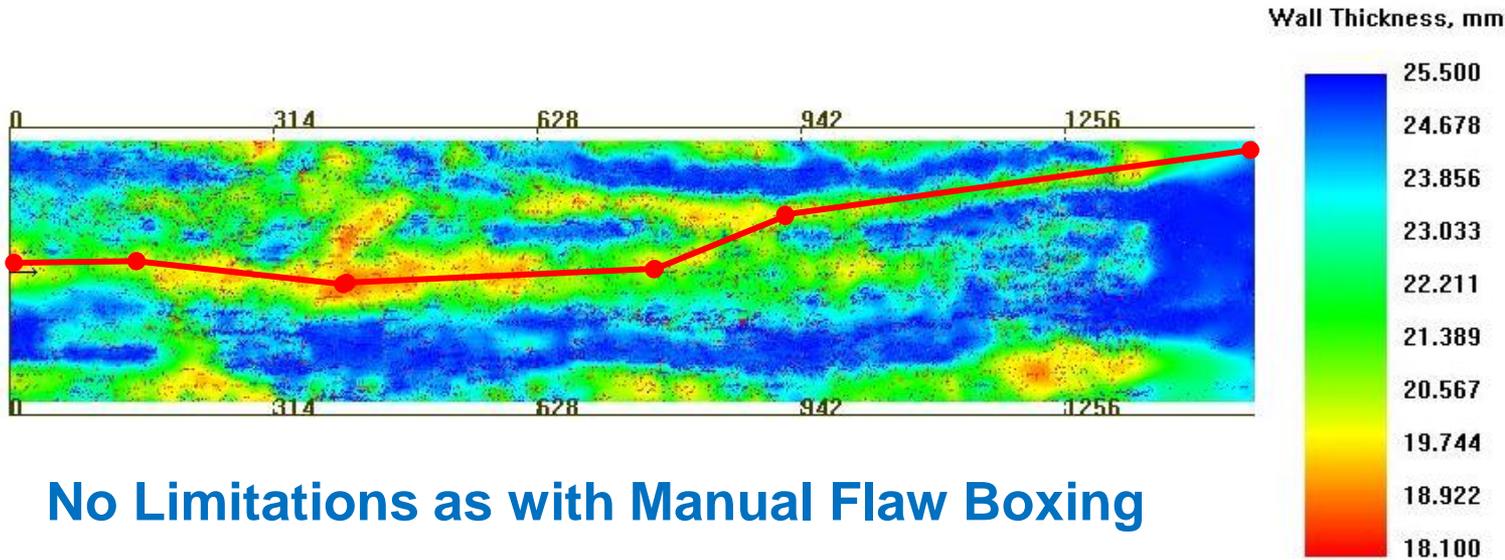
LifeQuest™ Visualization and Analysis Software

- High resolution 2D and 3D views of wall-thickness and inner profile for 100% of your data.
- Fully synchronized data display windows for rapid examination of your inspection results.
- Client configurable feature table compatible with GIS systems and exportable to Microsoft Excel®.

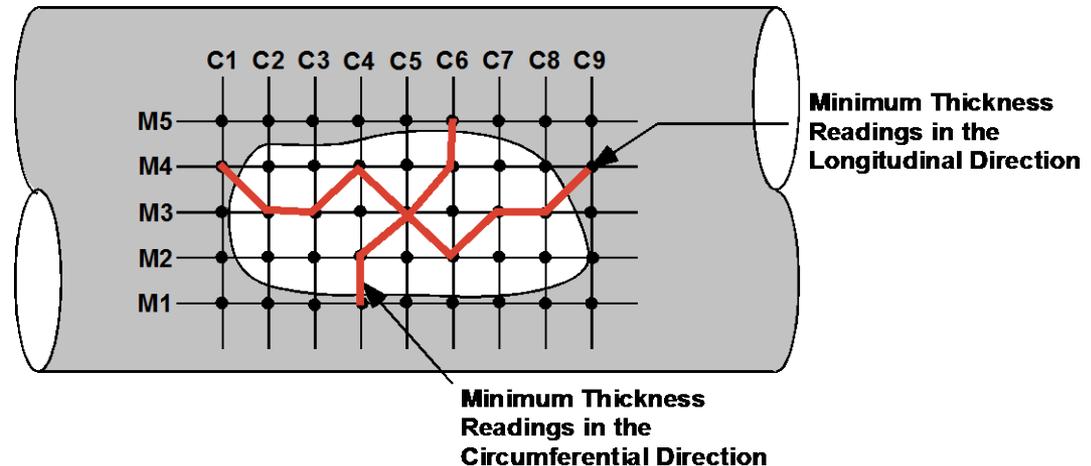
No Limitations as with Manual Flaw Boxing

- Obtain thickness data from inline inspection
- Compute RSF at short segments
- Rank corrosion damage over various segments
