Hydrogen Sulfide and Pipeline Corrosion

Integrated Solution Set Addressing Unpiggable and Difficult Pipelines Through Modern Technology

Flexible Ultrasonic In-line Inspection

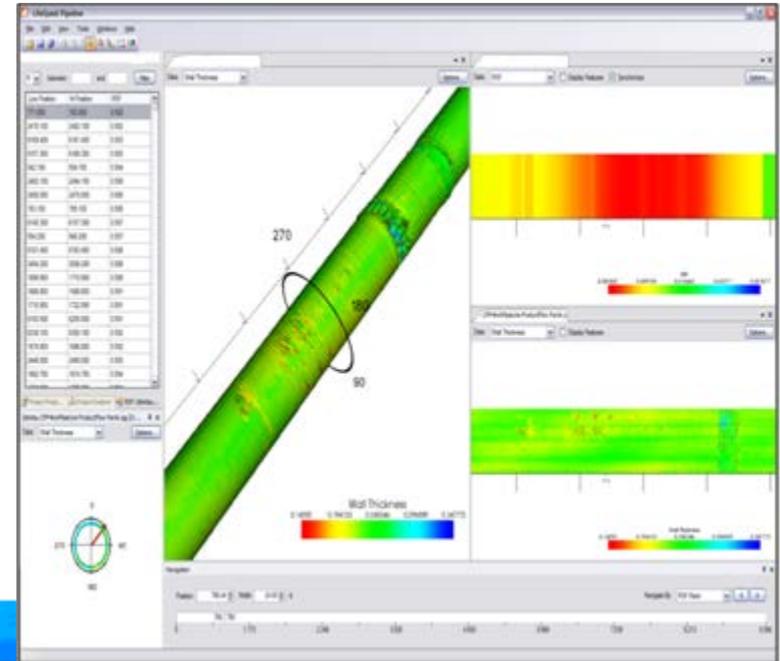
Measured Wall Thickness

Converts ILI data sets into synchronized 2D and 3D views

- Better defect characterization
- Simultaneous visualization of multiple data values
- More accurate defect growth models
- Visualization allows operators to improve mitigation
- Advanced analysis improves Fitness-for-Service assessment

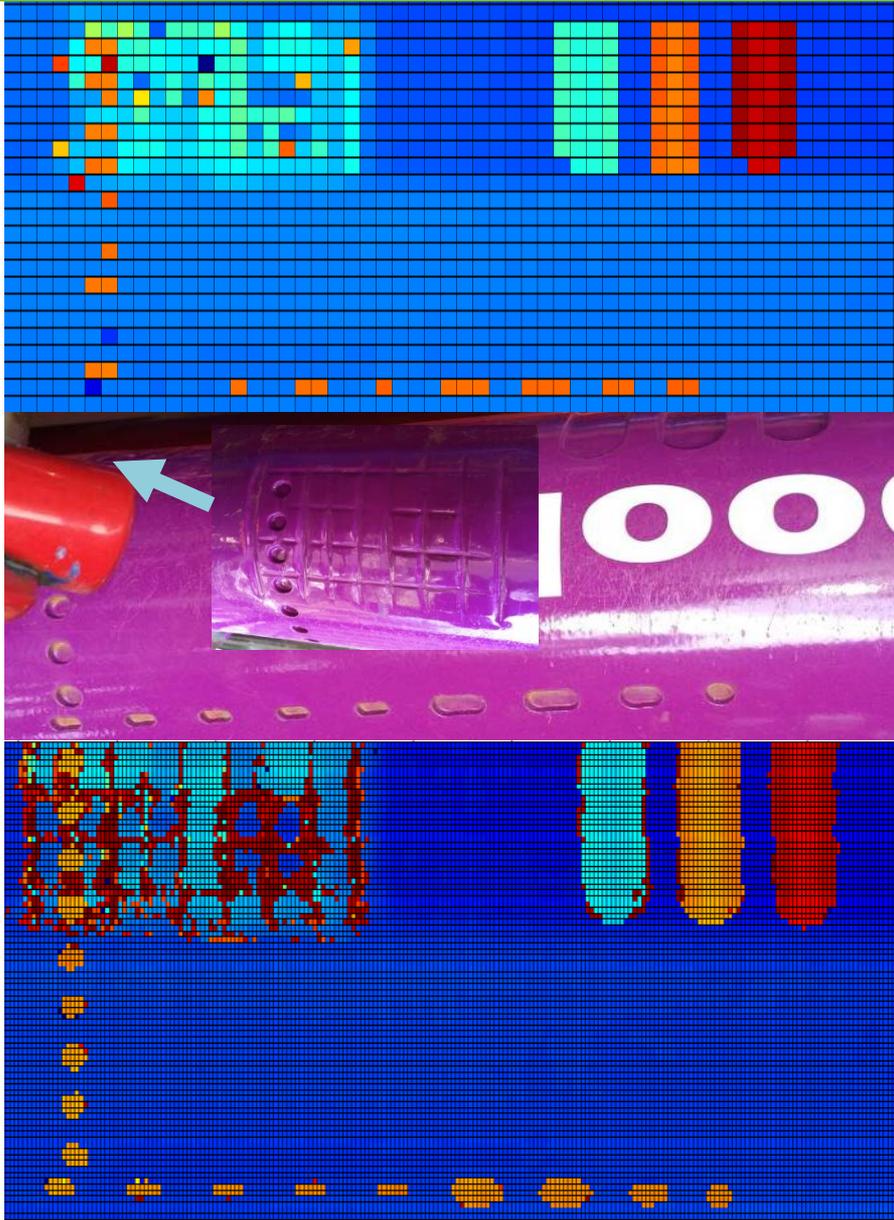
Breakthrough Developments: October 2014 – 10X

Current technology

- Industry leader in navigation
 - 1D & Back-2-Back Bends
 - Multiple Diameter
 - Un bared Ts
- Top-Tier Resolution – ¼" x ¼" Grid

- Industry Leader in navigation (same as above)
- Industry Leader in data resolution
 - Order of Magnitude Improvement in Resolution
 - 1 MP camera → 9 MP camera

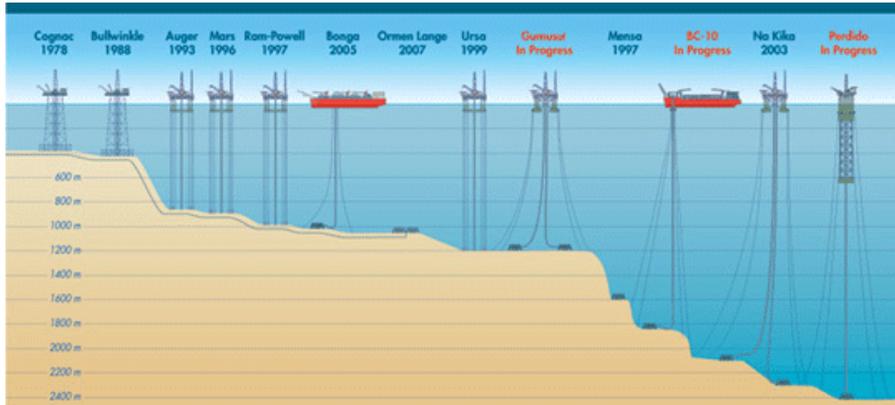
High Pressure Technology – 5000 psi

- Deep Sea Off-Shore Assets
- High Pressure Wells / Water Injection

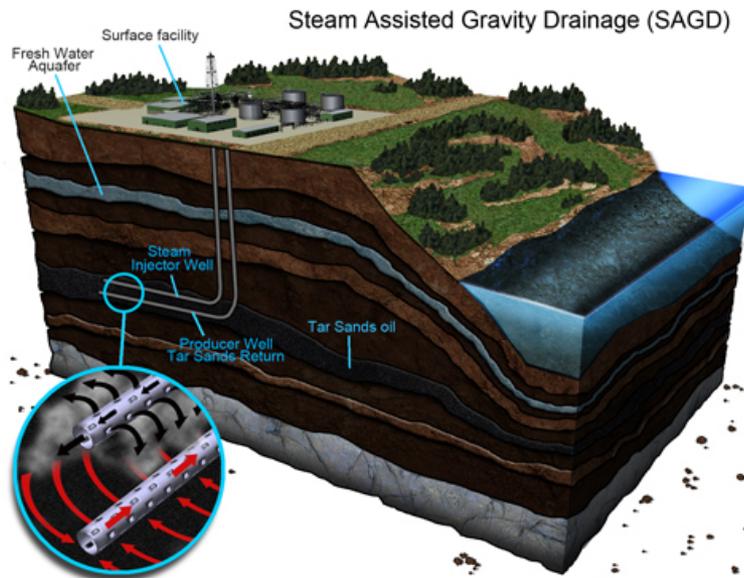
2" Tool Development

- Steam Generation (HRSG) and SAGD
- Distribution
