**APPENDIX D  
TENERA REPORT**

# Ocean Bottom Seismometer Cable Landing Habitat Characterization Study

## Diablo Canyon Power Plant

May 27, 2011

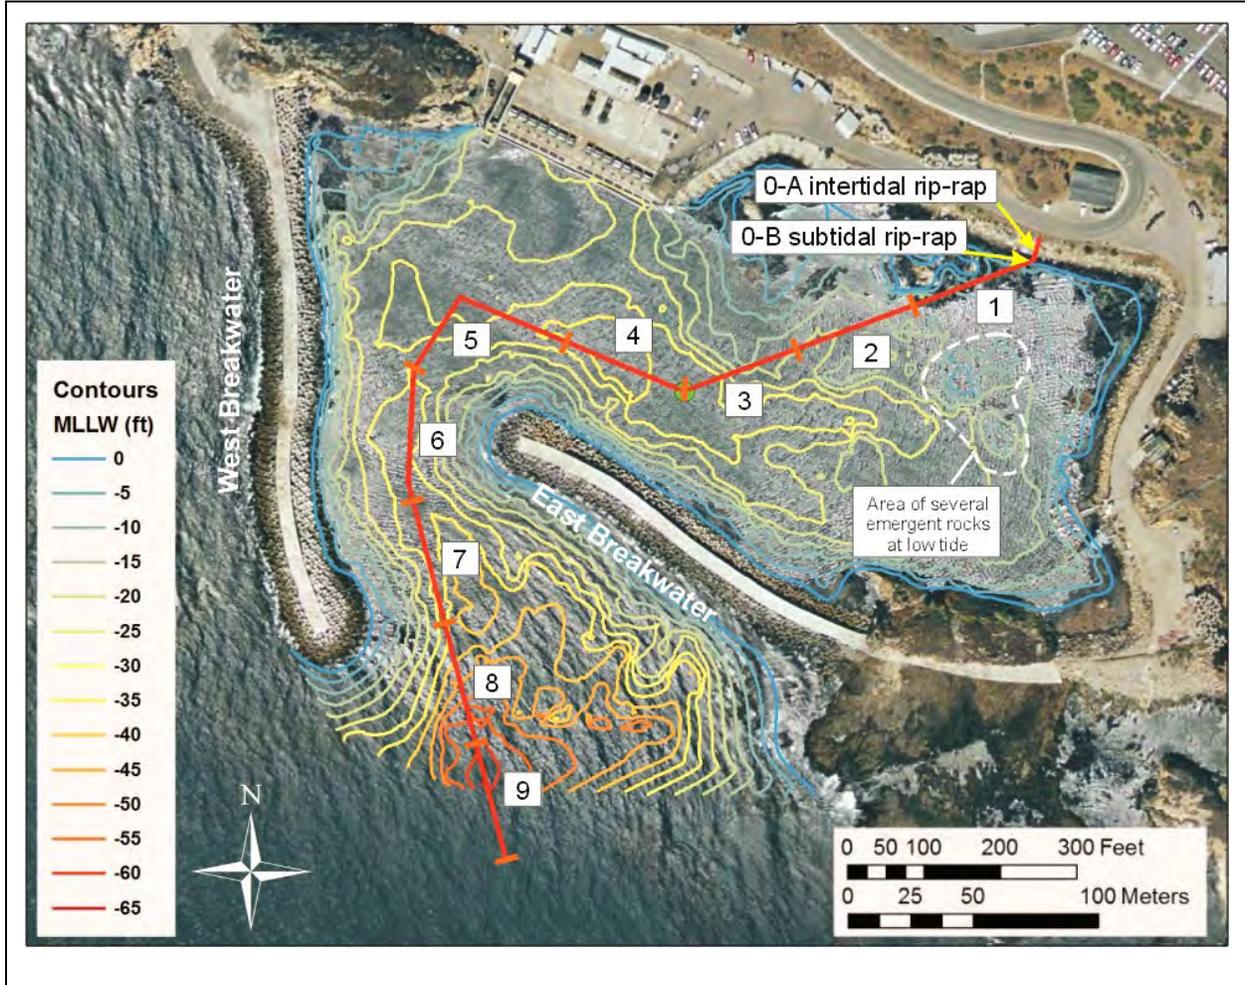
**Figure 1.** Proposed OBS cable corridor route (red line) and transect segments surveyed through the DCP intake cove on May 17–20, 2011. Depth contours are from multi-beam hydroacoustic surveys conducted in 2005.

A pair of 100 m (328 ft) reeled measuring tapes was deployed sequentially from the boat along the projected cable route starting from the embankment onshore and out through the intake cove to a location approximately 100 m (328 ft) beyond the end of the west breakwater (**Figure 1**). Weighted buoy lines marked the start and end of each transect segment.

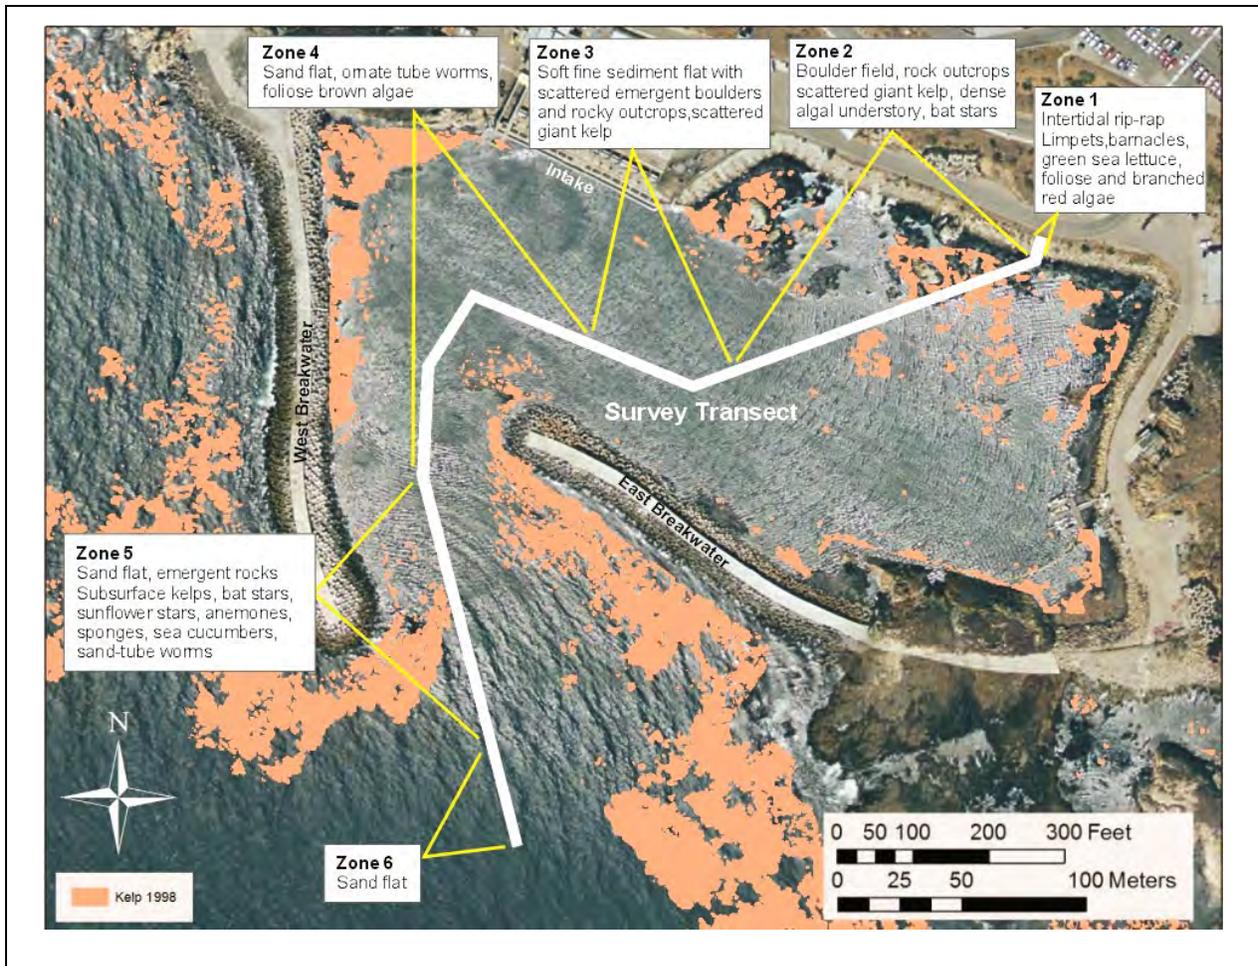
**Figure 2.** Survey transect and general habitat zones along nearshore segment of proposed OBS cable route. Depiction of kelp surface canopy is from an aerial kelp mapping survey done in fall 1998.

area traversed by the proposed nearshore cable route was classified into six habitat zones (**Figure 2**). A depth profile of the transect and these delineated habitat zones is shown in **Figure 3**.

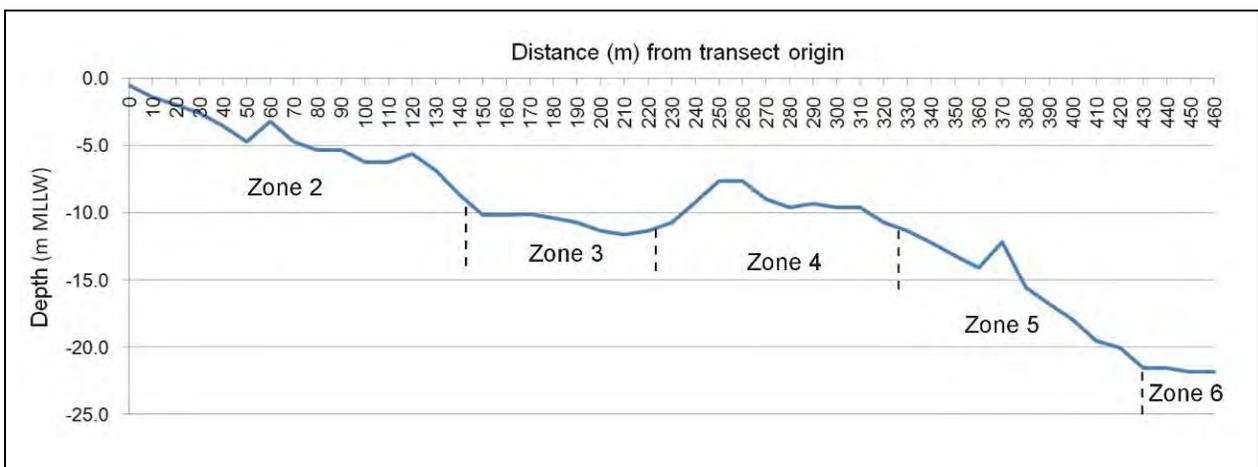
**Figure 3.** Depth profile of the subtidal survey transect showing locations of general habitat zones described in Figure 2. Vertical exaggeration of the depth scale is approximately 6:1.

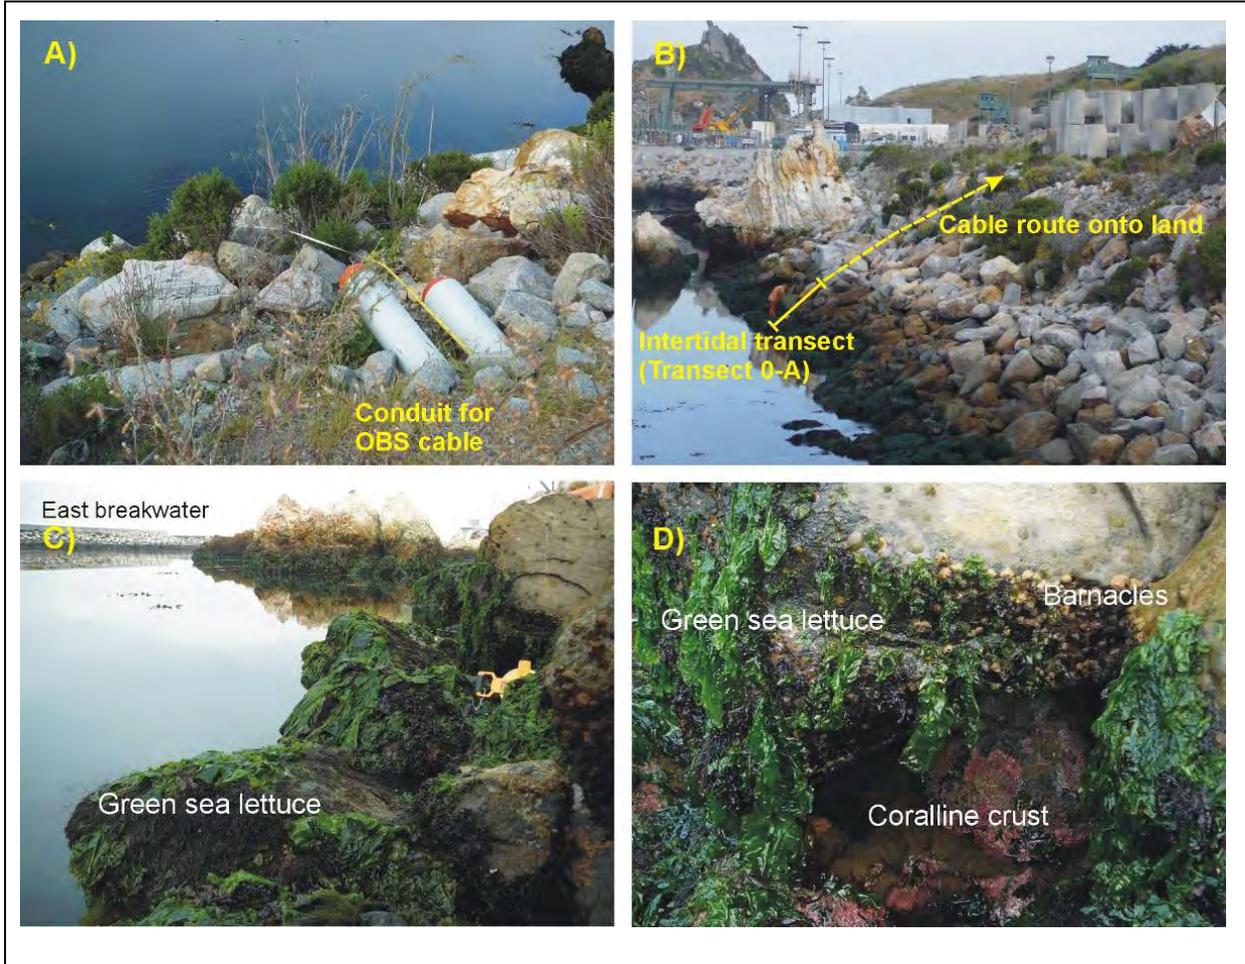
**Zone 1:** This short, steep segment (Transect 0-A) crossed the rock rip-rap embankment from the upper intertidal zone down to the lower intertidal zone. Most of the rocks were barren with little or no algae, but some had aggregations of several species of limpets and scattered barnacles (**Figure 4**). Green sea lettuce (*Ulva* spp.) was common. No black abalone or red abalone (*H. rufescens*) were found.

**Figure 4.** Proposed landing area for the OBS cable. A) Terminus of existing conduits at top of rip-rap embankment; B) Proposed conduit extension route up the rip-rap embankment; C) Intertidal zone; and D) Common intertidal biota.

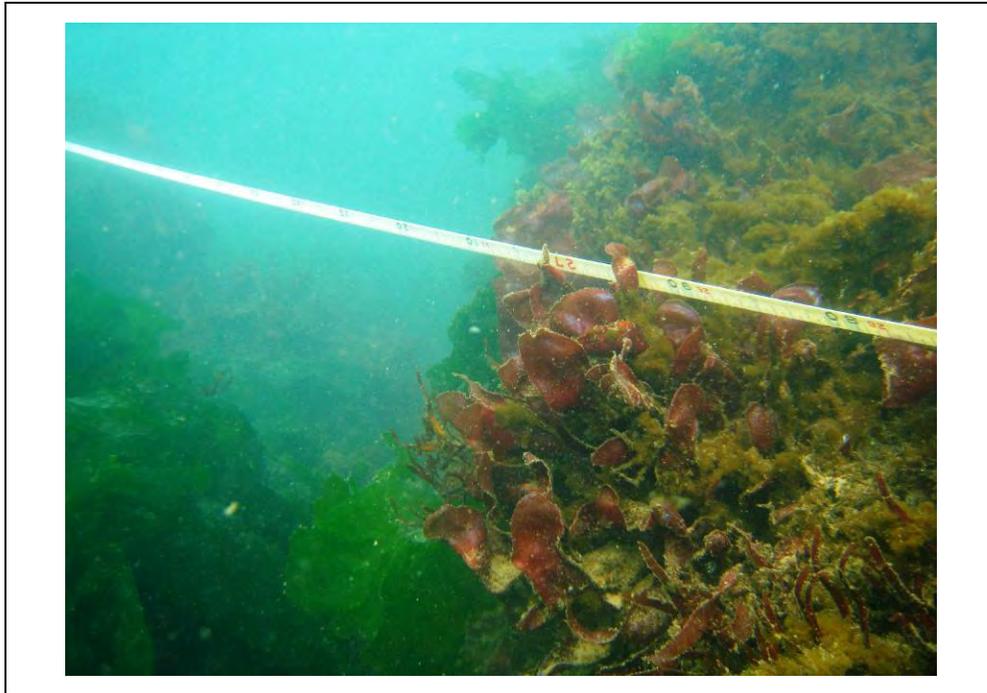
**Zone 2:** This zone was largely an expansive submerged boulder field with some rock outcrops and isolated pockets of fine sand and mud, and included some rocks forming the base of the rip-rap embankment. The average depth was approximately -5 m (-16 ft) MLLW. Nearly all of the submerged rocks throughout this zone were colonized by a mixture of algal understory types, but green sea lettuce was particularly common. Giant kelp was also common with a dense algal understory of perennial foliose and branched species (**Figure 5**). Detritus and fine sediments occurred as a layer covering some of the rocks, and drift (detached and disintegrating) algal blades were present. The cover of fine sediments resulted from quiescent conditions in the interior section of the intake cove; there are no currents and very little wave motion that would otherwise prevent these layers from accumulating. Sea cucumbers (*Parastichopus parvimensis*) and bat stars (*Patiria miniata*) were common macro-invertebrates.

**Figure 5.** Rocky habitat at a depth of -3 m (-10 ft) MLLW in Zone 2 with a dense understory of red algae and green sea lettuce (*Ulva* spp.).

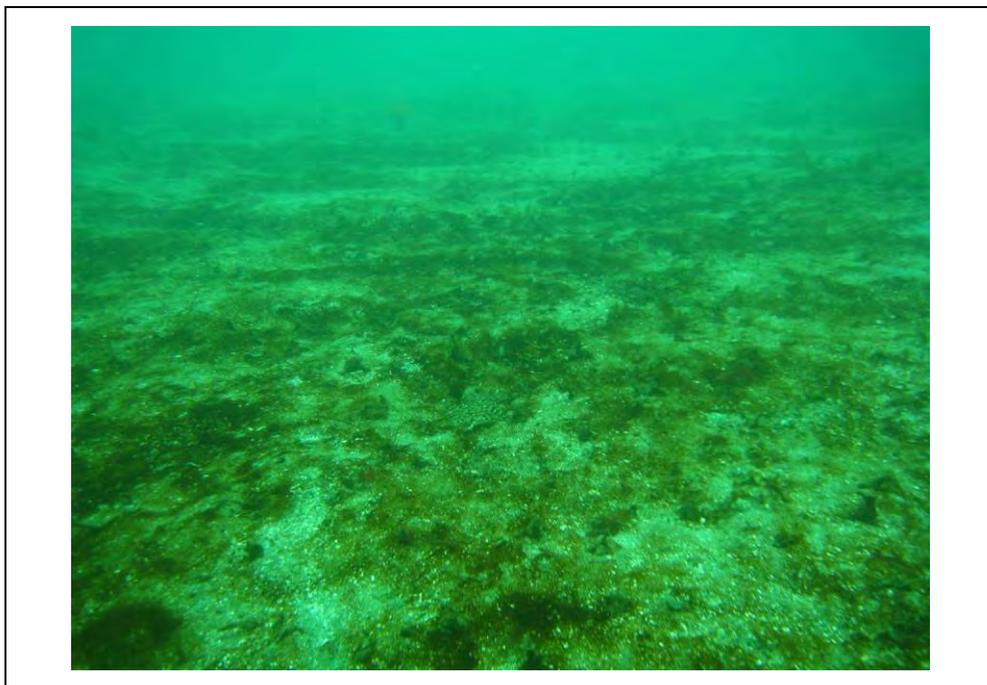
**Zone 4:** The area between the entrance to the intake cove and the DCPD intake structure is largely a compacted sand bottom (**Figure 6**) influenced by onshore currents generated by operation of the DCPD cooling water intake. The bottom was at an average depth of approximately -10 m (-33 ft) and was populated with ornate tube worms (*Diopatra ornata*), benthic filamentous diatoms, and the annual brown alga *Desmarestia* spp..

**Figure 6.** Low-relief sand area at a depth of -10 m (-33) ft MLLW in Zone 4 between the east and west breakwaters. The dark patches are clusters of low-growing foliose brown algae and benthic filamentous diatoms.

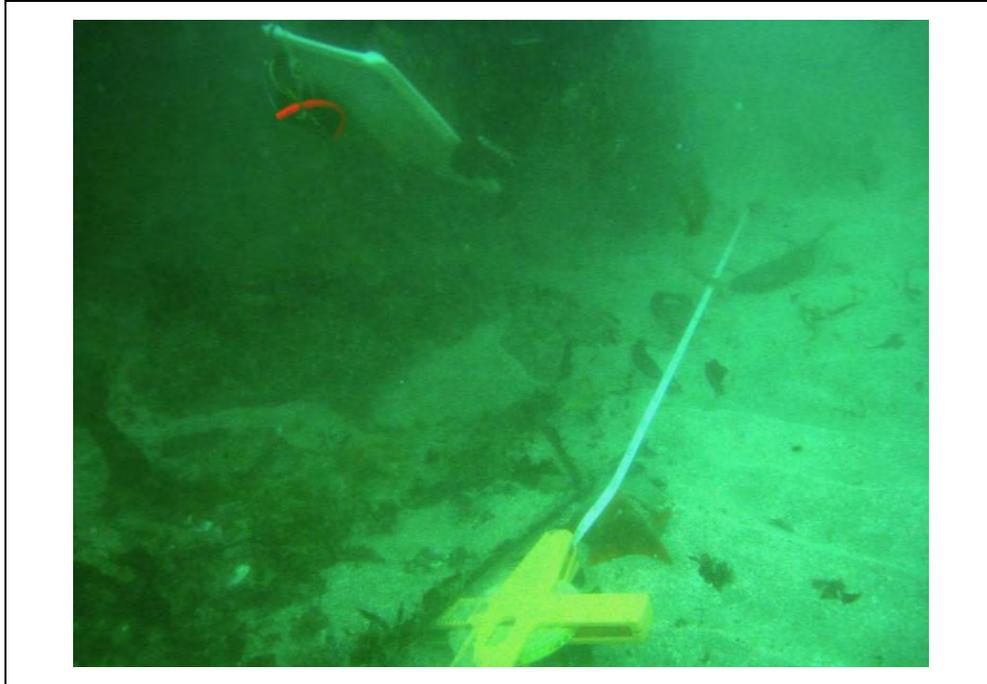
**Zone 5:** The seabed at the entrance to the intake cove is a slope comprised of rocky outcrops and large boulders emerging from the surrounding sand base (**Figure 7**). This zone also includes some concrete tribar fragments and granitic rocks forming portions of both breakwater bases. The average depth was approximately -17 m (-56 ft) MLLW during the survey. The rocks were colonized with subsurface kelps (*Pterygophora californica* and *Laminaria setchellii*), and common macroinvertebrates included bat stars, anemones (*Corynactis californica*, *Urticina* spp.), and several species of encrusting colonial invertebrates (**Figure 8**).

**Figure 7.** Diver-biologist surveys transect segment at -13 m (-43 ft) MLLW depth in Zone 5. Drift algae at the sand-rock interface includes detached fronds of tree kelp *Pterygophora californica*.

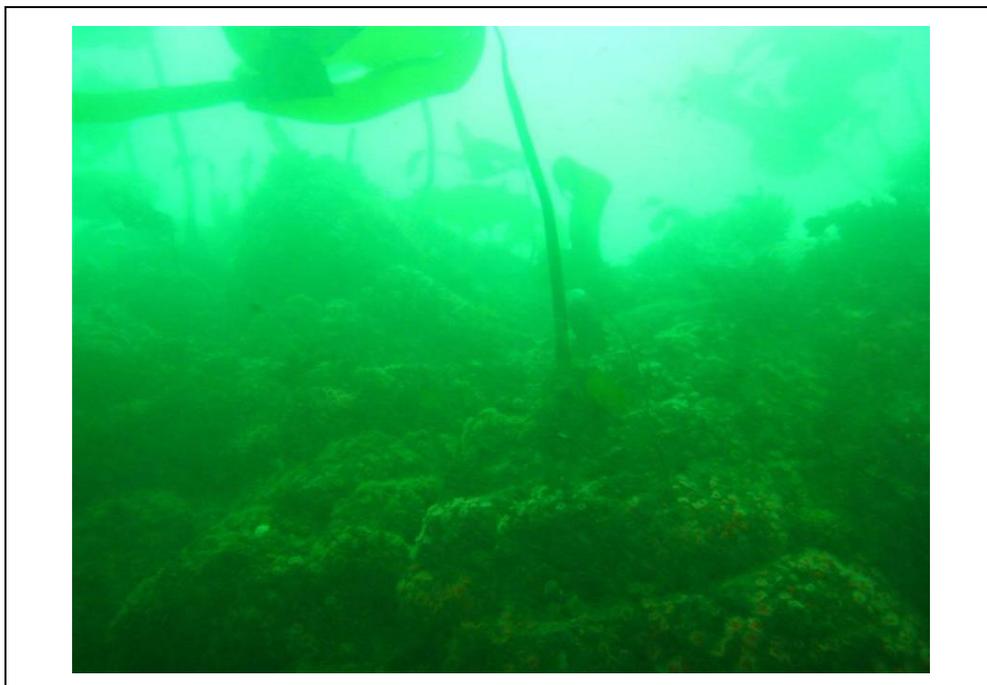
**Figure 8.** Rock outcrop at depth of -17 m (-56 ft) MLLW in Zone 5 at intake cove entrance. The sessile biota includes colonies of strawberry anemone, encrusting bryozoans and sponges along with scattered oar kelp plants *Laminaria setchellii*.

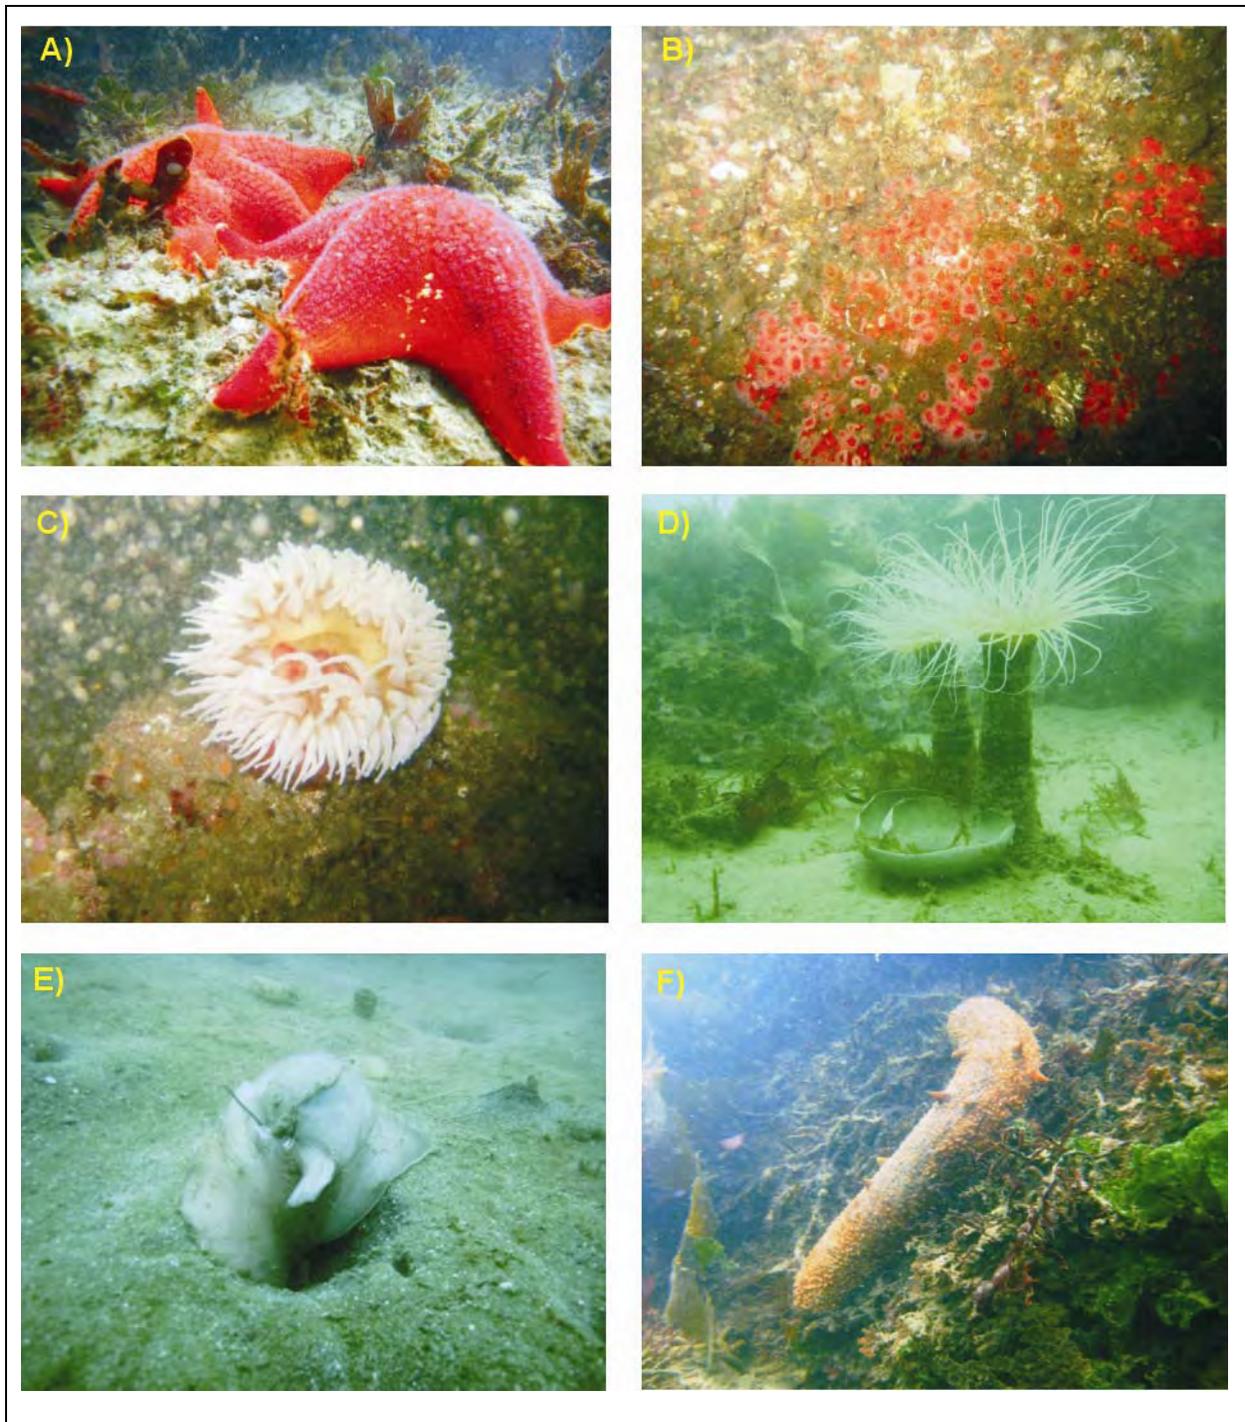
Some of the more conspicuous macro-invertebrate species observed along the transect were photographed during the survey (**Figure 9**). They include both motile and sessile species, and all can be considered common in their preferred habitats.

**Figure 9.** Examples of macro-invertebrate fauna observed along the survey corridor: A) bat star (*Patiria miniata*), B) strawberry anemone (*Corynactis californica*), C) anemone (*Urticina* sp.), D) tube anemone (*Pachycerianthus fimbriatus*), E) moon snail (*Euspira lewisii*), and F) sea cucumber (*Parastichopus parvimensis*).
