# Case Studies of Natural Shoreline Infrastructure in Coastal California

A COMPONENT OF IDENTIFICATION OF NATURAL  
INFRASTRUCTURE OPTIONS FOR ADAPTING TO SEA LEVEL RISE

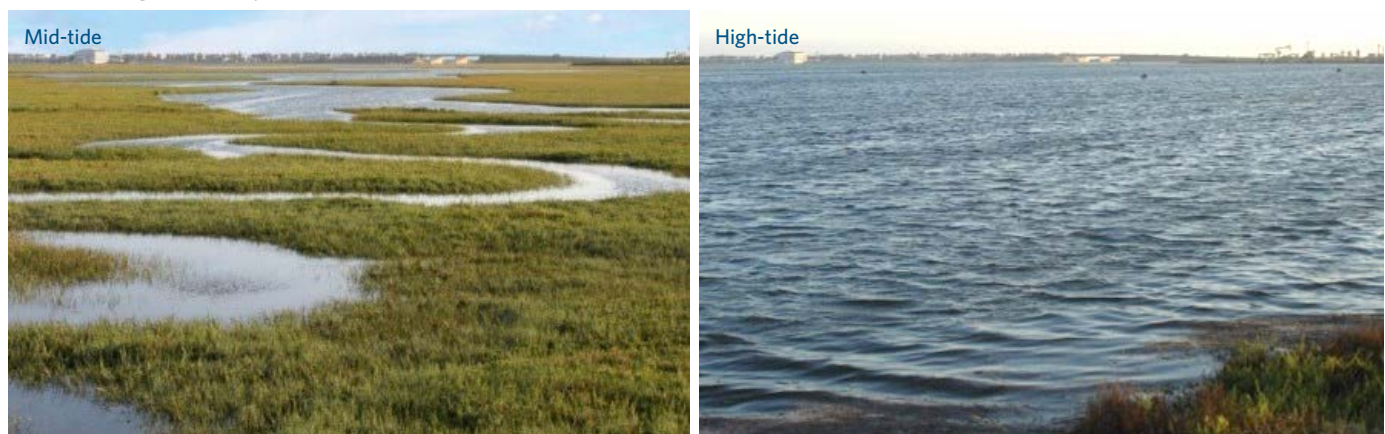
▼ **Figure 3:** Refuge before sediment augmentation at mid-tide (left) and high tide (right) showing complete tidal flooding of nesting habitat for endangered bird species. Photo credit: Rick Nye.

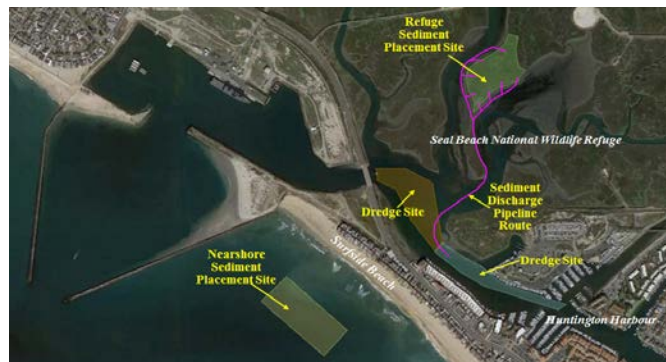
▲ **Figure 4:** Pipeline route from dredge site to augmentation site at the Refuge. The Nearshore Sediment Placement site was used in the larger dredging project and not the Seal Beach project.

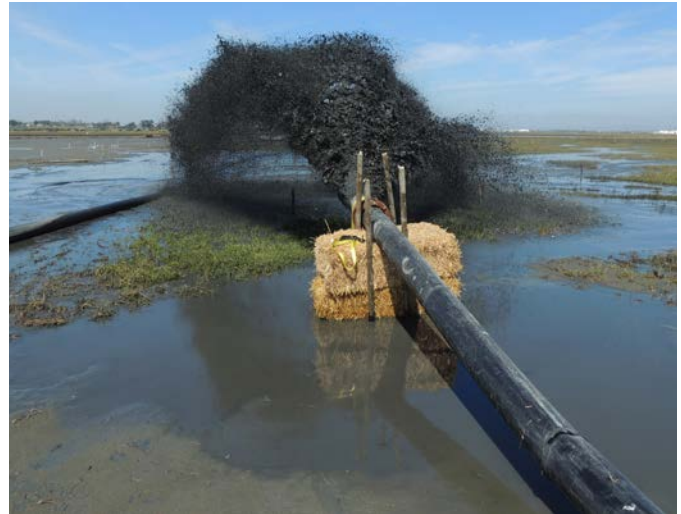
▲ **Figure 5:** 'Rainbow' spray of sediment onto the augmentation site.  
Photo credit: Rick Nye.

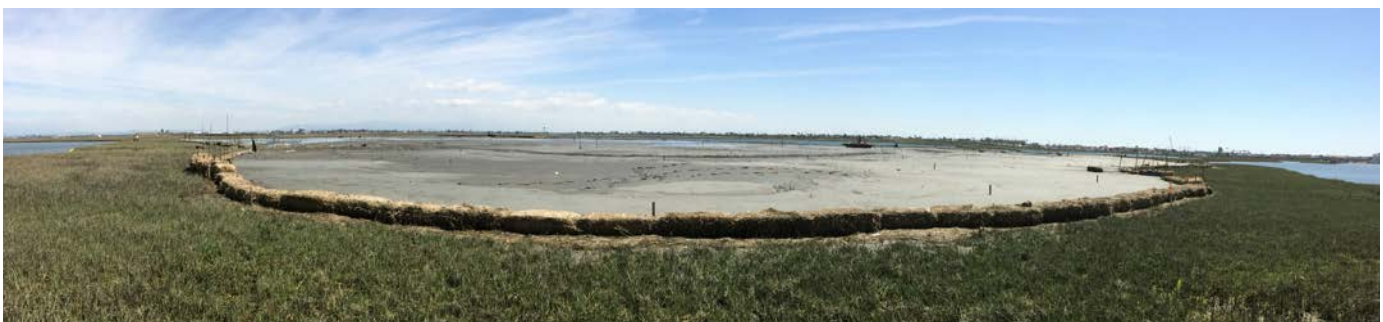
▼ **Figure 7:** Augmentation site after completion of sediment augmentation. Photo credit: Kirk Gilligan, USFWS.

of sediment in total. (Figure 7) The hay bales worked well to contain sediment except in places near channels where scouring was observed and additional measures were taken to contain sediment using sand bags, and geotextile fabric. An air horn and cracker shells were used to encourage birds to leave the spray zone, however they tended to return to forage on invertebrates in the sediment slurry and were not harmed. The last day of sediment application was April 4, 2016, although there was a considerable amount of garbage transferred along with the dredge spoils, which needed to be cleaned up. Post-construction monitoring began on June 1, 2016.

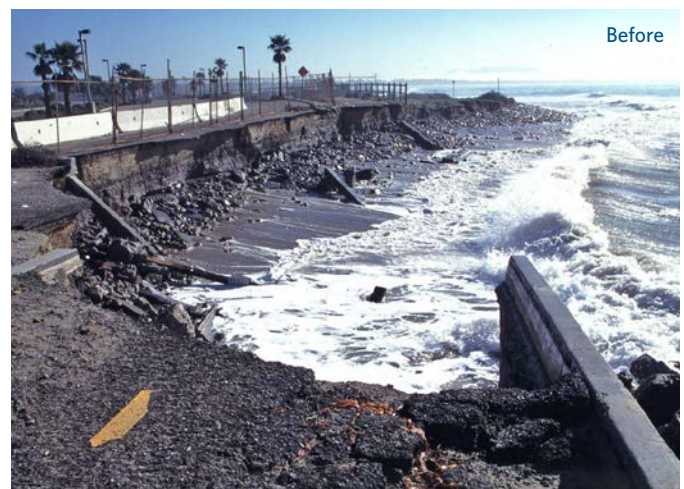
▲ **Figure 9:** Project site before landward realignment of built infrastructure and restoration of the dunes and beach. The bike path and parking lot were built on fill in 1989 and eroded within 2 years. Photo credit: Paul Jenkin.

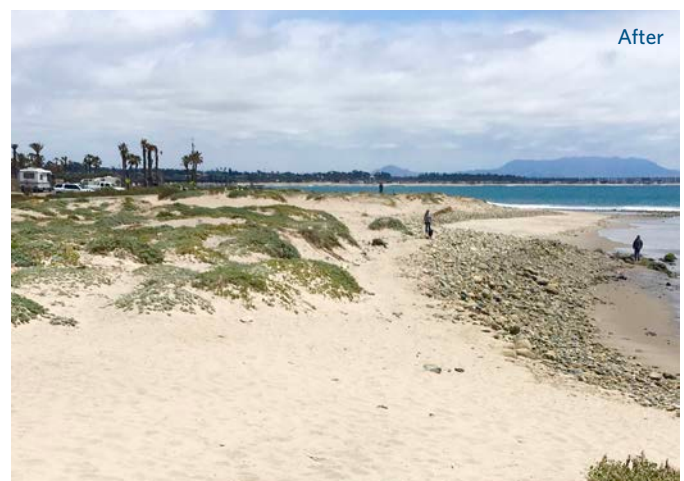
▲ **Figure 10:** Project site after managed retreat and restoration of natural processes. May 2016. Photo credit: Paul Jenkin.

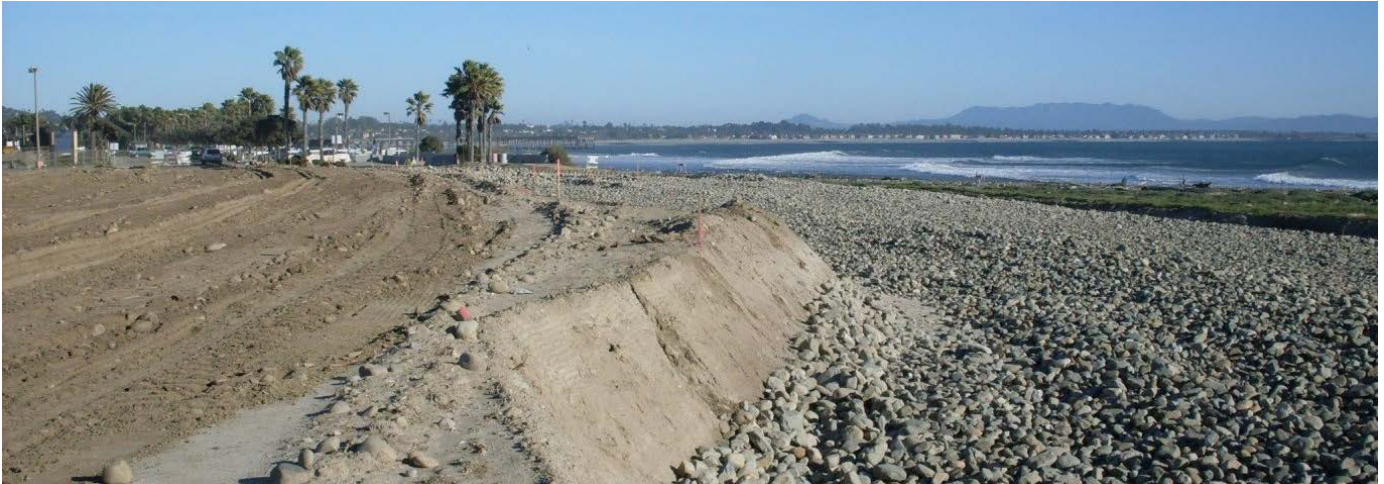
▲ **Figure 13:** After the eroded parking lot and bike path were excavated, cobble was imported and covered with sand to restore the cobble beach. 2011. Photo credit: City of Ventura.

Construction began in fall of 2010 with removal of the eroding edge of the parking lot and collapsed bike path and underlying fill. The contractor excavated test pits to confirm the depth of the fill layer and to test methods for charging the cobble voids with sand. Cobble sourced from Santa Paula Creek and sand sourced from Calleguas Creek were placed on the site and some hydroseeding was done. (Figure 13) Ultimately, the beach was widened by over 60 feet. By June 2011 the new parking lot and bike path behind the restored cobble beach were completed marking the end of Phase 1. However, by February 2012, there had been significant windblown sand transport over the flat, restored beach, causing sand build-up on the new parking lot and bike path. (Figure 14) To remedy this problem, dunes were constructed using sand from Pierpont Dunes. Contractors first placed imported dune sand in linear 4-foot high berms in April 2012 and then spread the sand in May when they installed sand fencing and additional sand from Pierpont Dunes. The sand transport issue continued, requiring maintenance to remove sand from the parking lot and bike path. In November 2012, the dunes were graded into a natural hummocky pattern with more sand from Pierpont Dunes. The dune restoration was implemented during a multiple year drought 2012-2015, led by Dave Hubbard of Coastal Restoration Consultants, Inc. The dunes were planted using seeds collected from Emma Wood State Beach in December (primarily beach bur, sand verbena and beach saltbush), and no irrigation was used, saving \$200k in project costs. Several methods were used to stabilize sand in the short-term while plants became established. (Figure 15) Surfrider Foundation and City of Ventura volunteers continue to weed the site each spring to remove primarily sea rocket (*Cakile spp.*) and ice plant, which is mostly eradicated but spreads quickly if not removed.

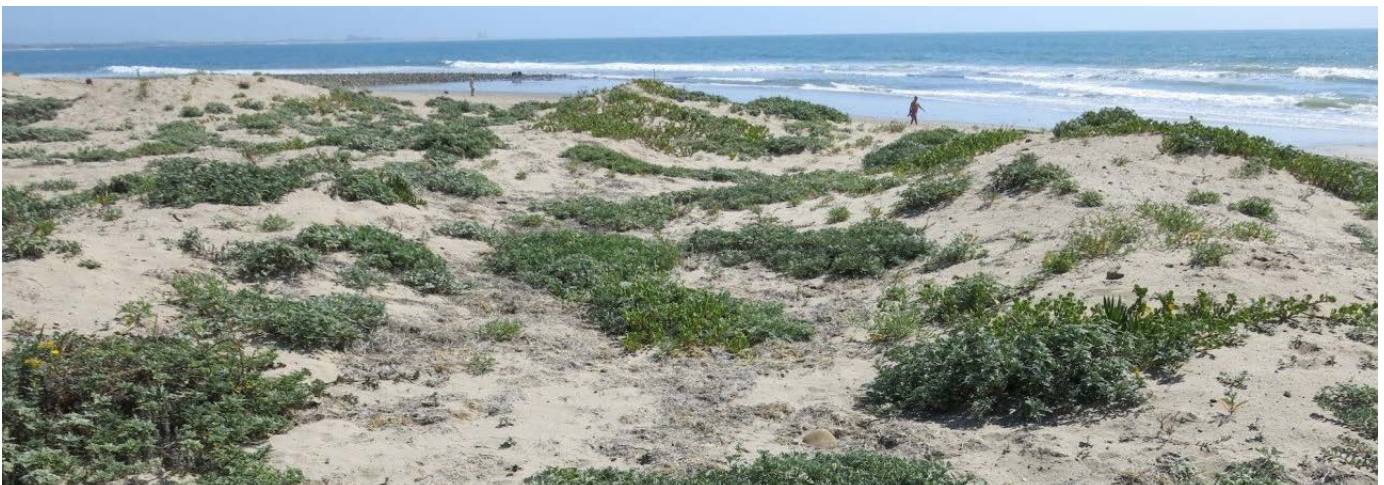
▲ **Figure 15:** Successful construction and vegetation of dunes, 2014. Photo credit: Louis White.

The areas of the beach backed by dunes have vegetated quickly and performed the job of protecting the space behind them from flooding during large storms. (Figure 15) Of interest, during high wave conditions in the 2015-2016 winter while other shore areas were damaged, no damage was experienced at the Surfers' Point Retreat project, and wave runup was documented to reach the bike path only where dunes were absent, in the area left flat to facilitate kite surfer activity (ESA 2016). In contrast, significant damages occurred elsewhere in the region due to these storms, including damage

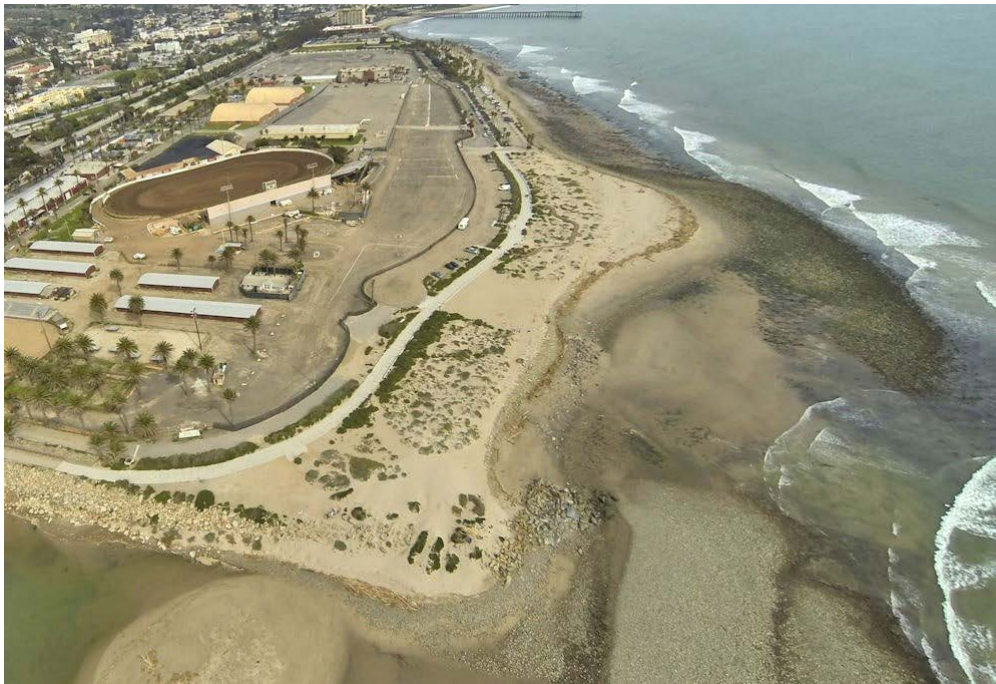
▼ **Figure 16:** Aerial view of project area after flood events, showing delivery of sediment from Ventura River and the dynamic nature of this site. March 10, 2017. Photo credit: R. Wilborn, Virtual Terrain Tours.

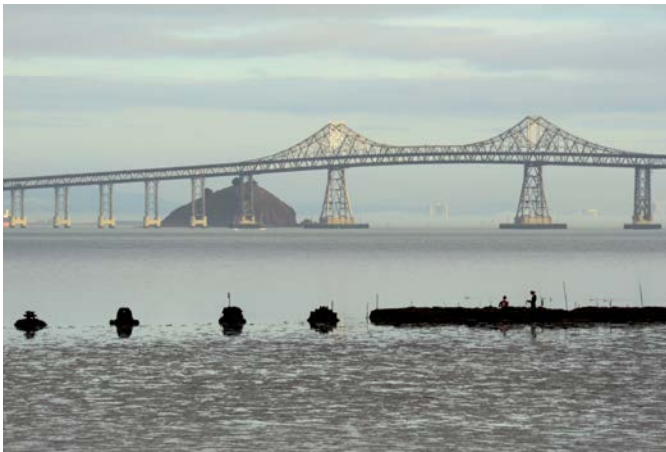
▲ **Figure 17:** Mounds of Pacific oyster half shell and baycrete structures off the San Rafael shoreline in San Francisco Bay. Photo credit: Sally Rae Kimmel.

- Clean Pacific oyster half shell (*Crassostrea gigas*) bagged up and placed into mounds is an excellent material to build reefs for oyster recruitment, and the shell bag mounds provide physical shoreline protection. The bottom portion of mounds became buried in sediment, so future designs should replace the bottom portion of the mound with baycrete or other material that is less valuable than clean half shell.

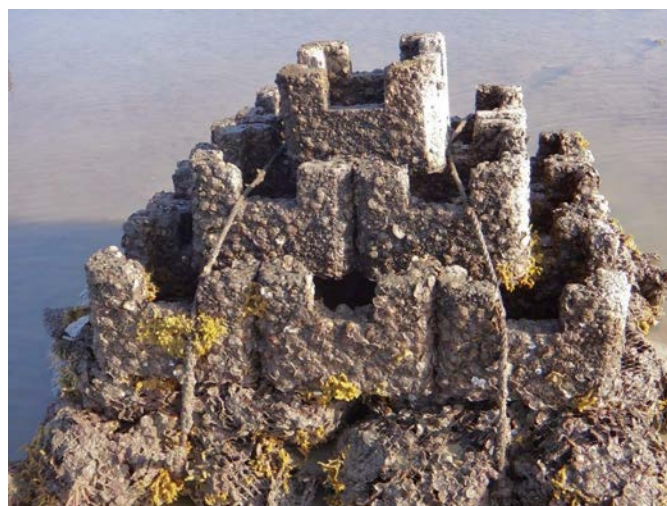
▼ **Figure 20:** Baycrete structure colonized by native Olympia oysters. Photo credit: Stephanie Kiriakopoulos.

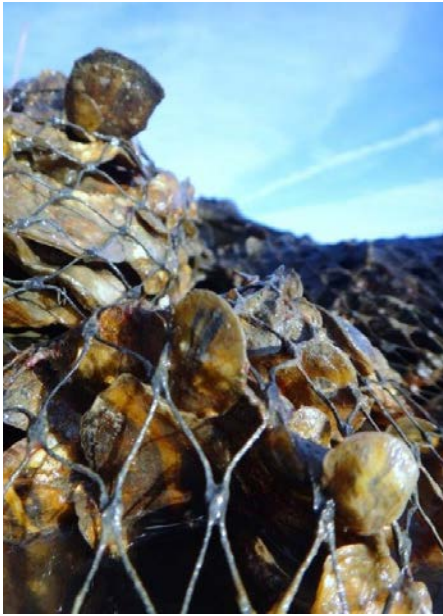
▲ **Figure 21:** Olympia oysters readily recruited to bags of clean Pacific oyster half shell. Photo credit: Stephanie Kiriakopolos.

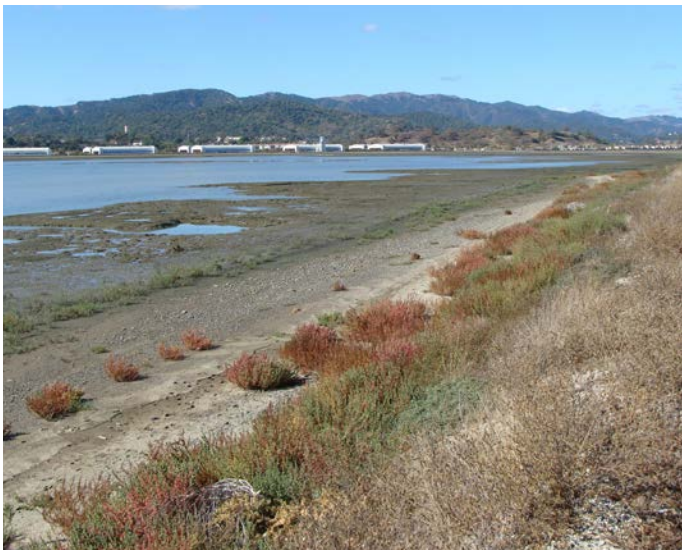
▲ **Figure 29:** The habitat-friendly levee bench on the north side of the project after 1.5 years has vegetated and resisted erosion although it has settled more than expected and may require additional sediment placement. Photo credit: Damien Kunz.

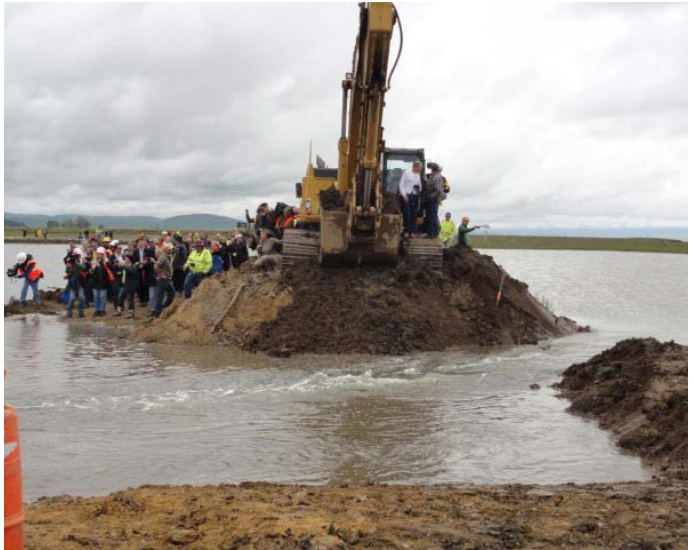
▲ **Figure 32:** Bayward levee was breached to restore site to full tidal action on April 25, 2014. Photo credit: USACE.

On April 25, 2014 the bayside levee was breached, restoring tidal action to the site and supporting natural sediment accretion, colonization of marsh vegetation, and use of the site by invertebrates, birds, and fish. (Figure 32) The USACE leads an adaptive management and monitoring plan and group. The nursery manager performs vegetation monitoring; bird, fish, invertebrate, sediment, wind conditions, and water drainage are monitored by ESA; and structural performance of the perimeter levee is monitored by USACE. The site is expected to reach full maturity between 2030 and 2050, although factors such as sea level rise and low levels of natural sediment accretion could delay or prevent the site from becoming fully restored.

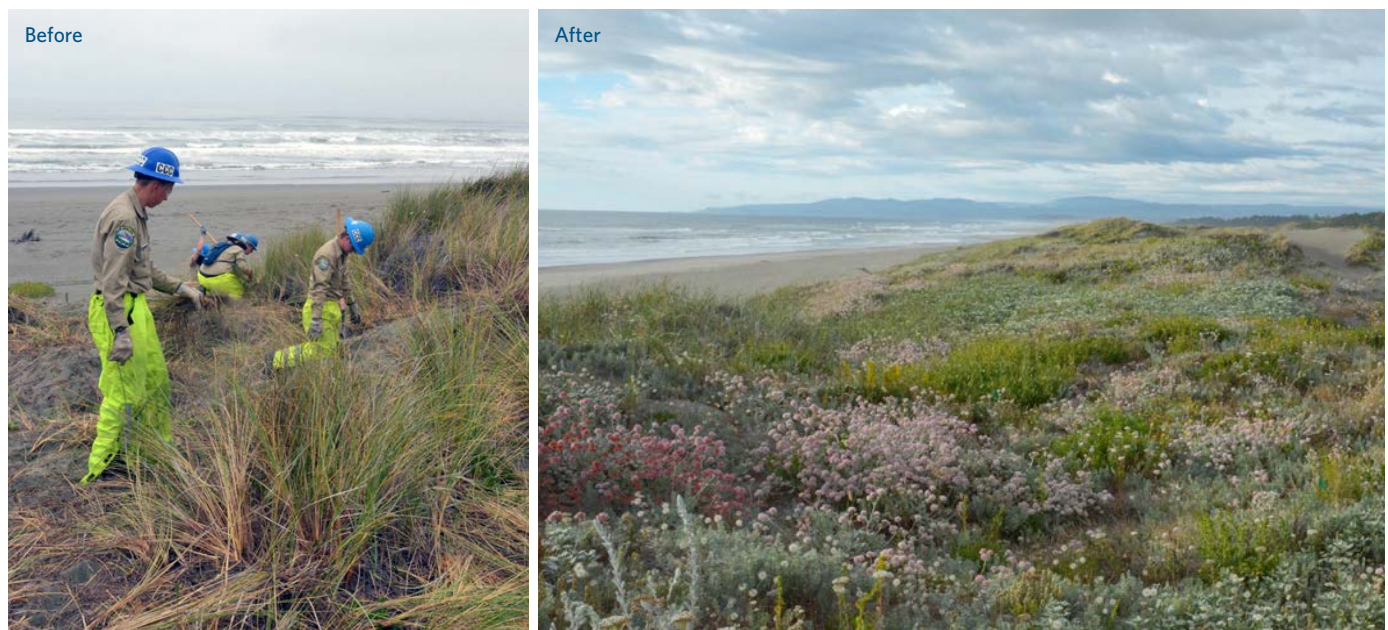
▼ **Figure 33:** European beachgrass being removed from dunes (left) to allow native vegetation and natural dynamics to return (right). Photo credit: Andrea Pickart.

The coastal barriers that enclose Humboldt Bay and the Eel River Estuary have historically supported expansive and diverse dune habitats. Much of the area was degraded by the intentional introduction and subsequent spread of non-native, invasive European beachgrass (*Ammophila arenaria*) and other species that overstabilize the dunes and crowd out native plants and animals. Beginning in the 1990s with the Lanphere dune restoration, land managers began collaborating to restore the dune ecosystems by removing non-native grass and, to a lesser extent, planting the native dune-building grass species. (Figure 33) Extensive dune restoration projects and monitoring have continued throughout this area since that time. To date, over 6 km of shoreline has been restored along the North and South Spits. This effort has returned the native dune species assemblage and restored dune system functions.

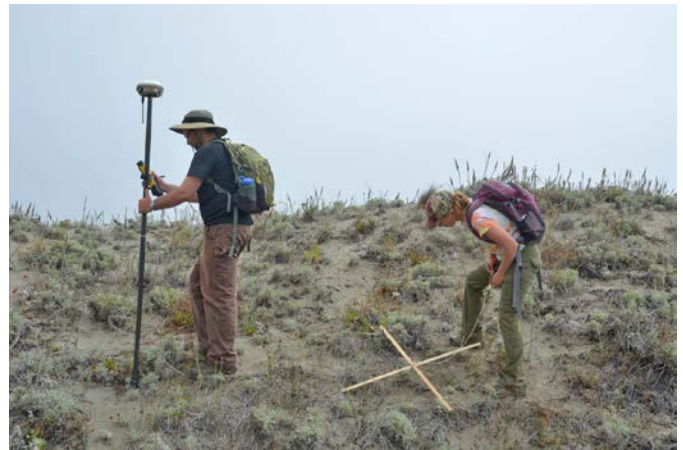
▲ **Figure 35:** Vegetation and RTK-GPS elevation surveys. Photo credit: Andrea Pickart.

Three surveys have been completed (winter 2016, summer 2015, winter 2017) and a fourth is in progress (summer 2017). Funding for two additional surveys has been secured (winter 2018 and summer 2018). Survey results have not been quantitatively analyzed, but show a trend of beach-dune recovery throughout much of the littoral cell following two extreme winters (2016 El Niño and 2017 characterized by extreme high water events). In the southern portion of the littoral cell, where a sediment deficit was presumed, recovery has not been observed, suggesting greater vulnerability.
